63555/X/01

**HOLDING DOWN BOLT FAILURE
INVESTIGATION**

ARMY AND NAVY FLYOVER

18 October 2018

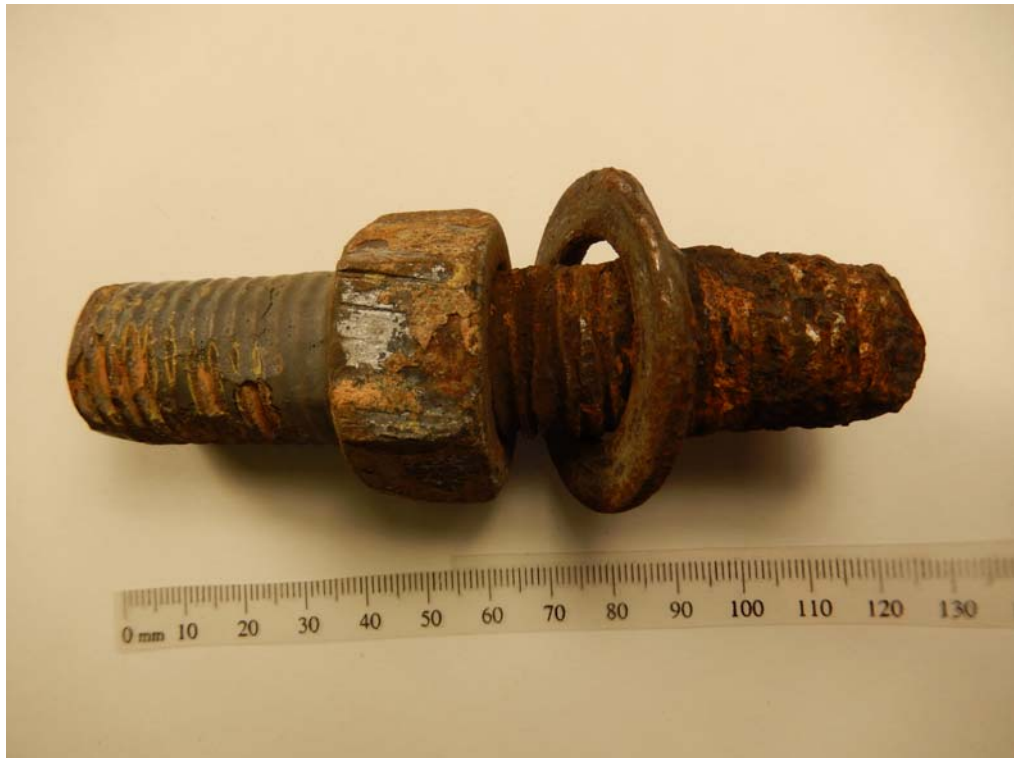
- 3.2.1 Samples were examined visually under bright light conditions taking particular note of the surface condition on the bolts. The fractured ends which had detached from the bolts are shown in Photographs 1 and 2, presented in Appendix A. It is of note that the

- 3.2.2 Where the threads pass through the width of the flange there was evidence corrosion, in the form of dark brown deposits which were firmly adhering to the bolt. Towards the lower end of these sections, where the bolts passed through the grout, the corrosion was associated with a major loss in cross section.

Photograph 1 End of failed holding down bolt, sample MY 774, showing coated threads above the mounting plate and corroded threads below the level of the mounting flange, in an area that would be surrounded by grout.

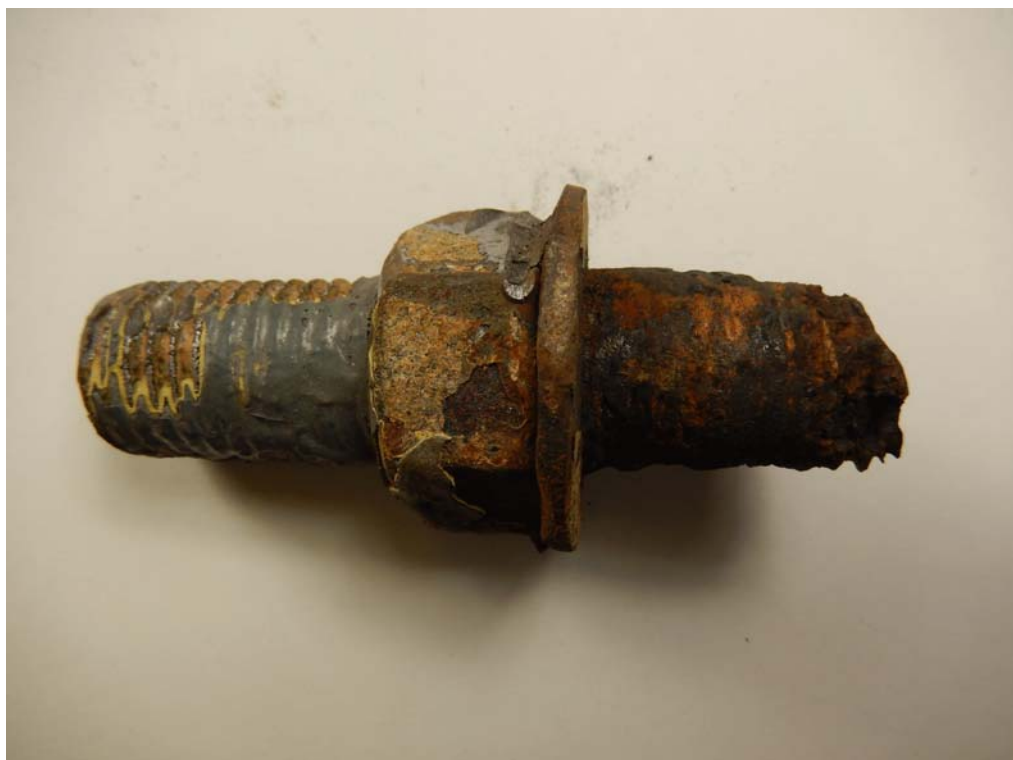
Photograph 2 End of failed holding down bolt, sample MY 775, showing coated threads above the mounting plate and corroded threads below the level of the mounting flange, in an area that would be surrounded by grout.

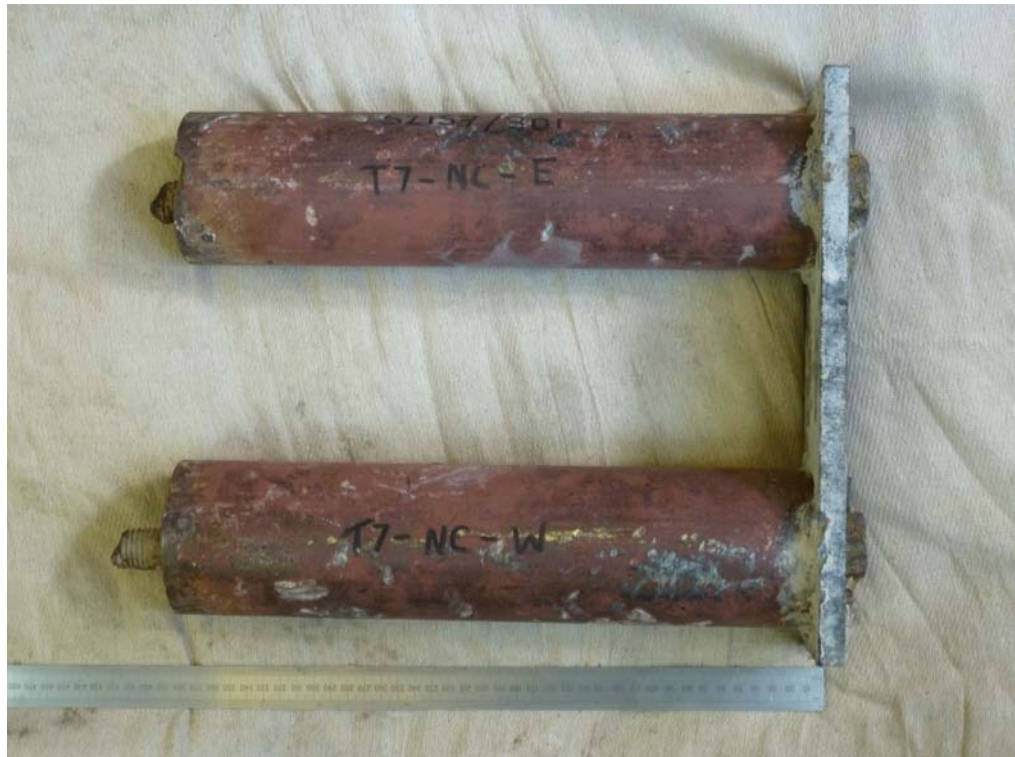
- 3.2.3 Examination of the grout tube samples confirmed that the holding down bolts had been inserted from the underside of the plate and passed through the length of the tube. Failure of the bolts was beyond the end of the grout within the tube, Photograph 3.

Photograph 3 Metal tube filled with grout surrounding the holding down bolts. Bolts had been inserted from the underside, such that the threads were uppermost to engage with flange under column.

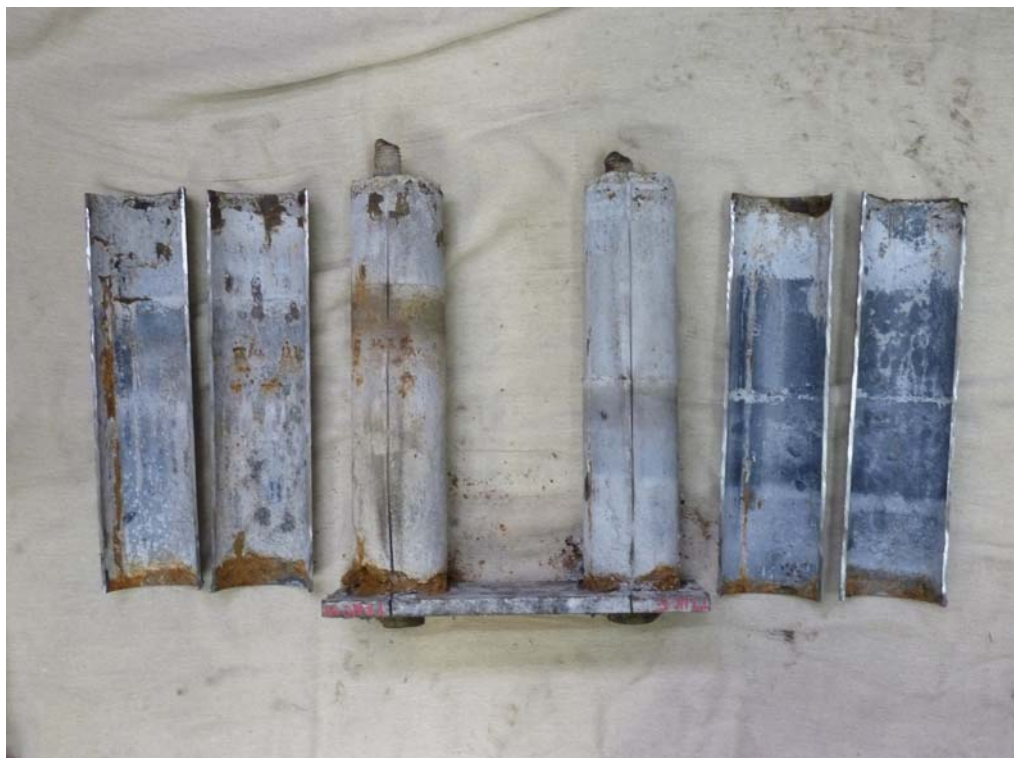
- 3.2.4 To examine the condition of the bolts within the grout, the steel tubes were sectioned and removed, Photograph 4. From the discolouration on the grout columns it would appear that the grout had been filled in stages.

Photograph 4 Metal tubes removed exposing grout fill. Grout in tubes appears to have been filled in two goes, with an interface between the separate fill materials.

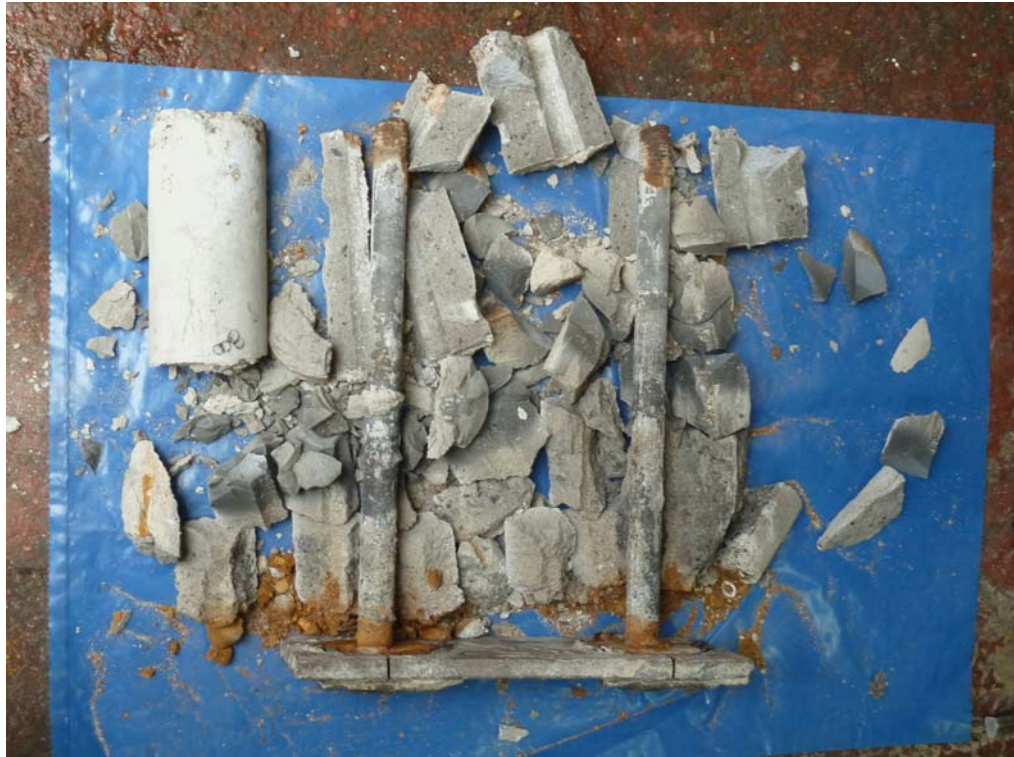
- 3.2.5 Grout was removed by crushing to expose the bolt shanks, Photograph 5. The shanks of the bolts were noted to be unaffected by corrosion in the area that had been within the grout tubes.

Photograph 5 Grout removed to expose shanks of holding down bolt. There was no evidence of corrosion or section loss of the bolts over the length within the grout tubes.

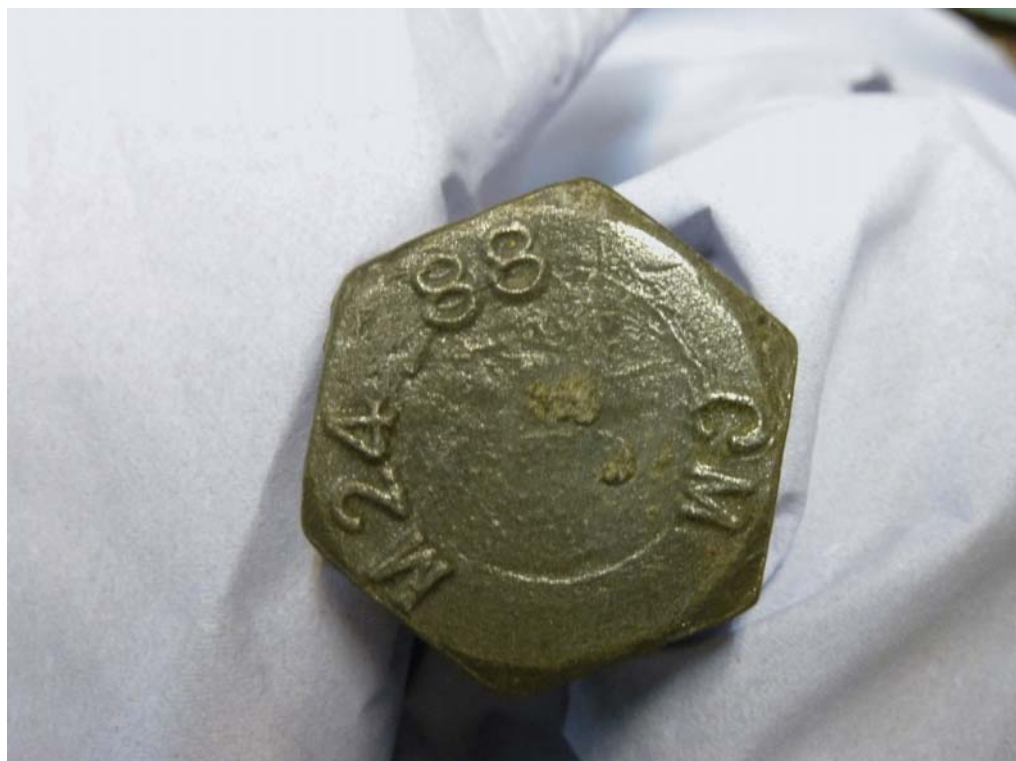
- 3.2.6 Examination of the markings on bolt heads, Photograph 6, confirmed that these were strength Grade 8.8, M24 diameter bolts. It was not possible to identify the manufacturer from the 'CM' marking.

Photograph 6 Head of bolt showing size, 'M24', grade '8.8', and manufacturer's mark, 'CM'.

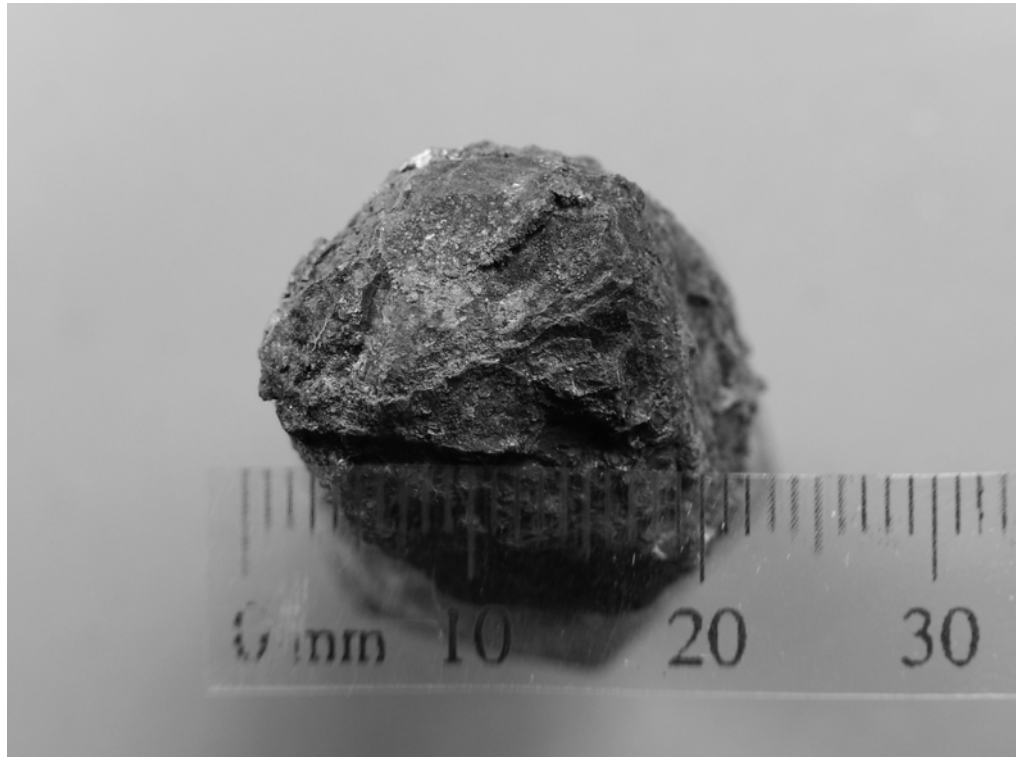
- 3.3.2 The end of sample MY 774 was completely corroded, however, there were still some features remaining which would be consistent with the presence of a fracture. This would indicate that after a major loss in cross section due to corrosion the bolt had failed mechanically. The mode of failure could not be positively determined due to the level of corrosion but may be consistent with a tensile action. Following failure the bolt had remind in-situ and many of the features associated with the fracture had been destroyed by further corrosion.

Photograph 7 End of sample MY 774 showing complete loss of section due to to corrosion. There was no evidence of fracture on this sample.

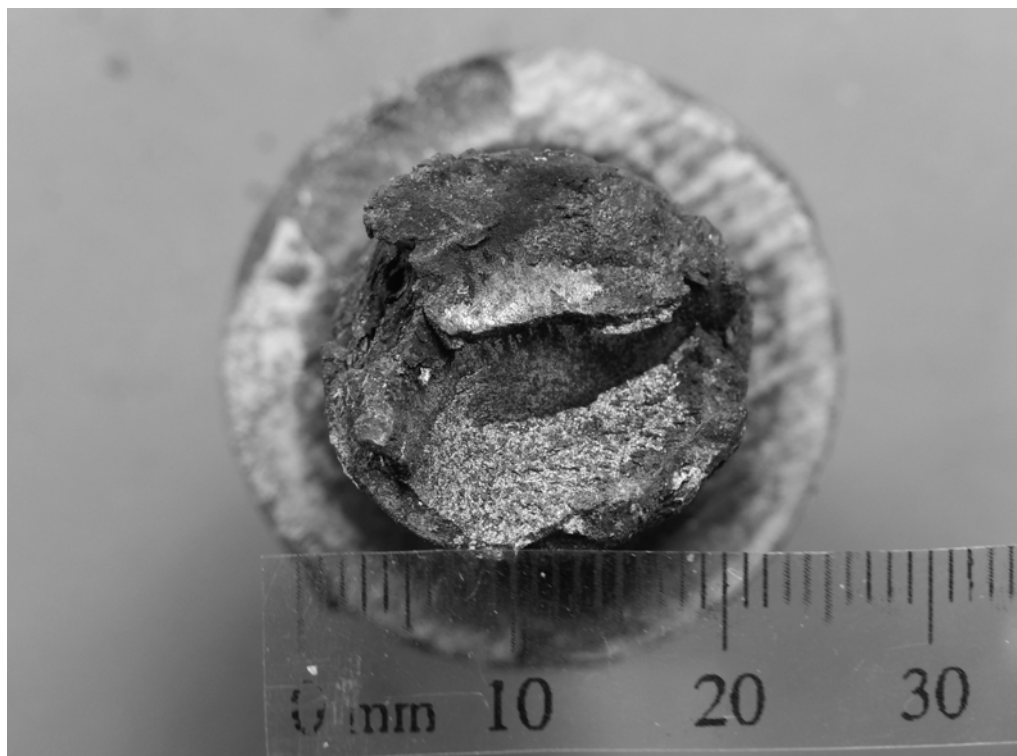
- 3.3.3 The end of sample MY 775 had also been subject to severe corrosion. In this case there was still evidence of a metallic fracture face, Photograph 8. The area of final fracture was estimated to be around 25-30 % of the original cross section.

Photograph 8 End of sample MY 775 showing large loss in cross section due to corrosion. Final fracture associated with bolt failure was around 25-30 % of the original cross section.

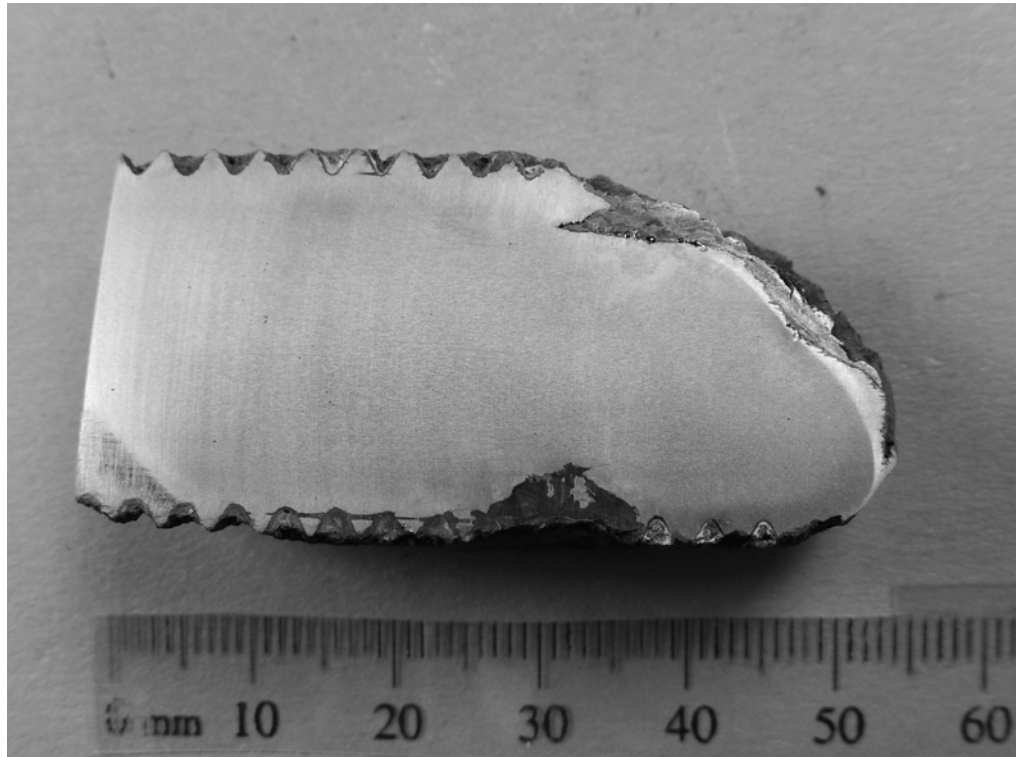
Photomicrograph 1

- 3.4.1 Sections were taken through the failed ends of the bolts and prepared for metallographic examination.
- 3.4.2 Section through MY 774 shows major corrosion around the end of the bolt where it failed, confirming the absence of any fracture features, Photomacrograph 1, presented in Appendix A.

Section through MY 774 showing loss of cross section due corrosion in the area which had been in the grout under the flange at the base of the column. There was no uncorroded that could be associated with failure under load.

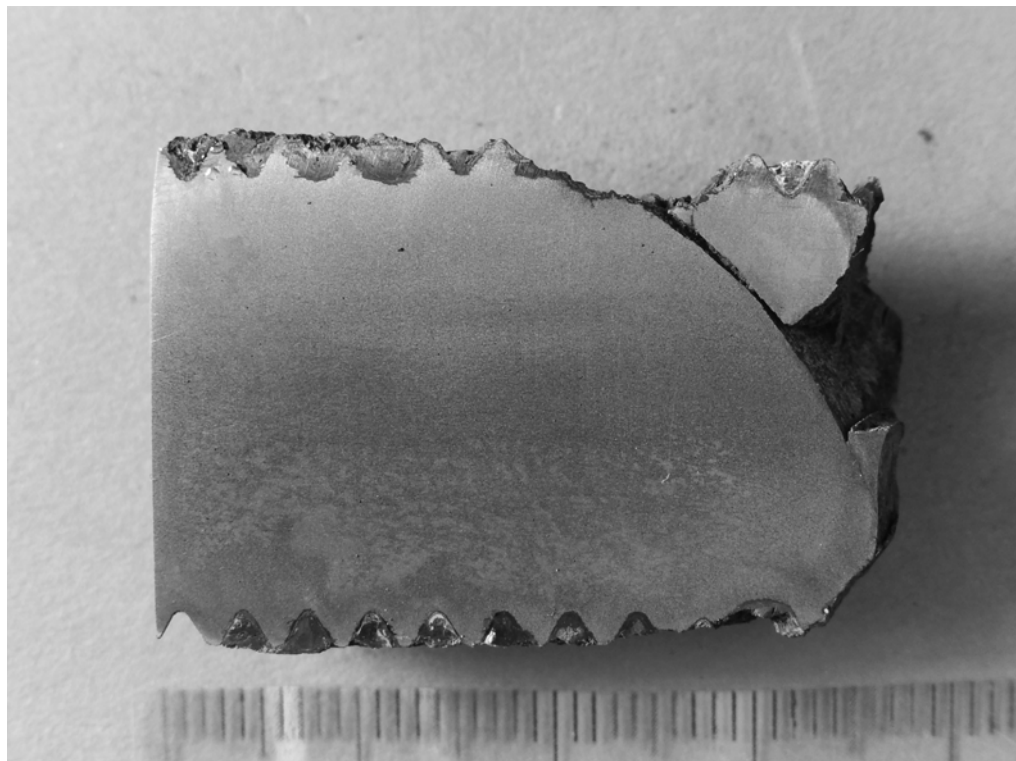
Photomicrograph 2

- 3.4.3 Similar corrosion is present on the section through MY 775 but the end of the sample is more sharply defined, Photomacrograph 2. The profile of the fracture would be indicative of shear rather than tensile failure.

Section through MY 775 showing loss of cross section due corrosion in the area which had been in the grout under the flange at the base of the column. The area of the fracture was small compared to the original cross section.

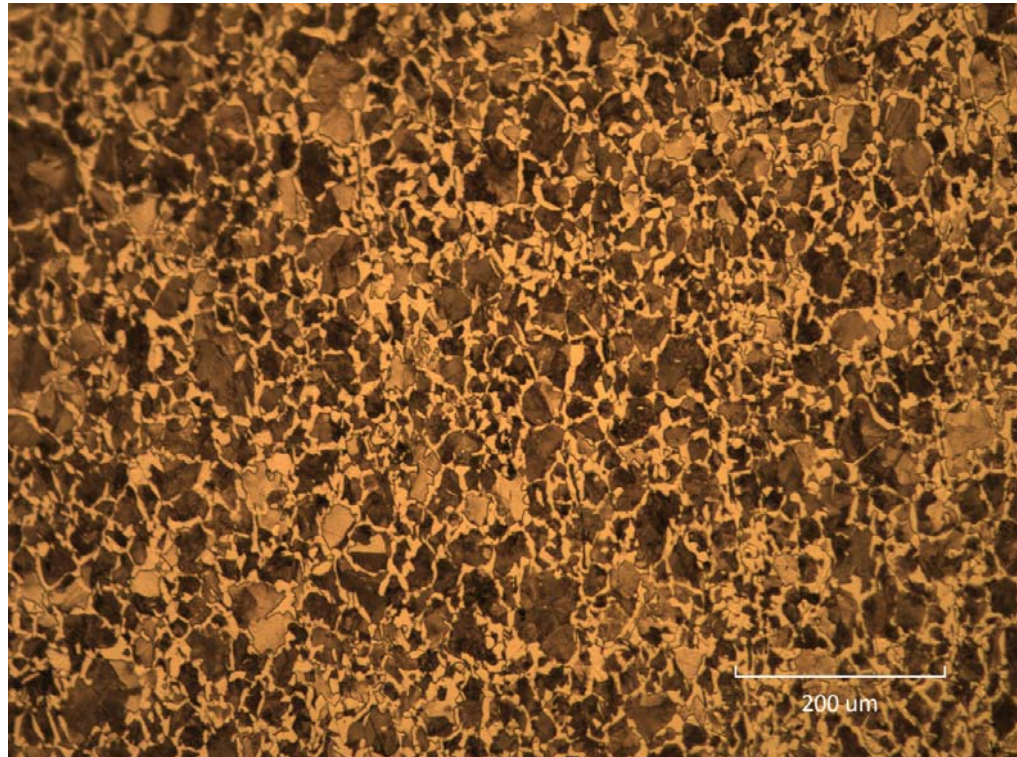
Photomicrograph 1

- 3.4.4 The section through MY 775 was mounted in Bakelite and prepared to a 1 µm finish and then etched in 2 % Nital for a more detailed examination of the matrix, shown in Photomicrograph 1. This was a primarily pearlitic matrix with fine equi-axed grain structure, delineated by fine ferrite grains, typical of a normalised medium carbon, i.e. 0.3-0.4 % C, steel.

Matrix of the bulk material showing fine grains of equi-axed pearlite delineated by fine grains of ferrite typical of normalised steel. The percentage of pearlite would indicate that it was medium carbon, i.e. 0.3-0.4 % carbon, material.

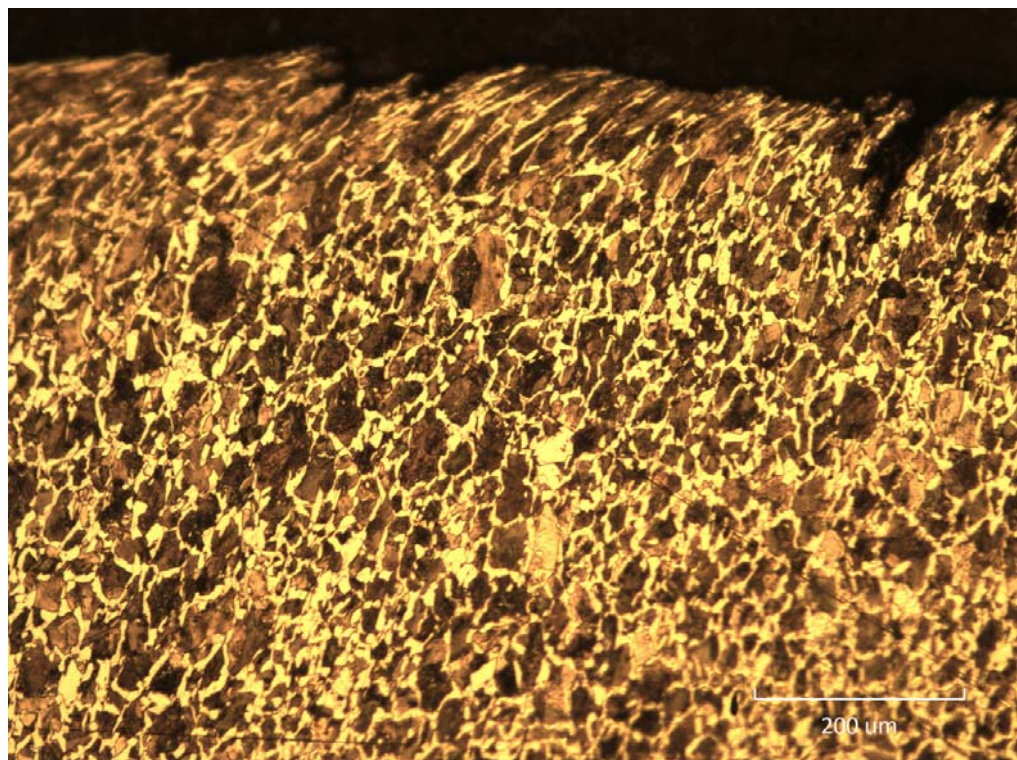
Photomicrograph 2

- 3.4.5 Examination of the section through the fracture face confirmed the presence of deformation at the surface, Photomicrograph 2. This would be consistent with failure under a shearing action.

Matrix of the steel at the fracture face showing evidence of deformation that would be consistent with failure in shear.
