Boxted Bridge - Questions and Answers

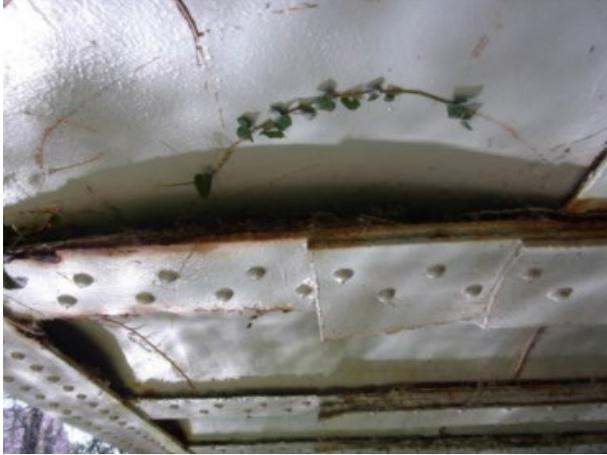
The possibility of repairing the current structure was explored during the early stages of the Option Study process, prior to considering the replacement of the structure. The structural form of the bridge, as well as its current condition, are prohibitive factors to undertaking effective structural repairs without replacing the structure as a whole. The bottom flanges of the transverse elements of the structure have deflected due to corrosion (refer to image 1). Replacing these elements would require the dismantling the inner deck apart from the main structural beams due to the configuration of the structure.

Above - Image 1: Plate deflection of transverse beams

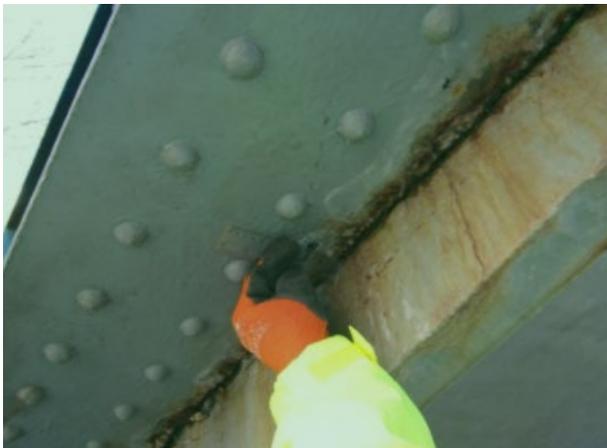
The main structural girders’ bottom flanges also present significant corrosion of the bottom flanges (refer to image 2). Due to the location and spacing of the rivets plate bonding would not be effective to strengthen these elements and these beams would also require replacement.

Above - Image 2: Corrosion of main edge girders

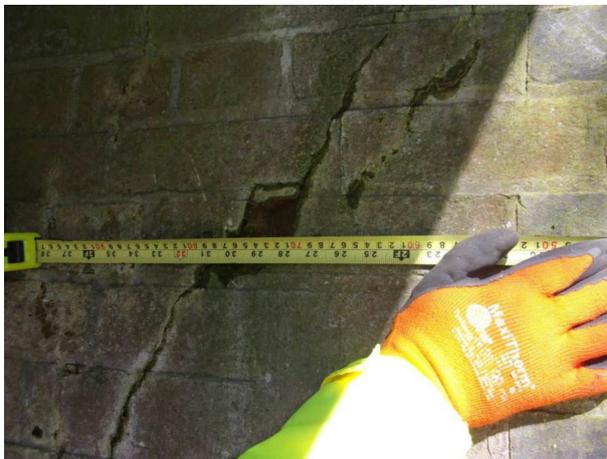
In addition to the severely corroded steel beams, both abutments have large cracks from top to bottom (image 3 and 4). The north-east wingwall has also cracked and separated away from the abutment (image 5).

Above - Image 3: North Abutment

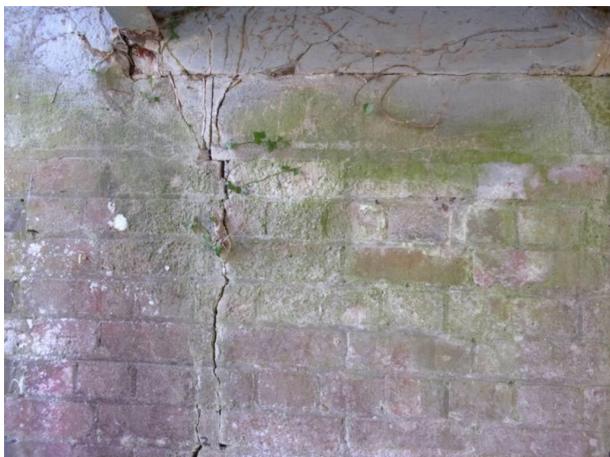
Above - Image 4: South Abutment

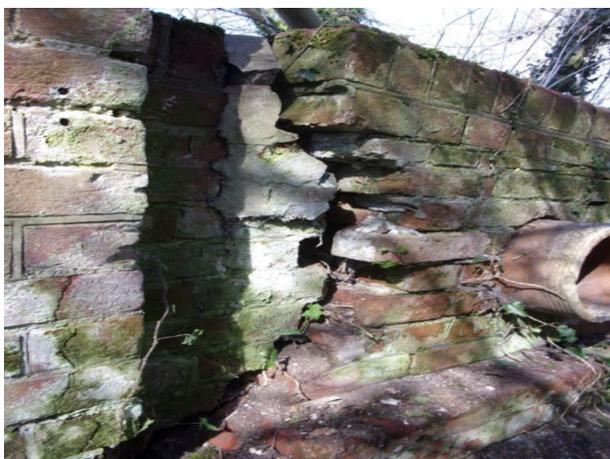
Above - Image 5: North-east wingwall
