TECHNICAL NOTE

Boxted Bridge ECC Br. No. 0059

Proving Load Test Commentary

December 2025

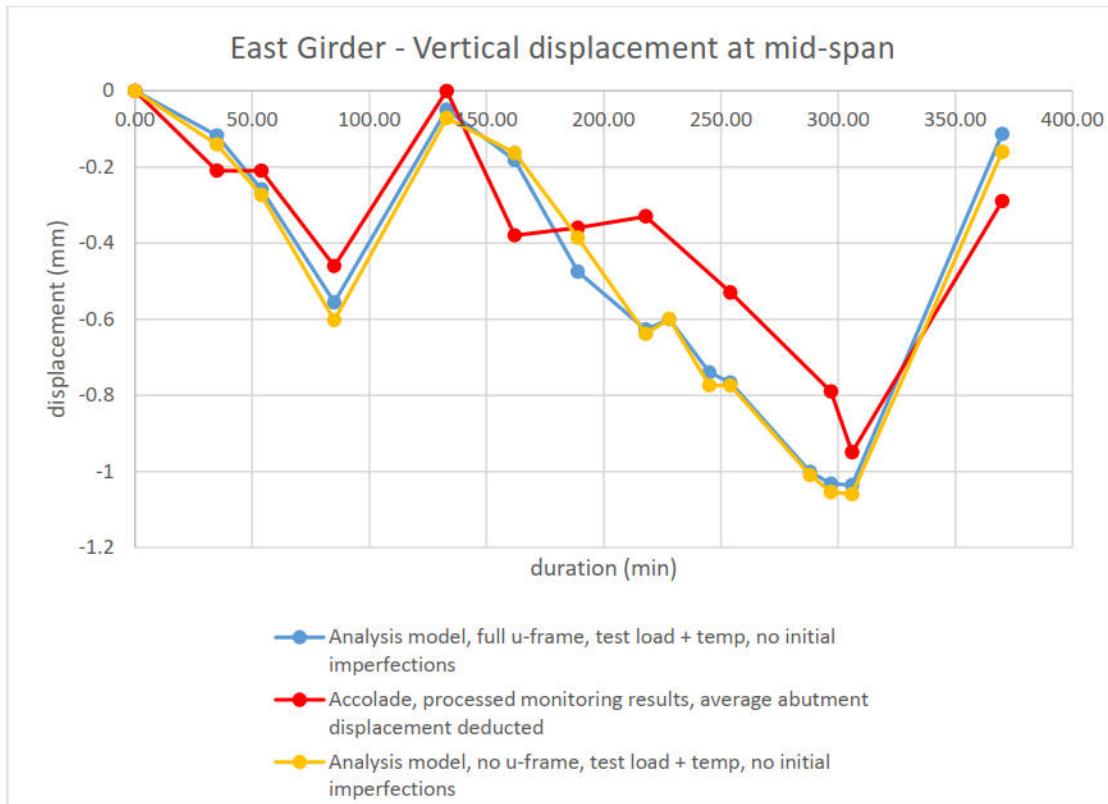
Figure 3. Boxted Bridge - mid-span vertical movement

A comparison of the predicted vertical deformation and the measurements observed during the load test at the east girder is shown in Figure 3. The graph shows how the vertical movement varied during the test. The test measurements shown have been processed where the average movement of the girder at the abutments has been deducted from the mid-span displacement, such that the deformation of the girder itself can be compared directly to the analysis model, in which abutment settlement was not assessed.

The relative vertical deformation is generally very similar to the predicted values. However, from the analysis model, a final recovery of the girder's vertical deformation of approximately 90% was expected while the test showed approximately 70% (note: the overall vertical recovery was 32% when including abutment settlement, see Appendix A).

Some of the difference between the predicted and the measured vertical deformation could be attributed to temperature variations. While the model included the effects of temperature change with each load increment, this has limited accuracy. For example, at various times some parts of the girder remained in shade while some were exposed to direct sun exposure during the test, which is not picked up by the analysis. Furthermore, Accolade confirmed that the vertical readings are generally reliable to a $\pm 0.3\text{mm}$ repeatability error which is large compared to the final deflection measured, and the differences between the analysis and the test results fall within this value.

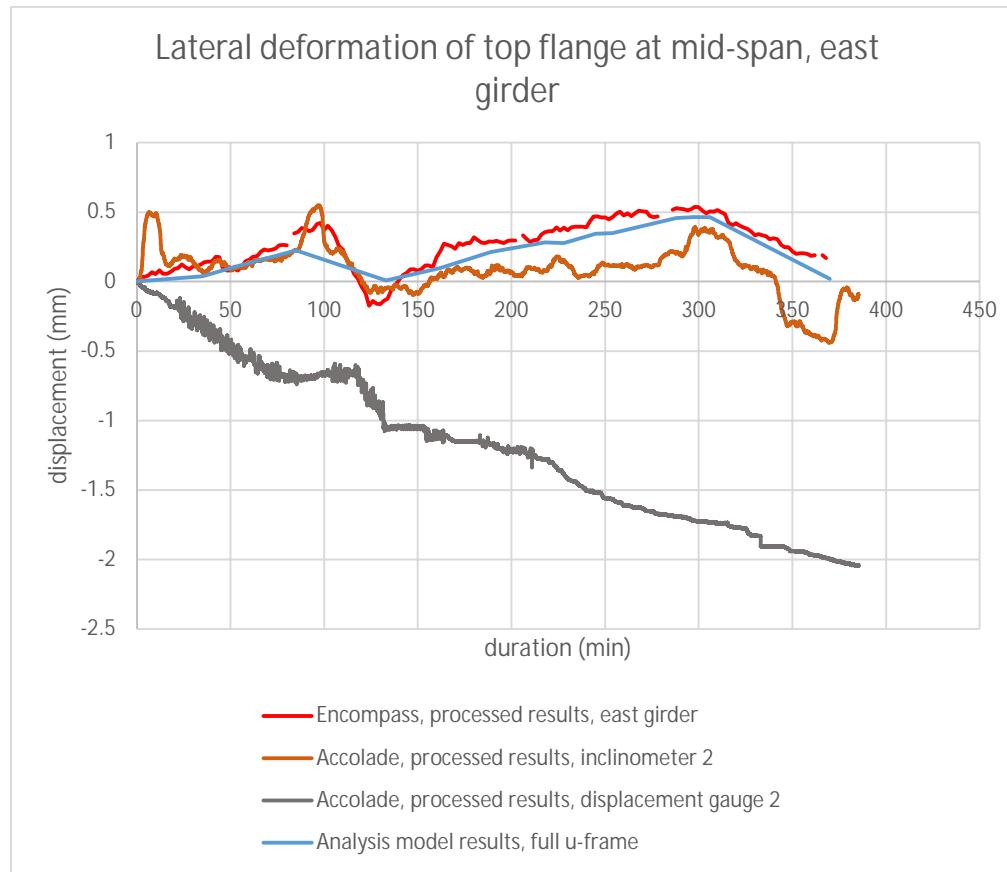
Figure 4. Boxted Bridge - east girder lateral deformation

The readings from the displacement gauges generally are not as expected, as they indicate outward movements of the top flanges. In order to verify this, the data from the tilt sensors and inclinometers was also processed and the angles of rotation converted to horizontal movement, assuming the whole girder cross-section rotates by the measured angle – the results are included in Figure 4 and Figure 5 as well.

The results from the converted inclinometer and tilt sensor data generally show the expected and desired behaviour of the girders, where the top flange moves towards the bridge as the test load is applied, and recovery can be observed when the load is removed. These results also match the output from the analysis model within a reasonable range, especially at the east girder. Similar to the case with the vertical measurements, the differences can be explained by the limited accuracy of temperature modelling, as well as unknown horizontal support stiffness, unknown details of initial imperfections of the girders, and no account of corrosion section loss in the analysis.

The different results from the displacement gauges could be attributed to the fact that the poles which they were attached to were placed at some distance into the deck and hence they could be picking up the movement of the deck itself. No other reasons to doubt the measurements were identified. As the

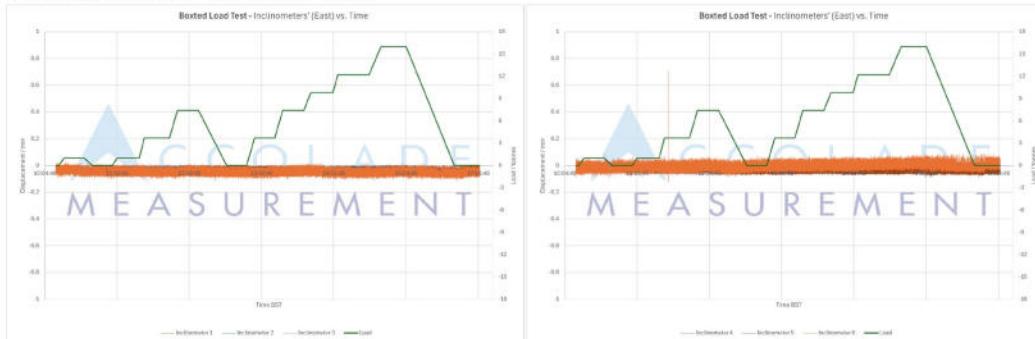
1. Change in lateral incline of the girder top flange is below the repeatability of the sensing and shows no measurable response to load. These results cannot determine pass or fail for proof loading, but raise no concerns.

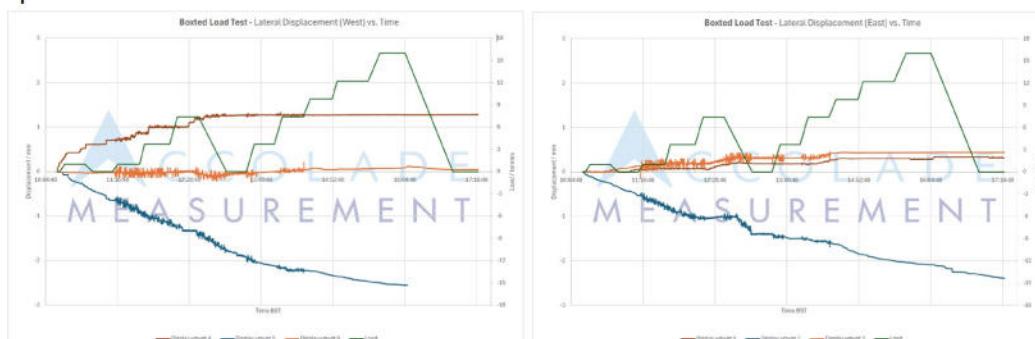
2. Horizontal movements of top flange are significant, reaching up to 2mm. There is no identified reason to doubt the validity of the measurements, though the results were not as expected. Fine jitters in the readings are noted on all these sensors at periods of stronger wind. In both girders, the mid-span reading shows outward movement (negative), increasing throughout the test. As it was not directly measured, it's hard to confirm, but during the testing there was a suspicion that the movements were increasing during times of bright sunlight, and not returning when the sky clouded over. Perhaps the deck was expanding forcing the girder apart.

The south-west corner (displacement 4) moves inwards, perhaps as a result of forced twisting in the girder, as the mid-span widens. The south-east and north-east do similarly, to a lesser magnitude.

We recommend that these results are not considered representative of the proof load testing. These have not identified any cause for concern.

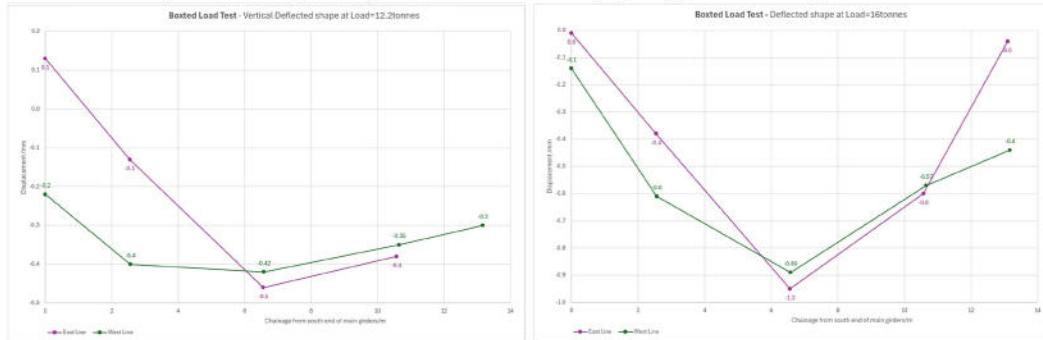
3. The bridge girders showed no detected signs of U-frame lateral torsional buckling in the test.
4. At loads up to and including 12.2 tonnes, the deflected shape does not wholly show the assumed behaviour, perhaps affected by some unintentional restraint or embedded/thermal stresses and small movements at the support positions confuse the results. At 16 tonnes, the

deflected shape is as might be predicted for a simply supported bridge.

5. Vertical displacements show small movement at mid-span, similar to the modelled predictions (conducted by Essex Highways in advance of the test). There is some evidence that the bridge has a slow response to applied loads, which is normal in reinforced concrete bridges, but not so for steel bridges and hence wasn't expected here.

Maximum movements of less than 0.5mm can be seen at the planned target load of 12.2 tonnes. At the increased upper load limit (16 tonnes) maximum movements are still no greater than 1mm.

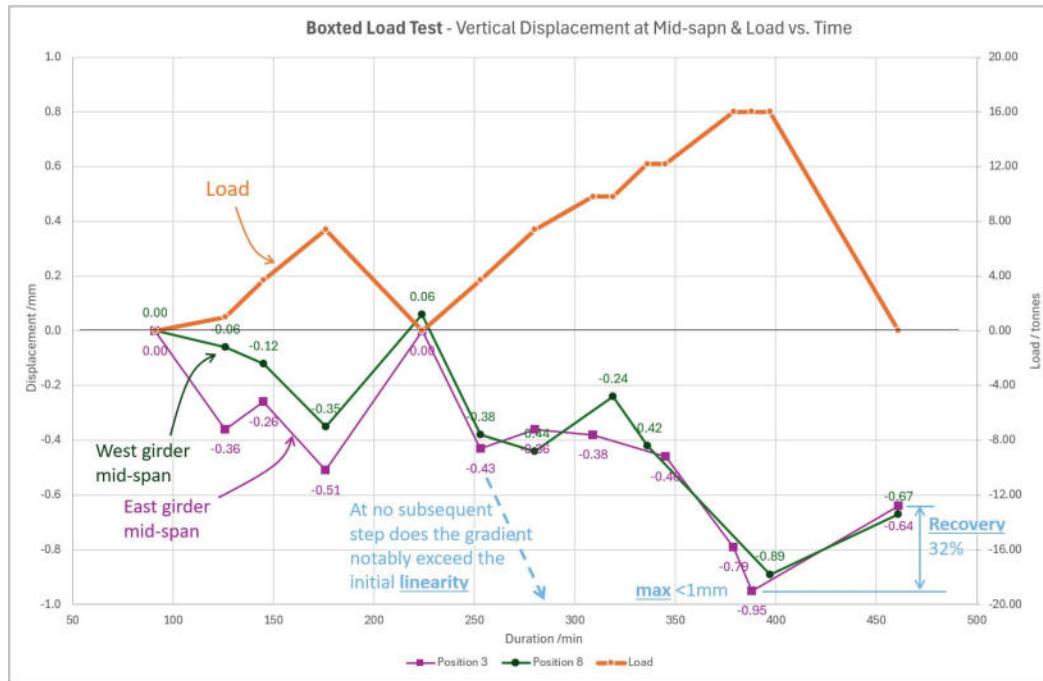
6. Linearity in the vertical displacement is acceptable. After an initial movement at low load, thereafter at no point is a gradient seen in the displacement vs. load at greater incline. This could be attributed to the slow response of the structure to load. At the lowest load on the final cycle, the bridge has recently been exposed to a greater magnitude and hence its response is swift; but as the load continues to increase the structure lags in its response to a greater load.

However, there is no sign that the linearity criteria is breached within the test.

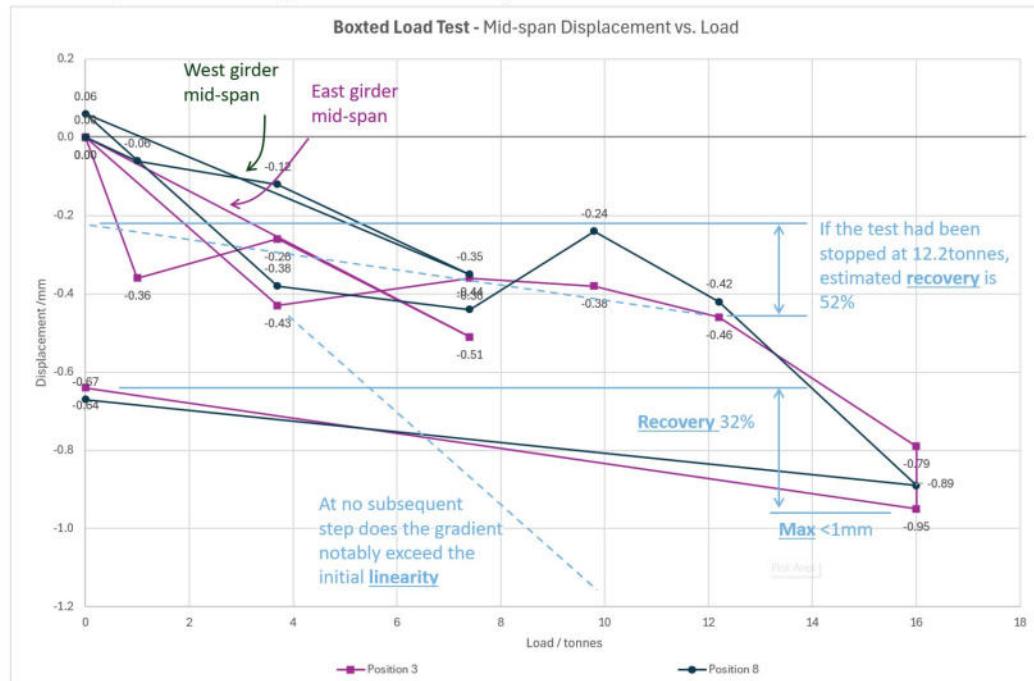
7. Recovery in vertical displacement did not meet the stop criteria of 90%. From the maximum load of 16tonnes, a recovery is seen of just 32%. Taking the same gradient of the unloading, applied from the measurement at 12.2tonnes, we can estimate that the recovery might have been 52%. On the basis that we can see some signs which infer a slow response of the structure to applied load, it can be reasoned that the same is true in the unloading. Perhaps a greater recovery would have been measured if additional vertical displacement measurements were taken later. (Time limited this on the testing day, and the reference pins have been removed.)
