Spring Lane and Bakers Lane Route study Highway Improvements

September 2015

Report Title	Spring + Bakers Lane Route Study
Project Number	DC3330
Status	Final
Revision	-
Control Date	September 2015

Maldon Road Tiptree Proposed Footway Highway Improvements Team

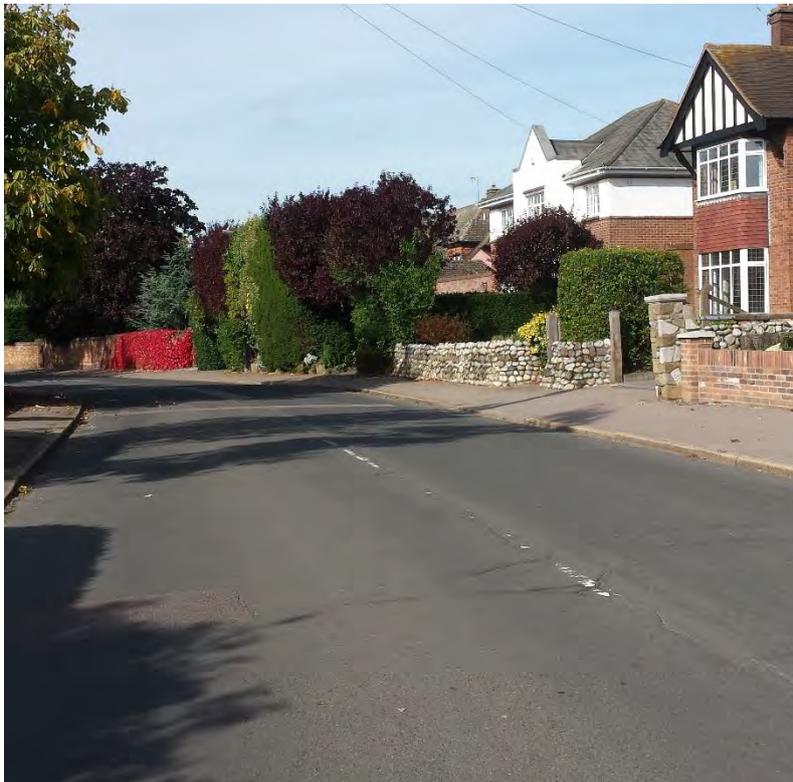
Urban section – lane markings almost lost longitudinal and transverse cracking suggesting composite carriageway

Also within the urban section there is regular transverse and longitudinal cracking which can be seen on the carriageway surface. This cracking suggests

that the original construction of the road may have been concrete, which has been overlaid with black top micro surfacing product in subsequent years.

Given the existing condition of the road a plain and in-lay treatment is recommended, this will require the existing surface course to be removed to a depth of 40mm and replaced with a new wearing course of the same depth, this approach will improve the structural integrity, skid resistance and shape of the surface.

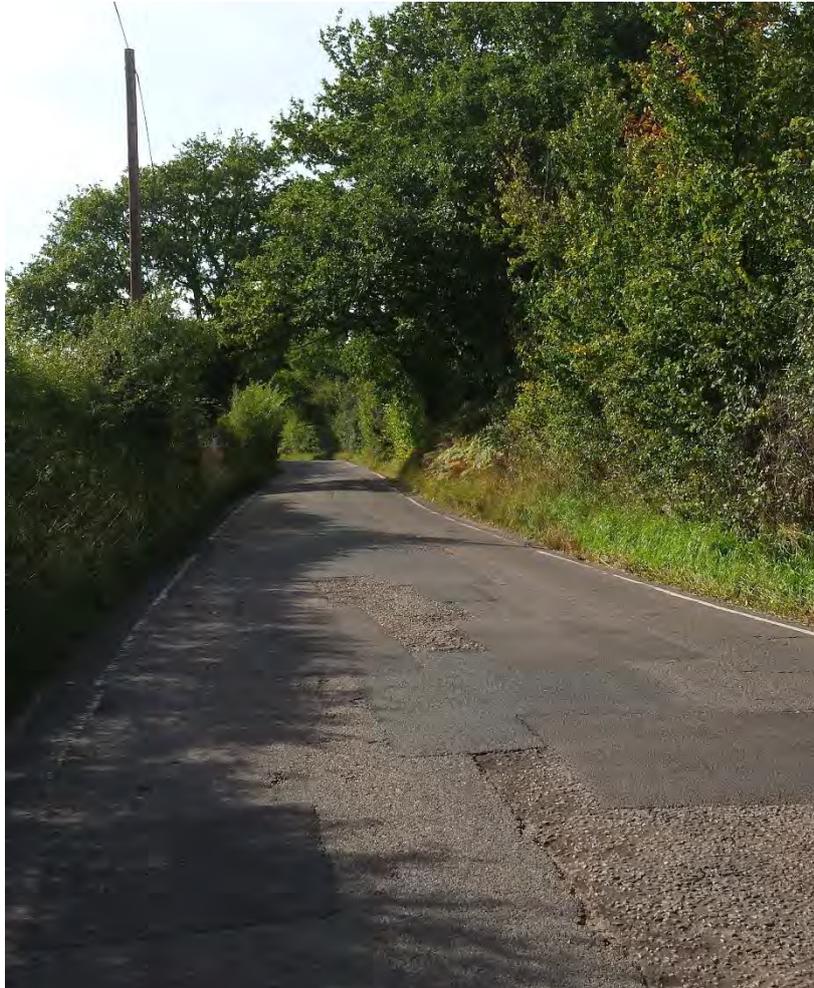
Rural section – edge markings almost lost – multiple patching throughout

On the rural section there are many patches some of which have deteriorated along the edges. The number of different materials used and the amount of patching suggest that these ad hoc repairs have been undertaken over a number of years.

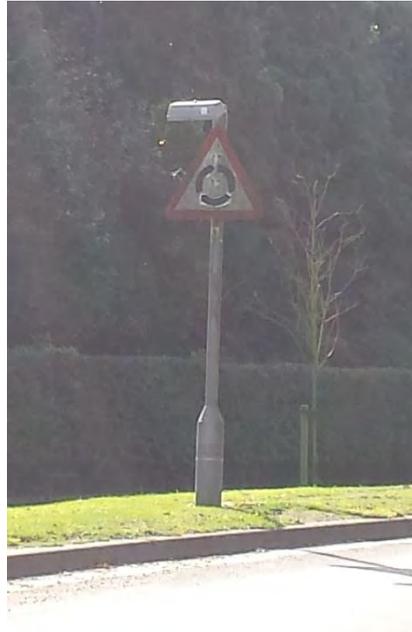
Many of the existing warning signs are very dirty and need to be cleaned so that they are suitably visible and provide the proper retro-reflectivity. Generally they appear to be in reasonable condition and relatively new however the condition cannot be properly assessed until they have been cleaned.

Roundabout warning sign approaching Spring Lane roundabout

All the signs along the route would benefit from a clean and vegetation trimming to improve the forward visibility it is recommended that these works are undertaken by the rangers as soon as possible with Bakers Bridge signing being given the highest priority.

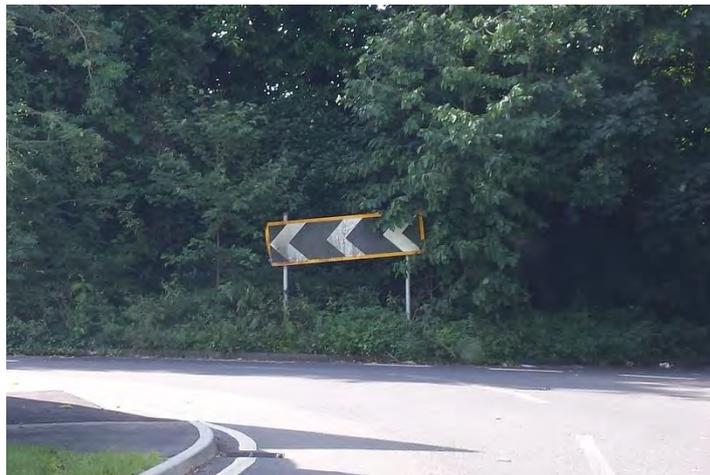
Chevron sign near Mill House

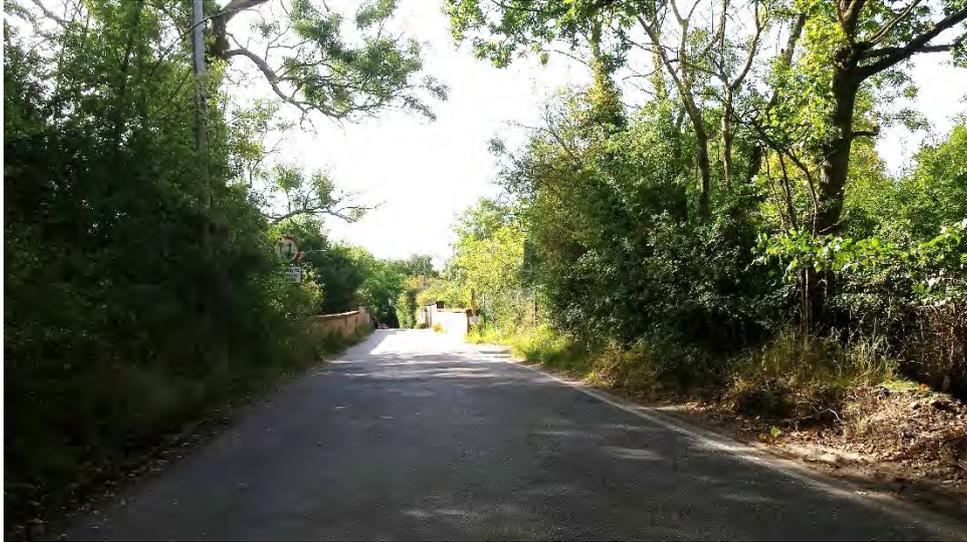
Priority working sign (nearside) at Bakers Bridge

The regulatory sign for the priority working at Bakers Bridge is partially hidden by vegetation which is of particular concern as there are no supporting give way markings. This could result in an increase in the risk of head on collisions.

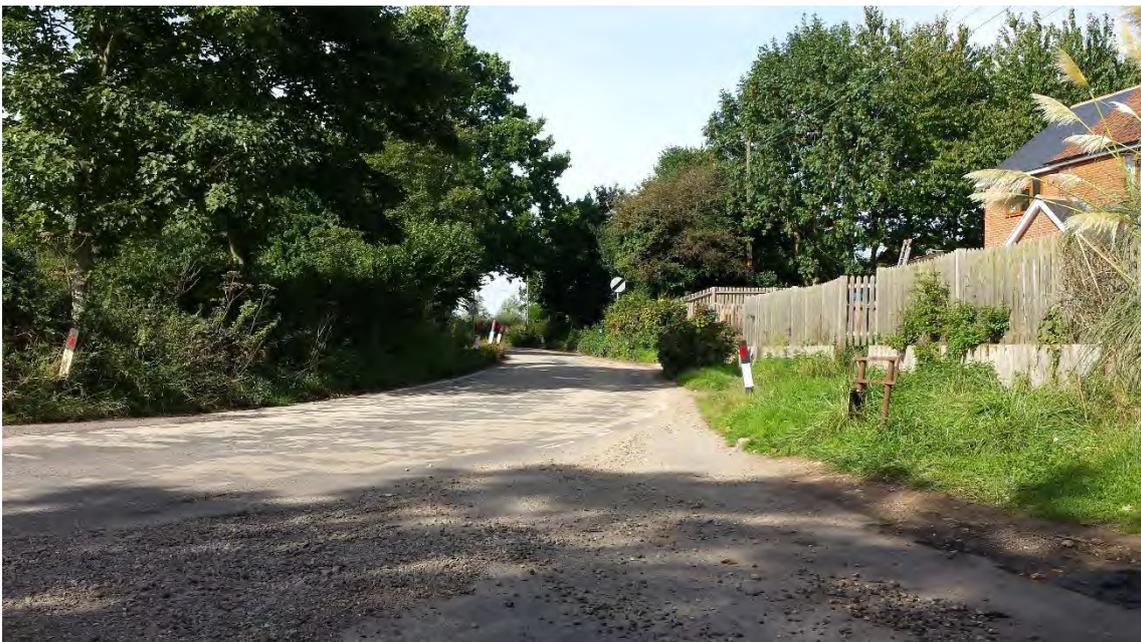
The two sections of Calcined Bauxite (High Friction Surfacing) surface within the route provide increased skid resistance but again are showing signs of deterioration as much of it is stripped off.

This surfacing has been installed to provide an increased skid resistance on the bends and as there are not any personal injury collisions recorded at either bend it appears to be working.

It is also recommended that the increased skid resistance is maintained with the bends as it is now, however rather than replacing the surface applied Calcined Bauxite treatment, plaining out of the existing wearing course to a depth of 40mm and replacing with a 65 PSV chip material is recommended, this will provide the increased skid resistance and should have a longer life than the surface applied treatment.

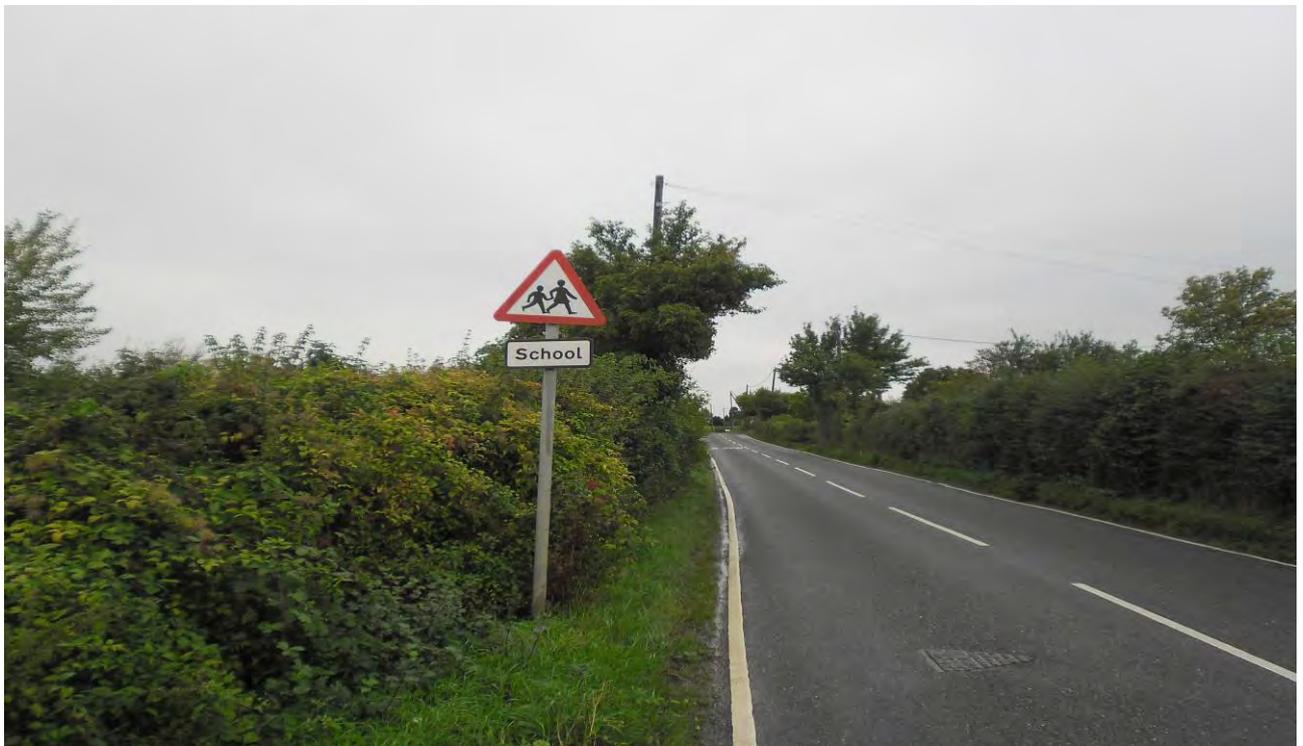
Figure 2: First warning sign for northbound vehicles

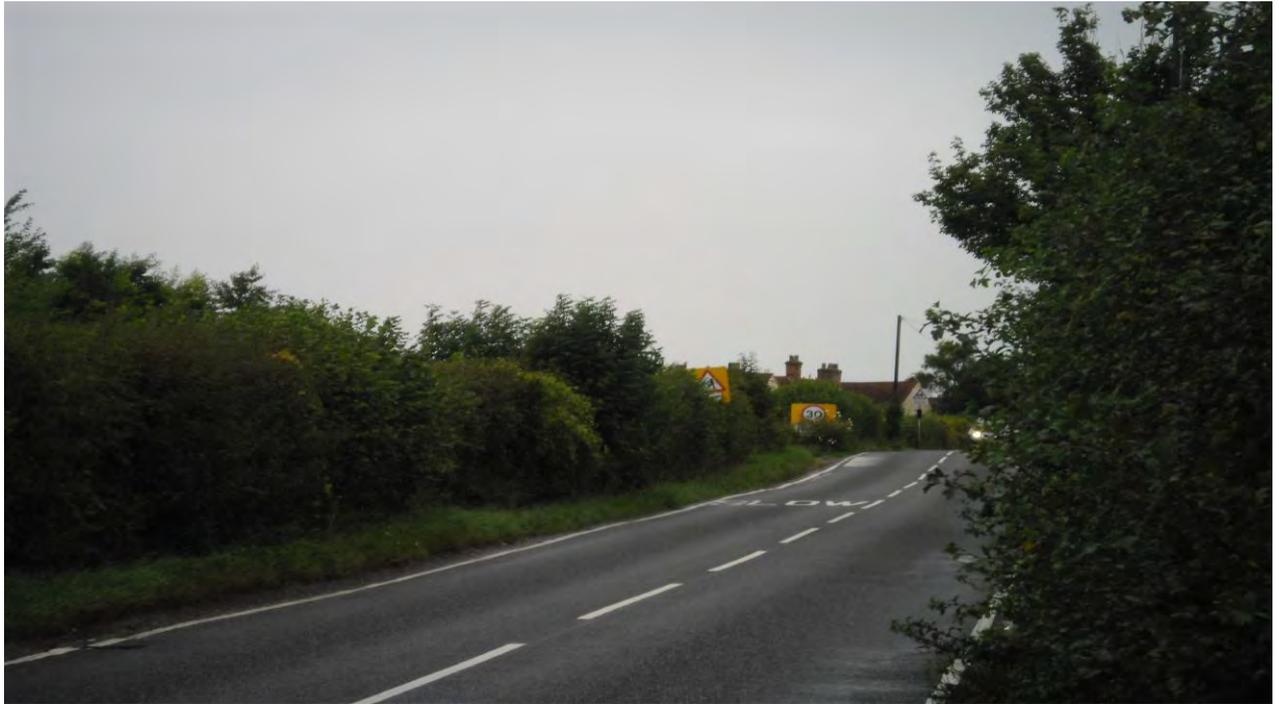
Figure 3: Second warning sign currently hidden behind vegetation

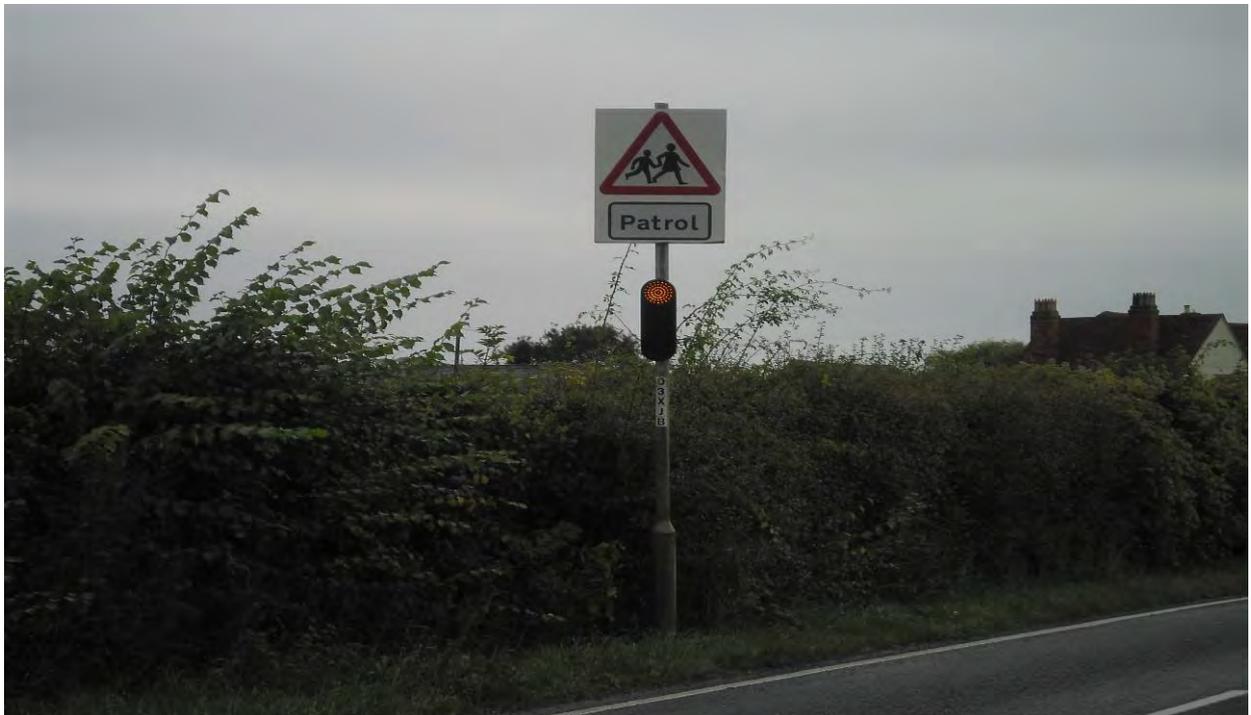
Figure 4: Existing Patrol sign with wig wag adjacent to school entrance

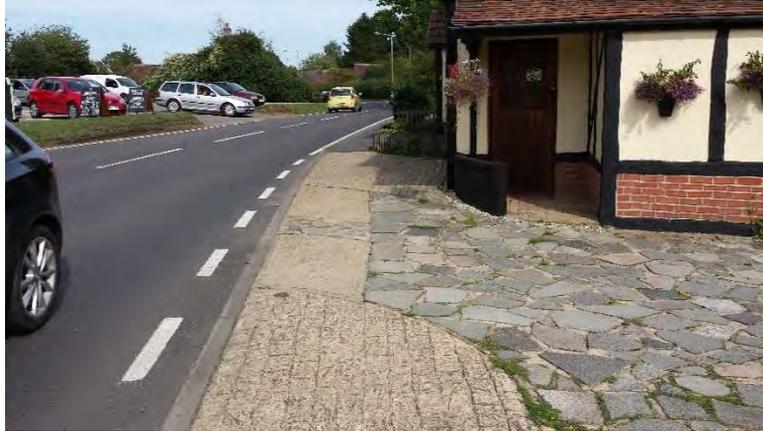
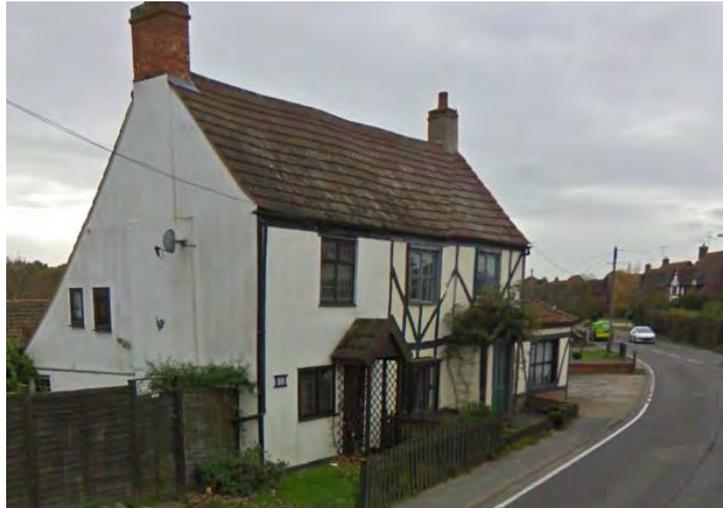
2.1 Property 129

This property has an open frontage finished with concrete, portions of which are imprinted, and elements of 'crazy paving'.

There is a dropped kerb throughout the access although the layout suggests that this may have been two separate accesses at one time which have been joined. Pedestrians are able to walk this section unimpeded and access the narrow footway which extends in an easterly direction. Although slightly uneven this frontages does not present an obstacle to pedestrians

The highway boundary was determined to be 1m back from the front face of the kerb throughout this property boundary. This is confirmed by a change of surface on site which tied in exactly with this measurement.

If a new footway is to be provided a minimum of a 25mm water check is recommended on the kerb face and a 2.5% cross fall on the footway towards the carriageway. These improvements would require the height to be increased at the back of the footway by 50mm relative to the current channel level. This would result in the need for accommodation works on the existing private drive to meet the new back of footway level.

It would provide a significant improvement in visibility for all the properties if the fence and hedge fronting 127 were removed, this is a rental property and if the land lord was in agreement this removal could be included as part of the works.

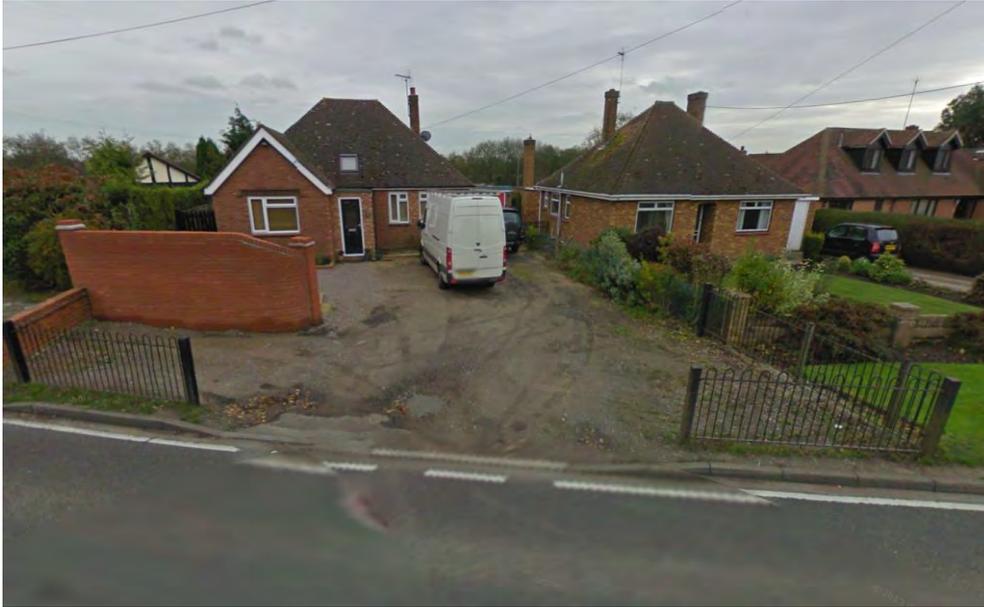
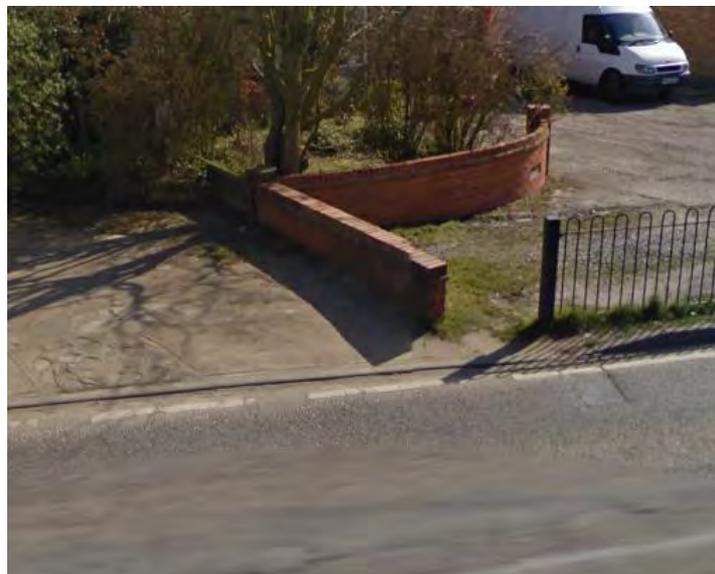
2.2 Property 129a

This property has a 1.8m wall set back approximately 4 to 5 meters from the carriageway, and a further railing set back 0.2m from the carriageway. There is a small wall between the railings and the larger brick wall, which it would not be possible to negotiate with a push chair or wheel chair without entering the carriageway.

During the original site visit in 2014 the property resident approached the author, and explained that he had erected the low wall and the railing to address an issue with impatient drivers driving over the area to get round vehicles waiting to turn right into West End Road.

To the northeast the visibility from this drive is also obstructed by the hedge and fence fronting 127; the corner of the structure of property 129 also partially obstructs the view, but it should be noted that 129 significantly pre-dates 129a.

Before the design is finalized however I would like to offer the owner of 129a an alternative option of a 1.5m footway with the bollards set 450mm back from the kerb face this would increase the distance between the 1.8m brick wall and the bollards to 3.55m at the narrowest point, rather than 3 m with the agreed design.

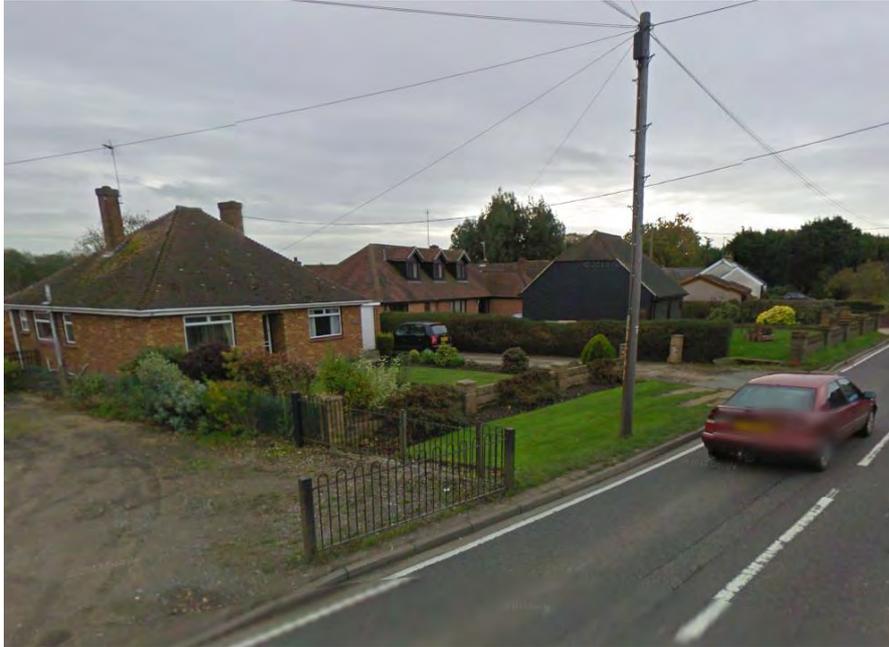
2.3 Property 131

This property has a boundary wall set back approximately 5m from the carriageway, however there is a BT pole set back 0.75m back from the kerb face. A shoot gully with associated access chamber is also present.

The highway boundary was found to be 1m back from the kerb face, this was discussed with the residents, and they were under the impression that highway rights existed over the whole width of the verge in-front of the boundary wall.

Again the water check on the bull nose kerb is less than the recommended 25mm and providing this or even greater up stand should help to address the water run off issue the owners are experiencing.

We need to consider the best course of action for the BT post, if it were left in situ the footpath could be diverted around the back, or the post relocated behind the new footpath. Relocating the pole would of course have cost implications.

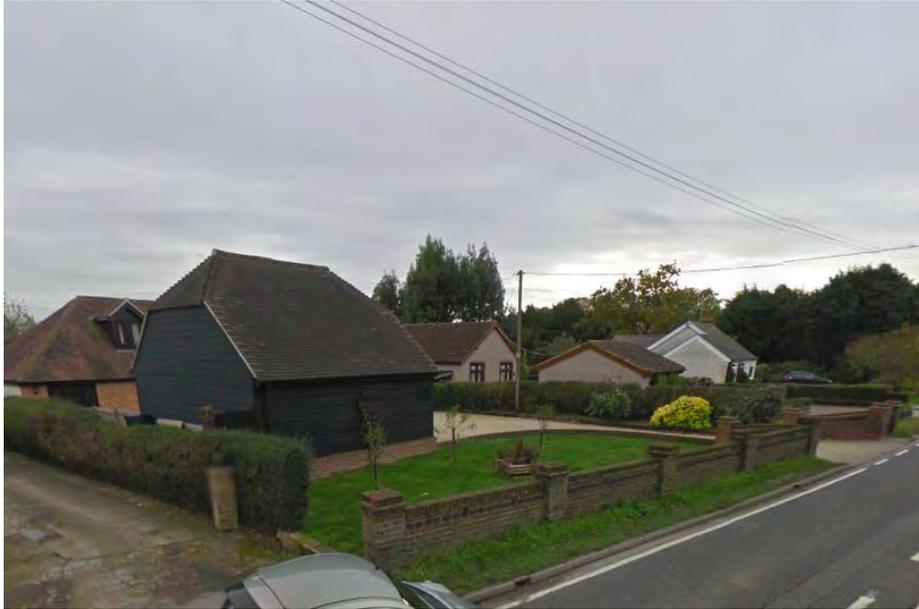
2.4 Property 133

This property has a substantial brick boundary wall, approximately 0.75m to 1m back from the kerb face, the brick work does not match the rest of the wall and therefore appears to have been erected at a later date.

We had permission from the landowner to access the property to set out the highway boundary and this confirmed that the wall had been constructed on private land, and had not encroached.

However apart from the email agreeing to access for the highway boundary we have not had the opportunity to discuss the scheme with the owner and it is recommended that this is undertaken as a priority as if an agreement cannot be reached with regard to this property the benefit of the scheme would be reduced.

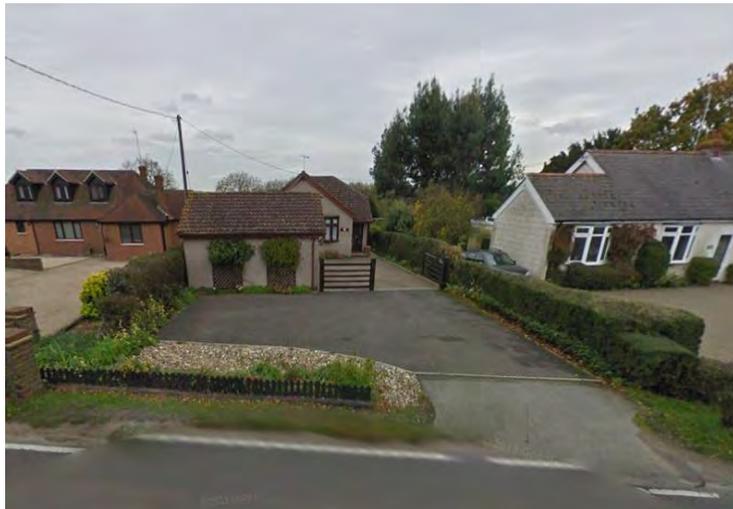
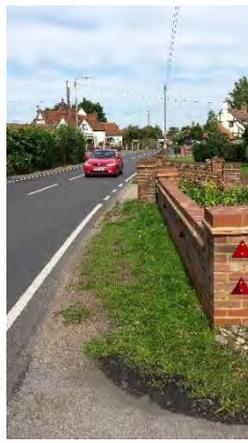
2.5 Property 135

This property originally had a small picket fence but this has relatively recently been changed to a brick wall

This wall is set back 1.3m from the carriageway and although this does provide a small refuge area for pedestrians this is below the recommended minimum width of 1.5m

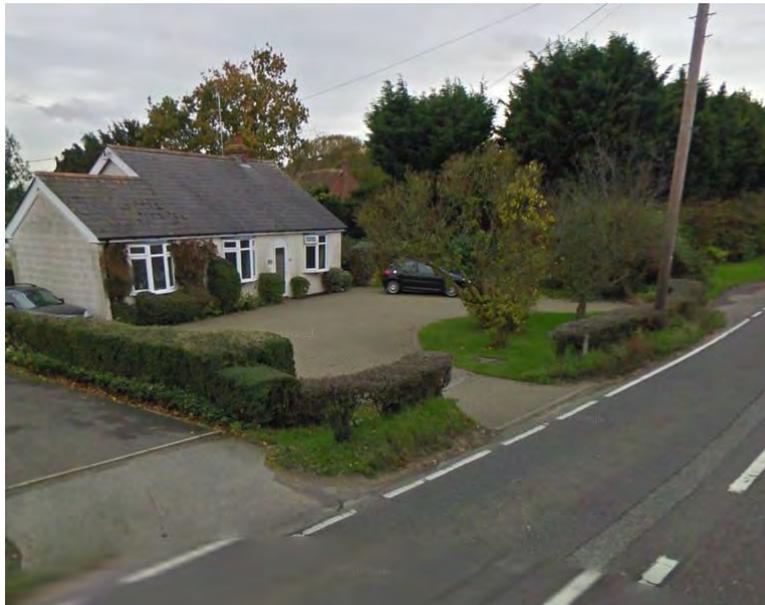
2.6 Property 137

Property 137 has a low privet hedge and an in-out drive, the hedge is only set back around 400mm from the carriageway. There is a further BT pole which is around 500mm back from the carriageway within the hedge.

There is a slot drain and an access chamber approximately 3 m back from the carriageway, again this is likely to discharge into the piped ditch.

My colleagues spoke to the resident and he agreed that as long as the hedge was replaced with a wall he would consider dedicating additional land.

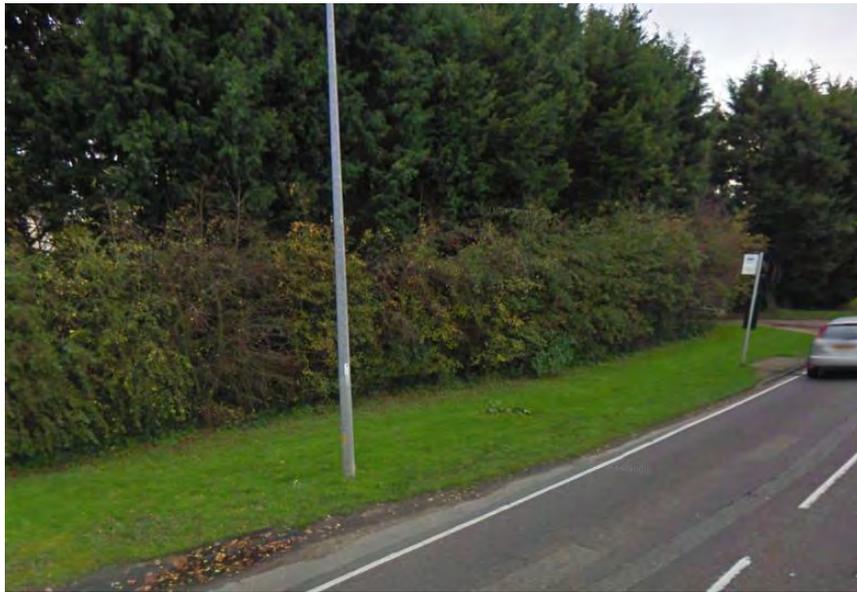
2.7 Property Quinces

The verge outside this property is around 5.5m in width, there is an existing bus stop set 1 m back from the carriageway and a lamp column set 1.7m back

The highway boundary was confirmed to be 5.5m back from the edge of carriageway at this location, therefore land dedication is not required, and the desirable width of 2m can be provided entirely within highway land.
