# Boxted Bridge ECC BR0059

**Principal Inspection**

Inspection Date: March 2018

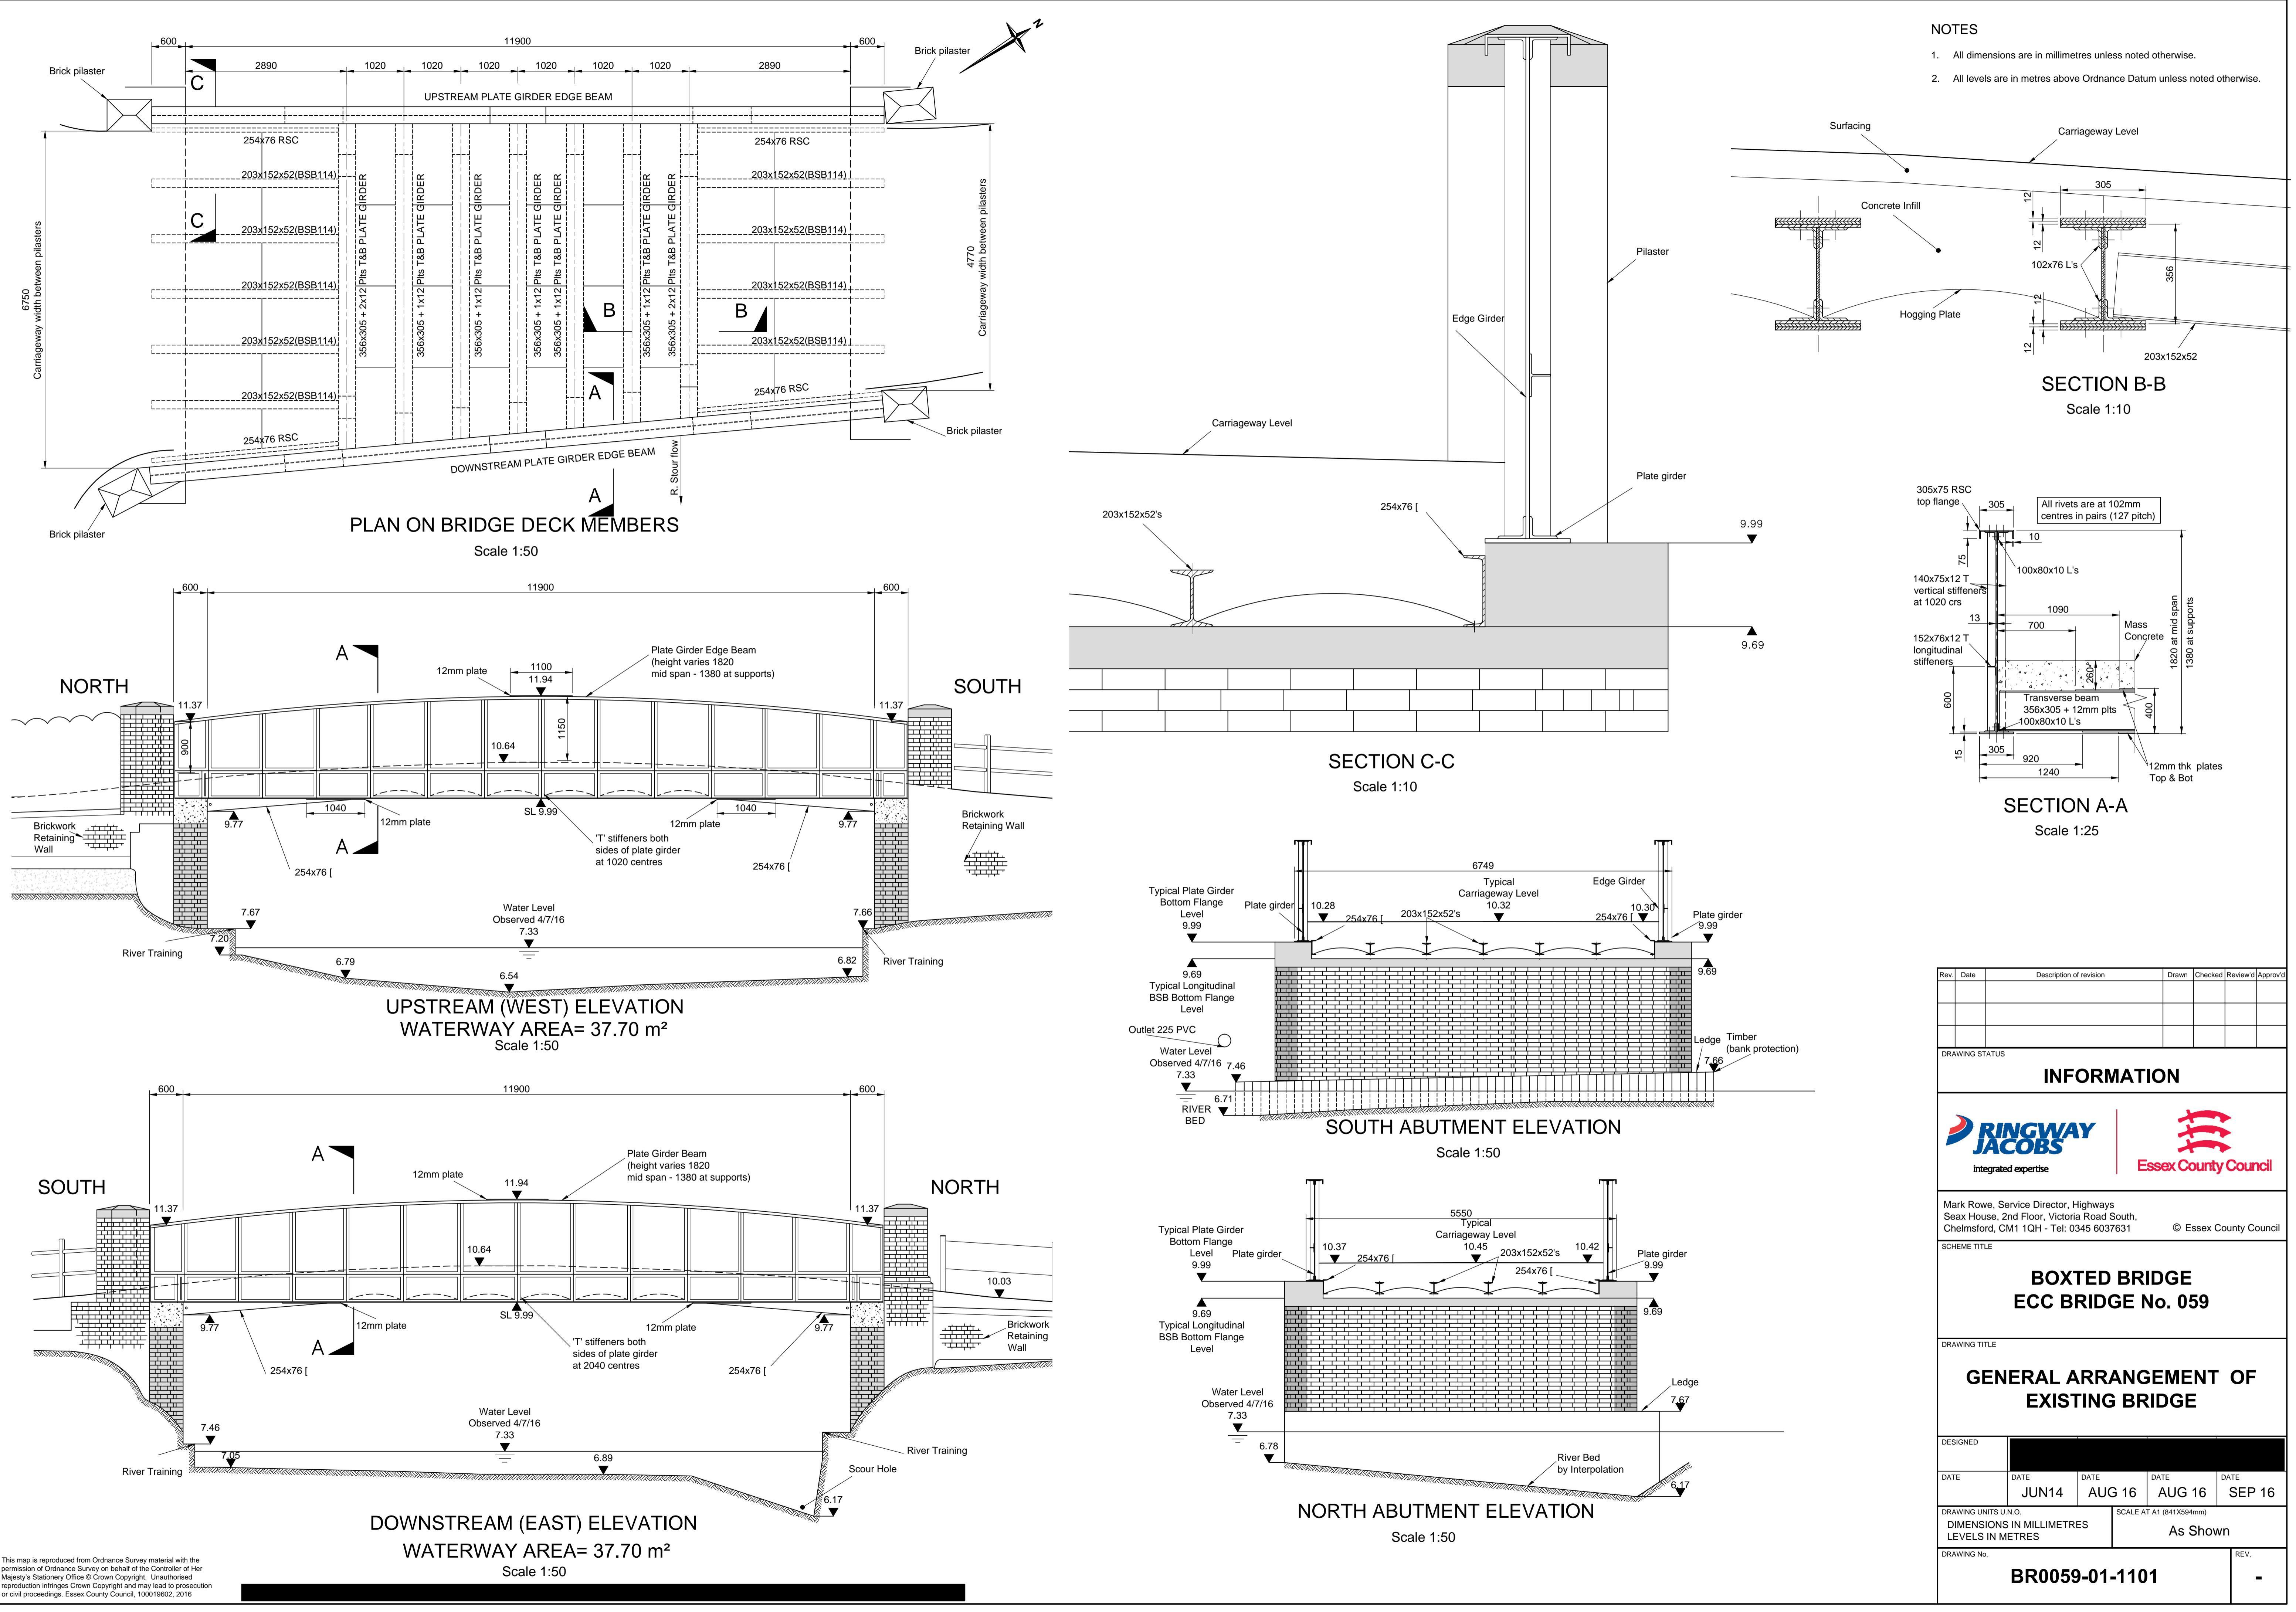
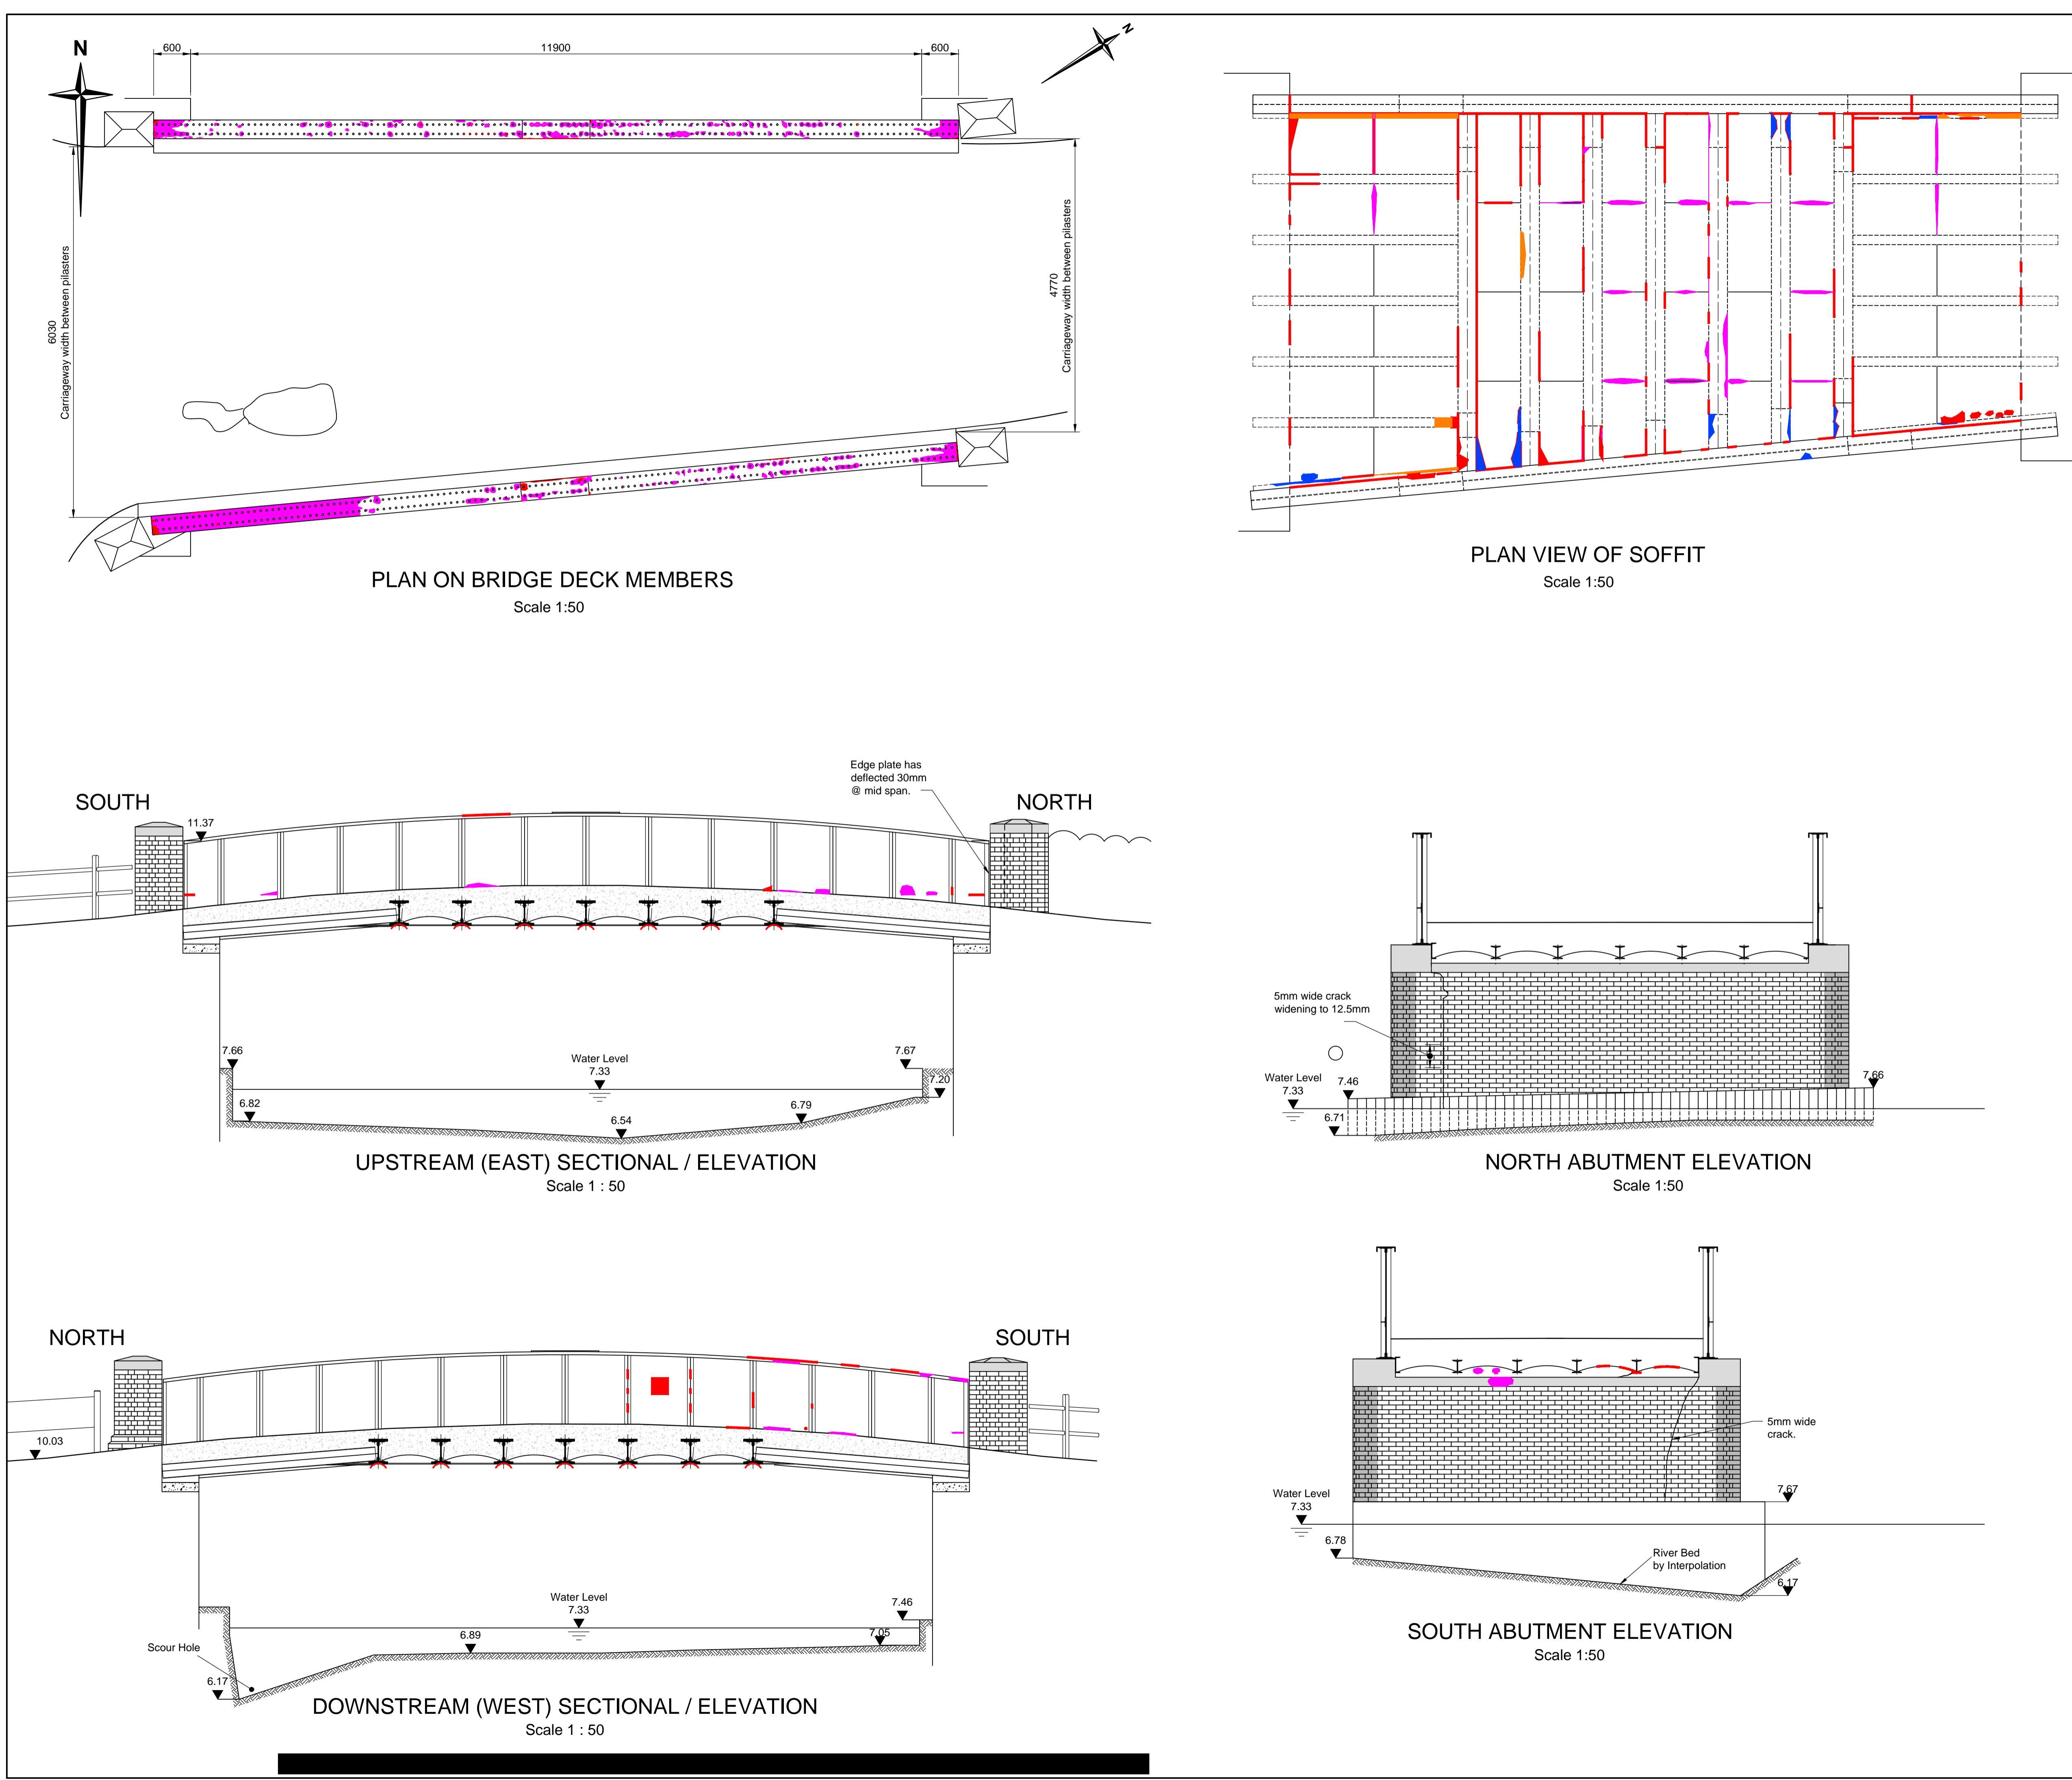
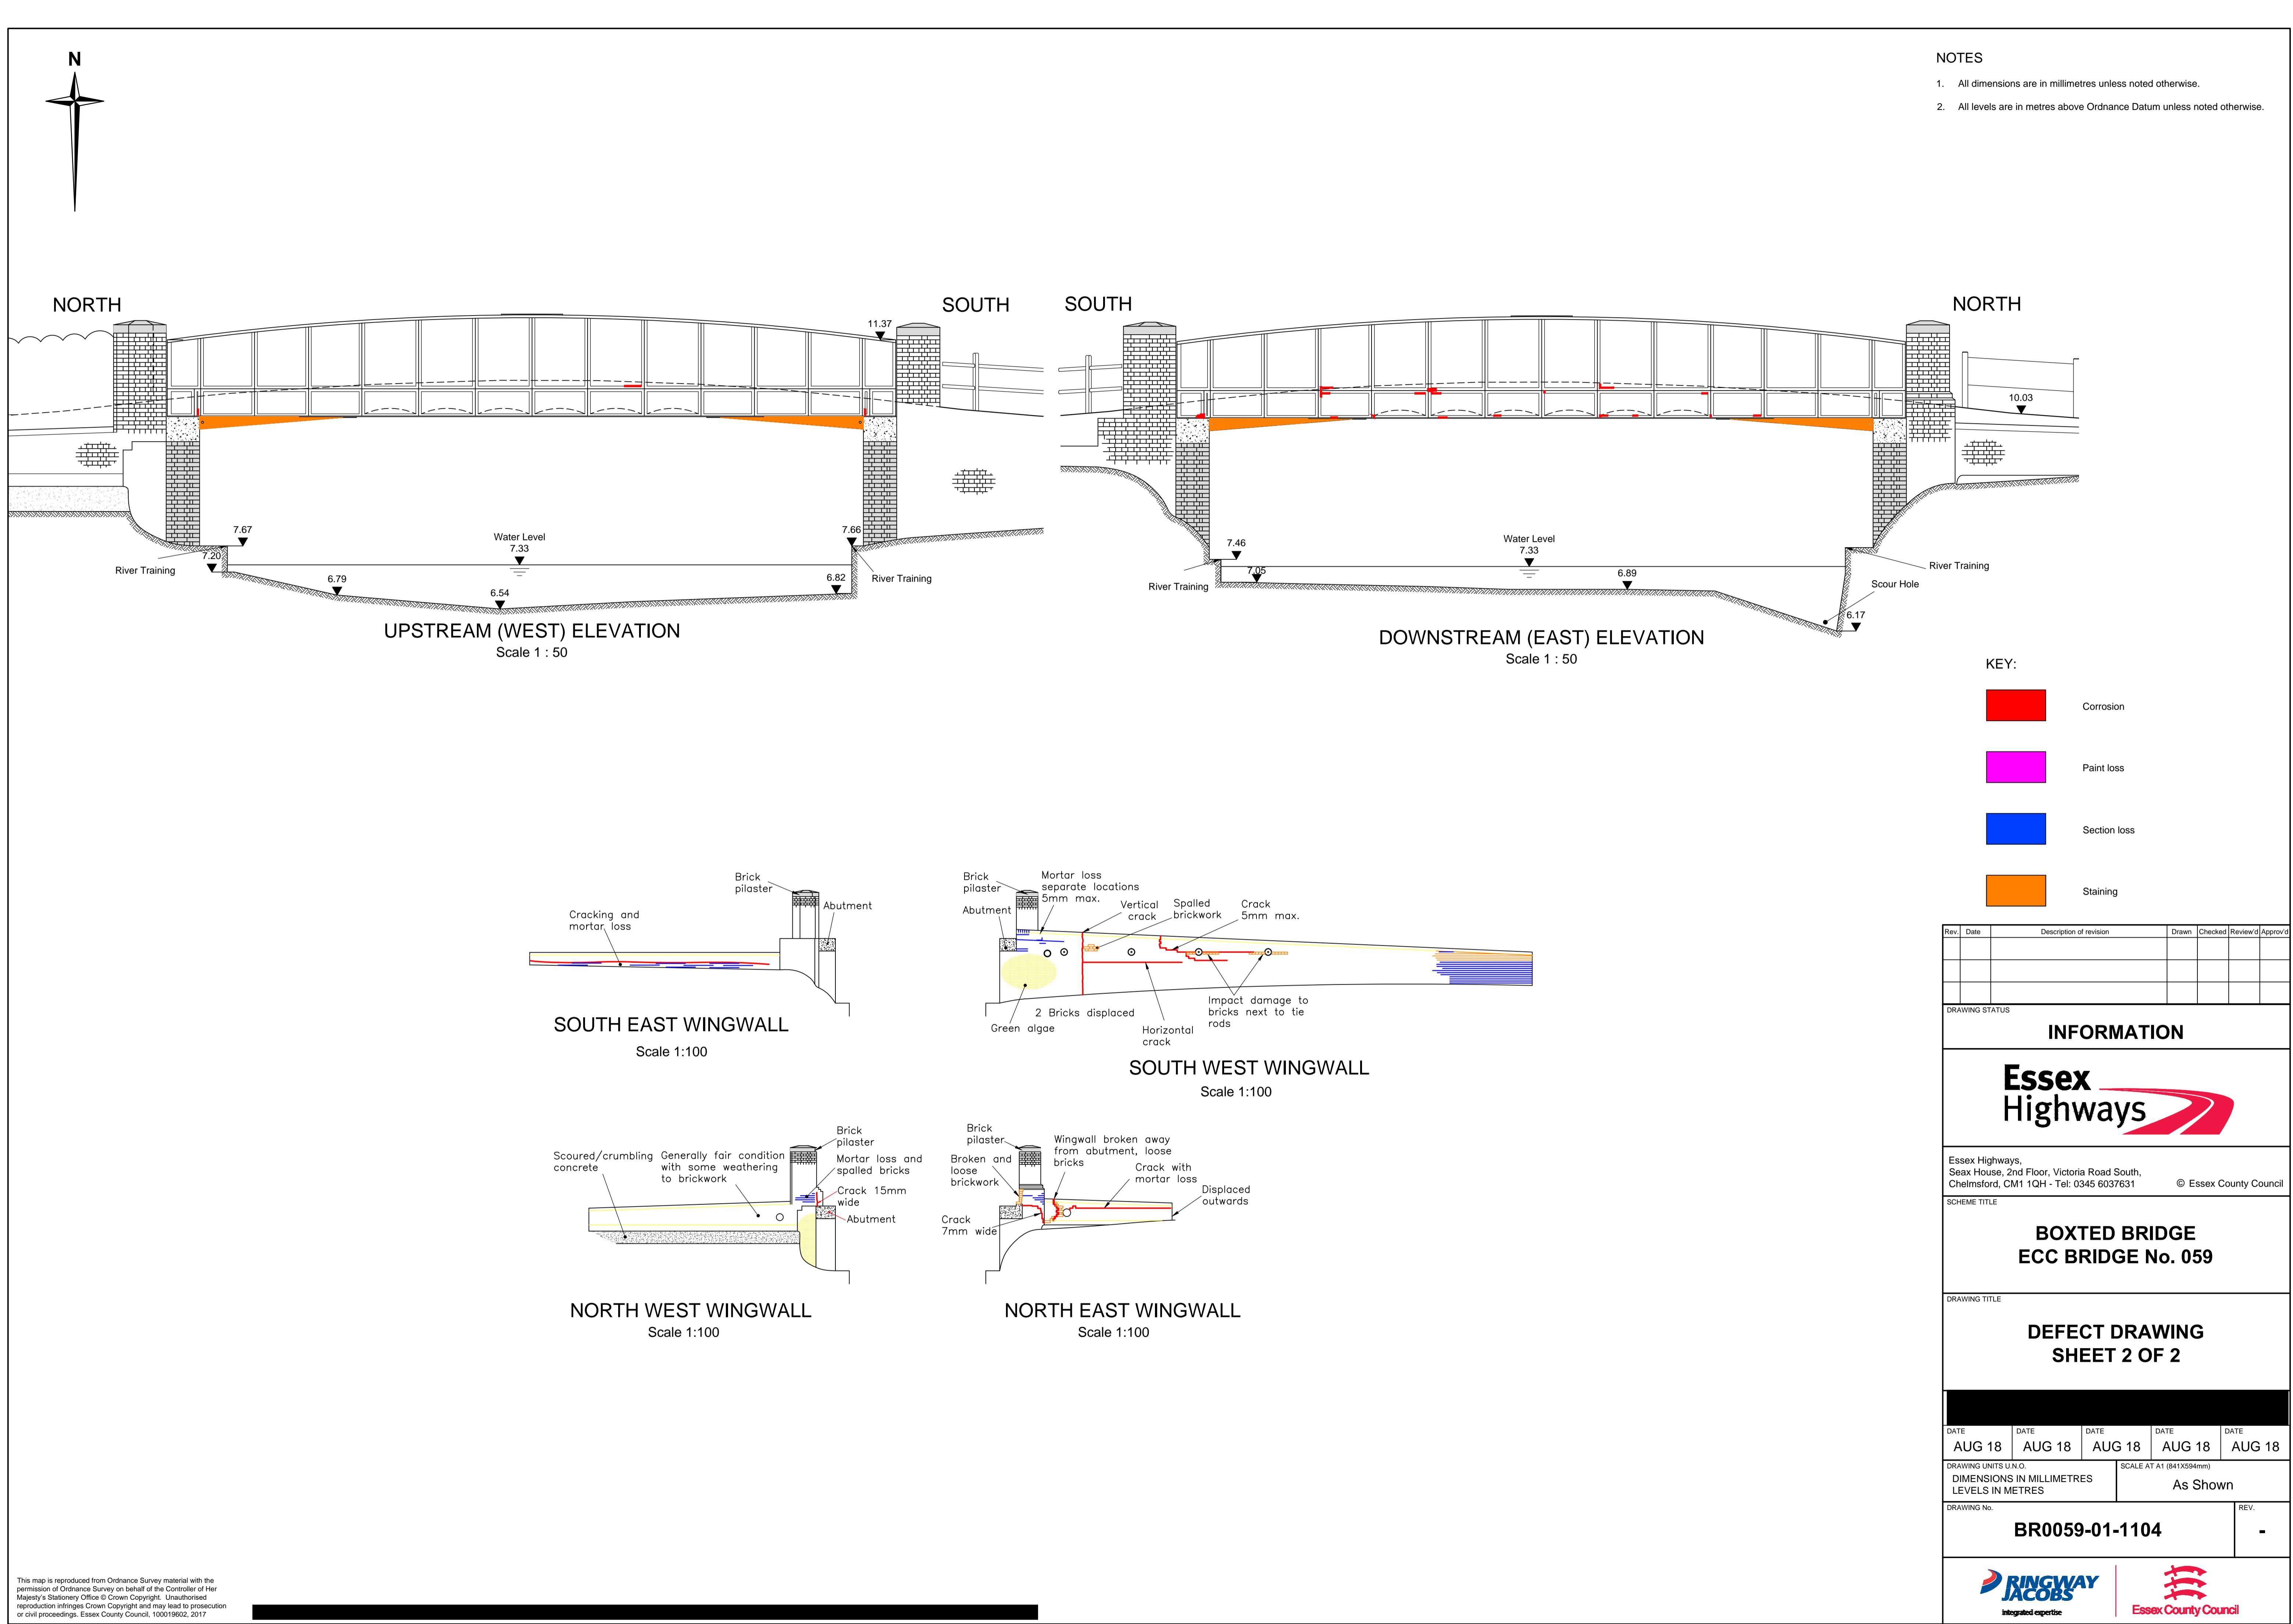
## Appendix D Defect Sketches

The defects recorded during the inspection are described in Section 5 of this report, and noted on defect sketches included in Appendix D.
