Boxted Bridge, Boxted ECC BR 59

Option Study

October, 2018

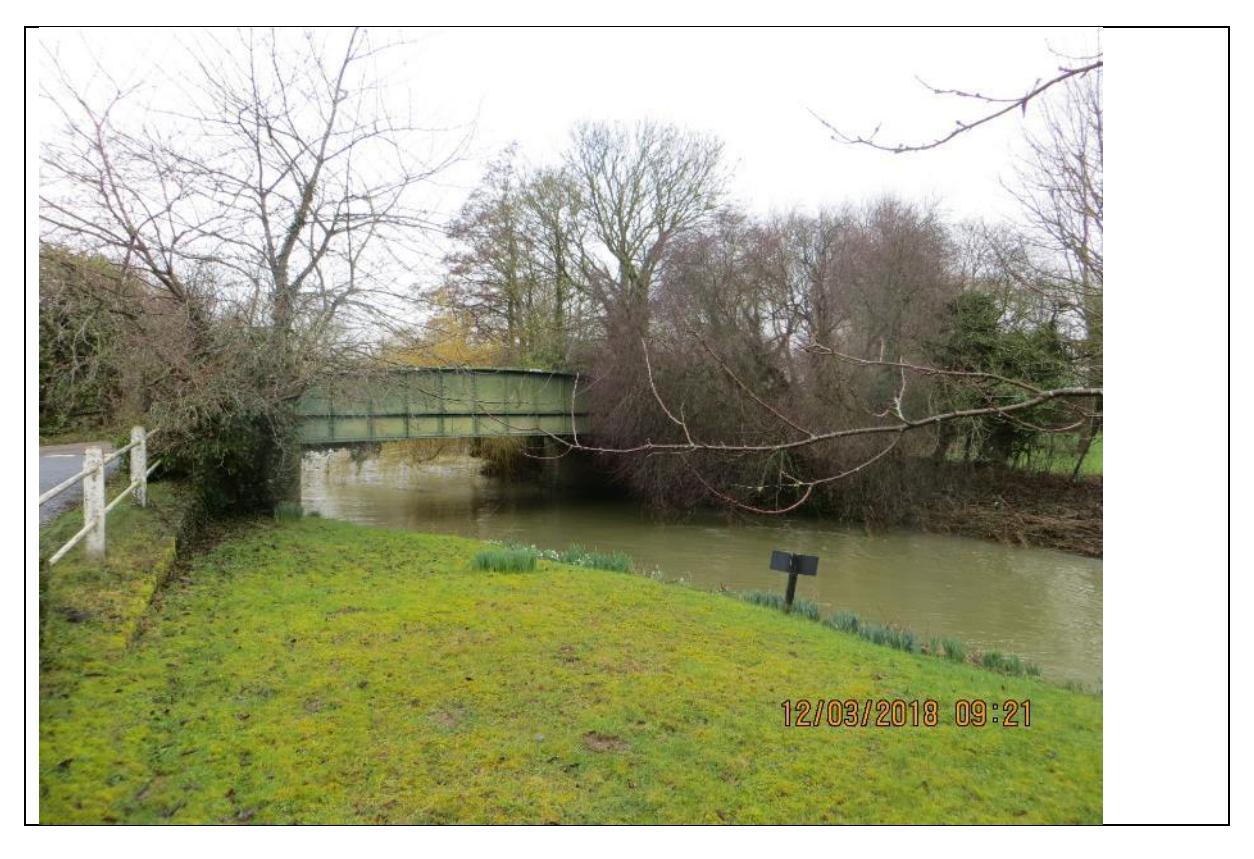
Photo. 1 Bridge east (downstream) elevation – plate girder edge beam

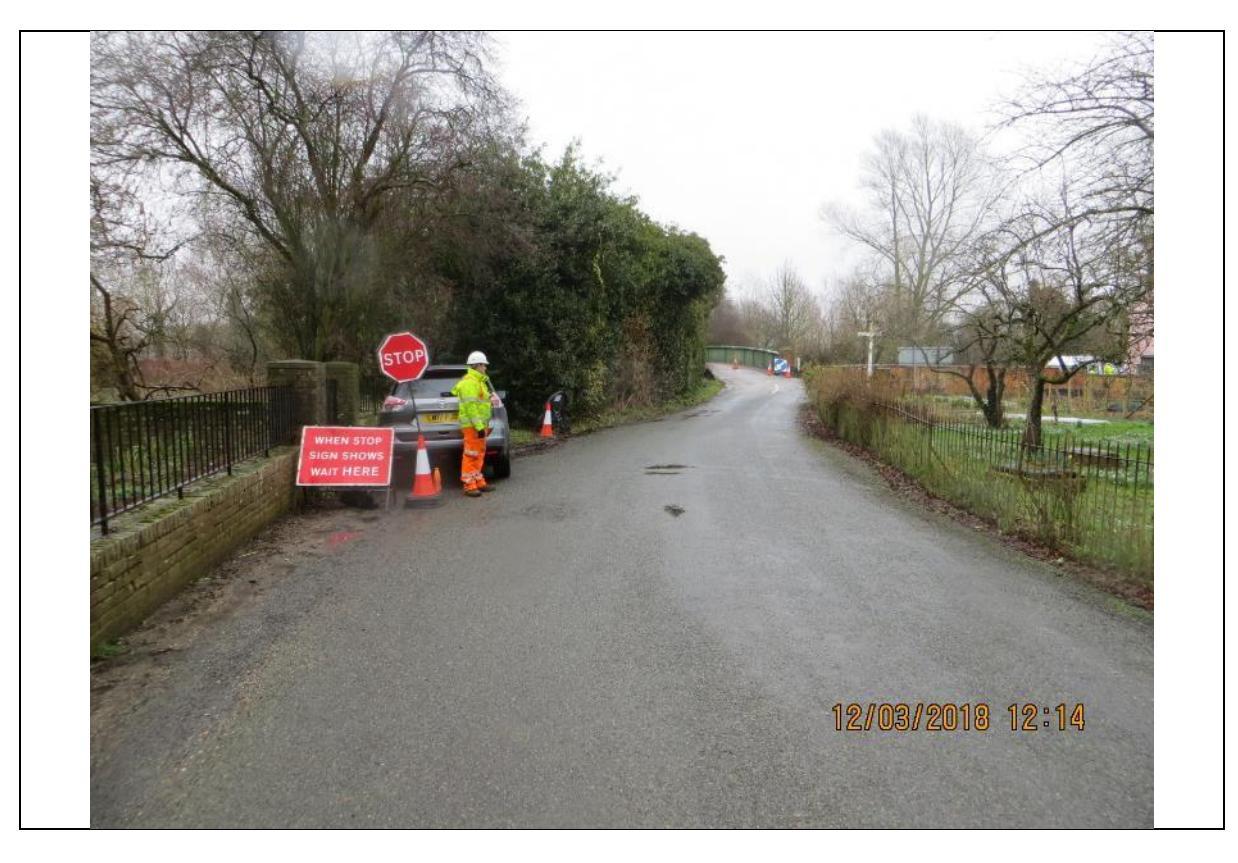
Photo, 3	Looking toward bridge from South (Lower Farm Road)

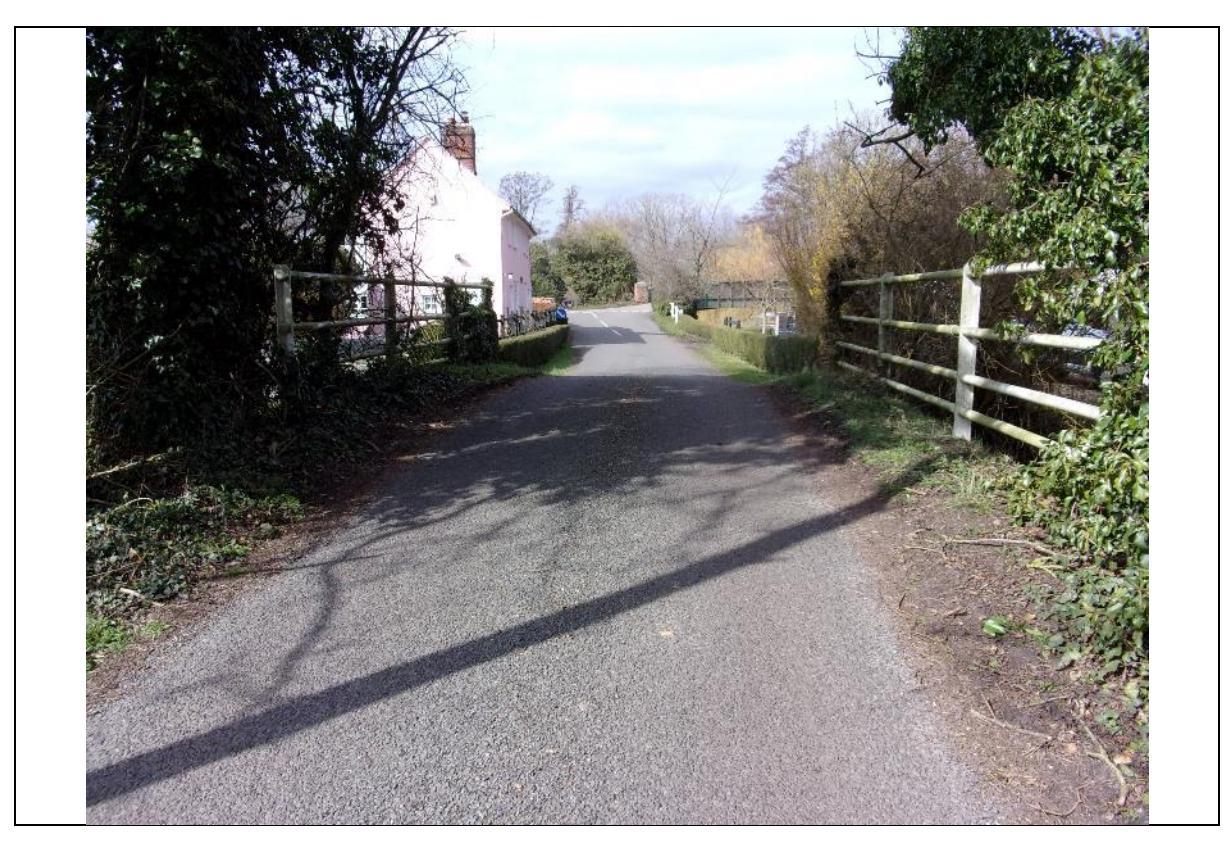
Photo. 4 View along Sky Hall Hill looking toward Boxted Bridge/Lower Farm Road

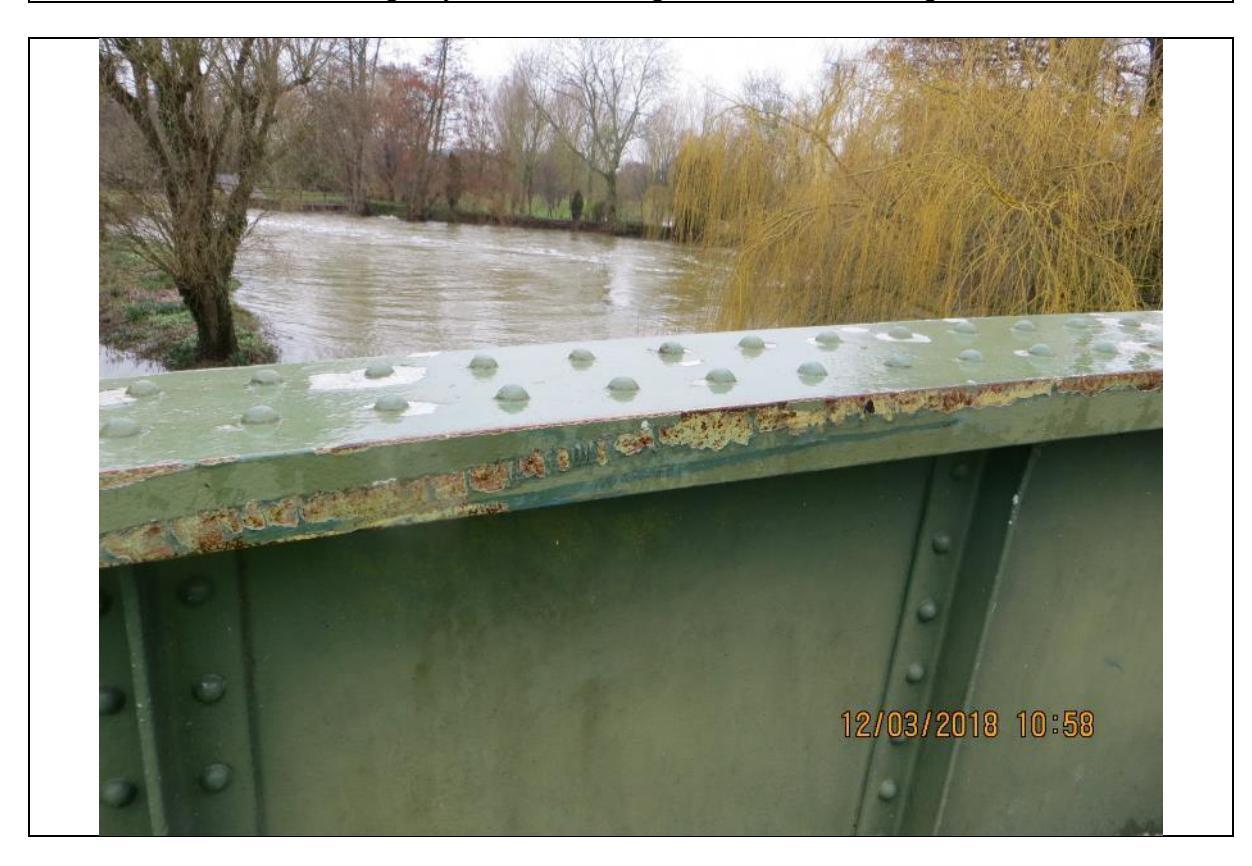
The bridge edge girders and pilasters exhibit evidence of vehicle impact damage; the abutments exhibit cracks which are likely to be have developed as a result of girder impacts.

Edge girder top flange HGV scrape

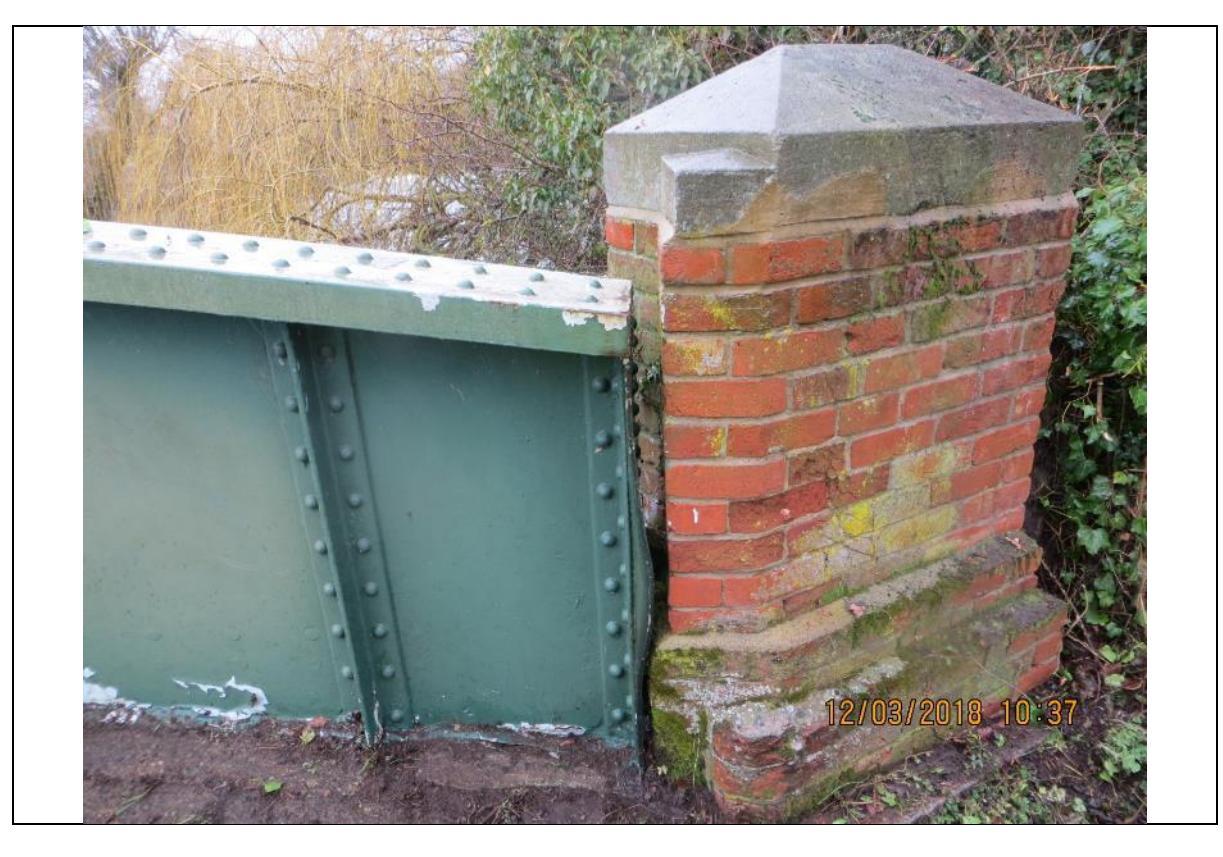
Photo. 6 Edge girder bearing stiffener - vehicle impact damage

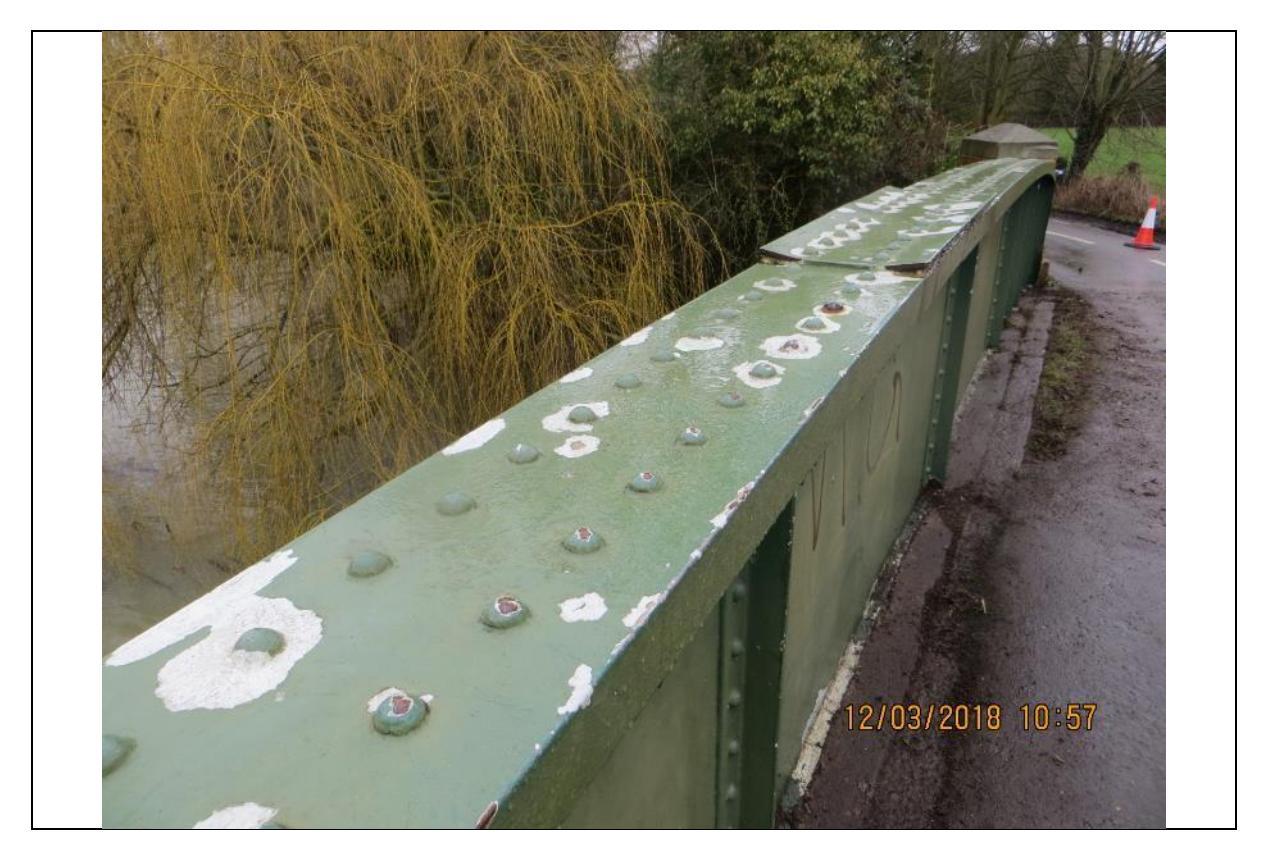
Photo. 7 Edge girder top flange cover plate distortion and failing corrosion protection

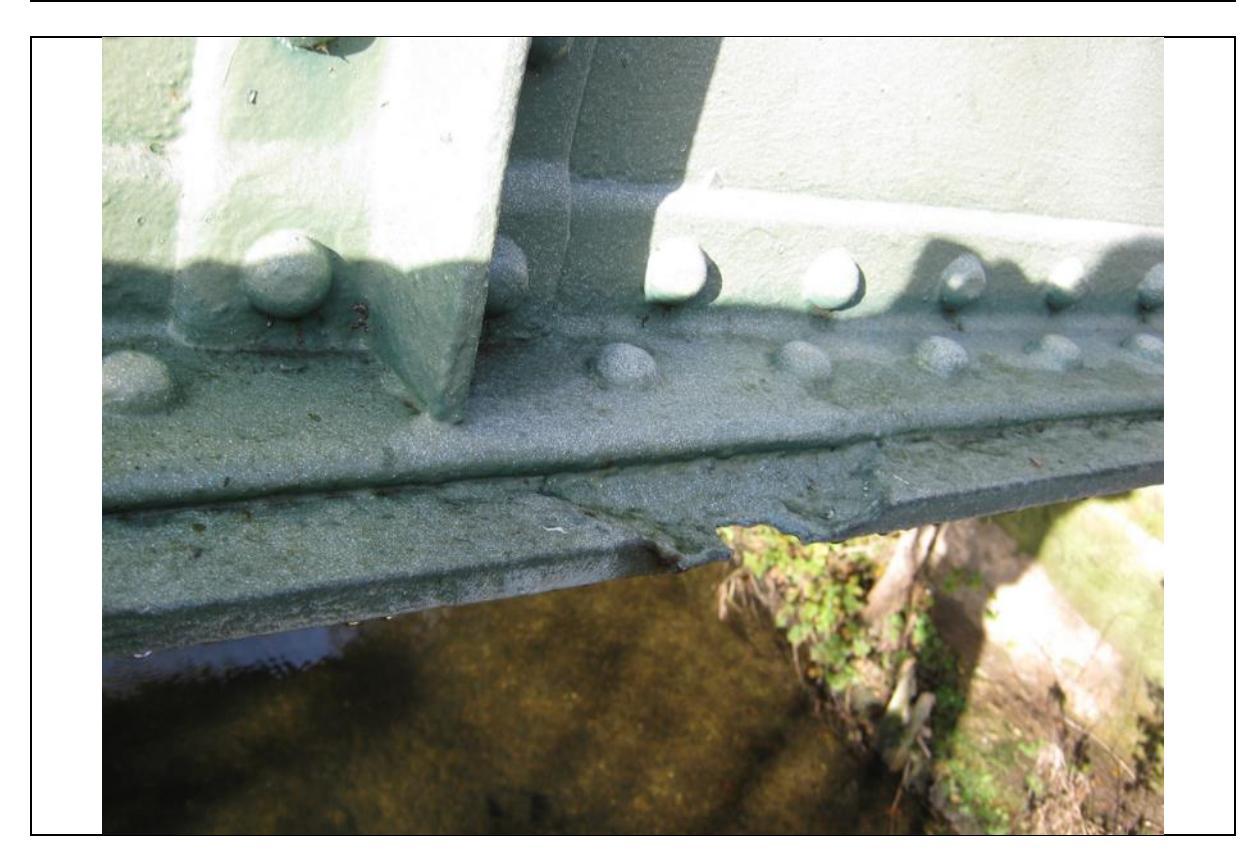
Photo. 8

Edge girder bottom flange section loss

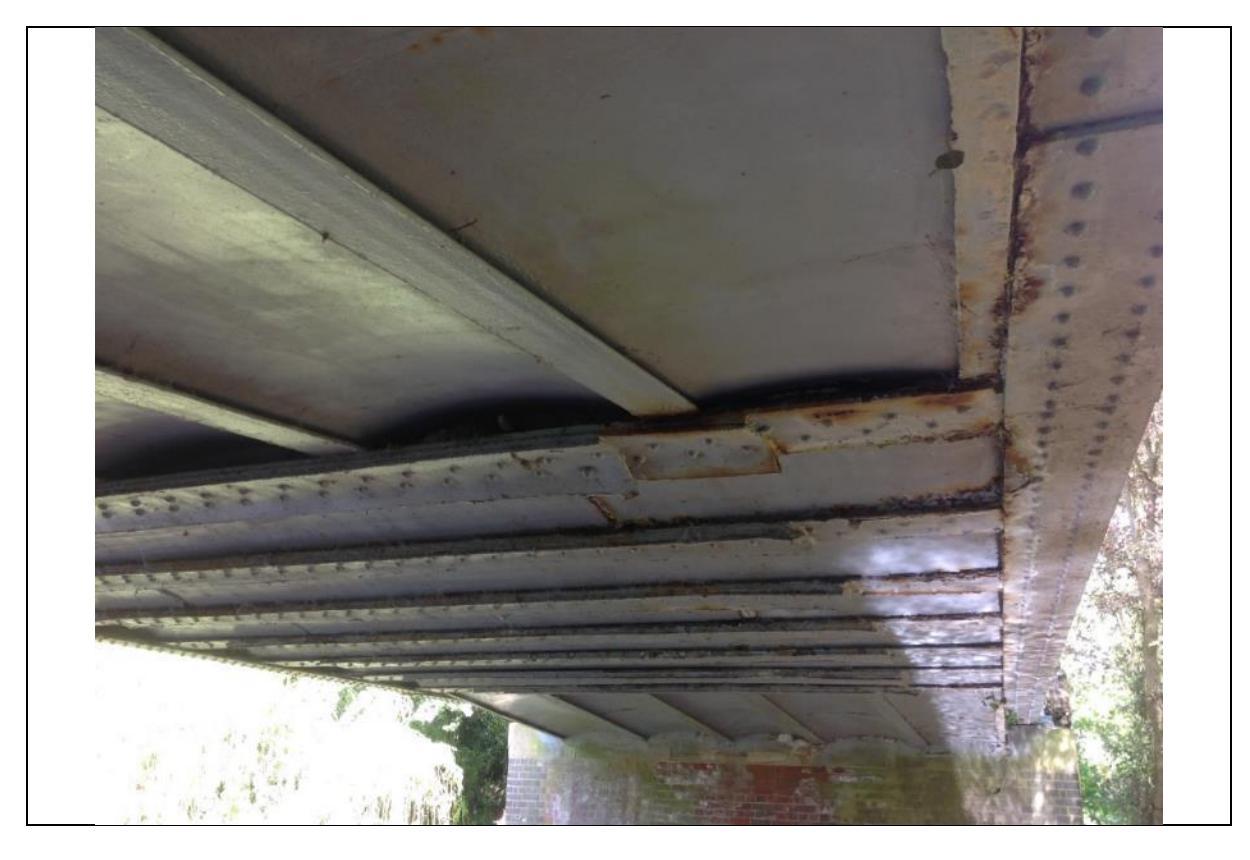
Photo. 9 General view of deck soffit

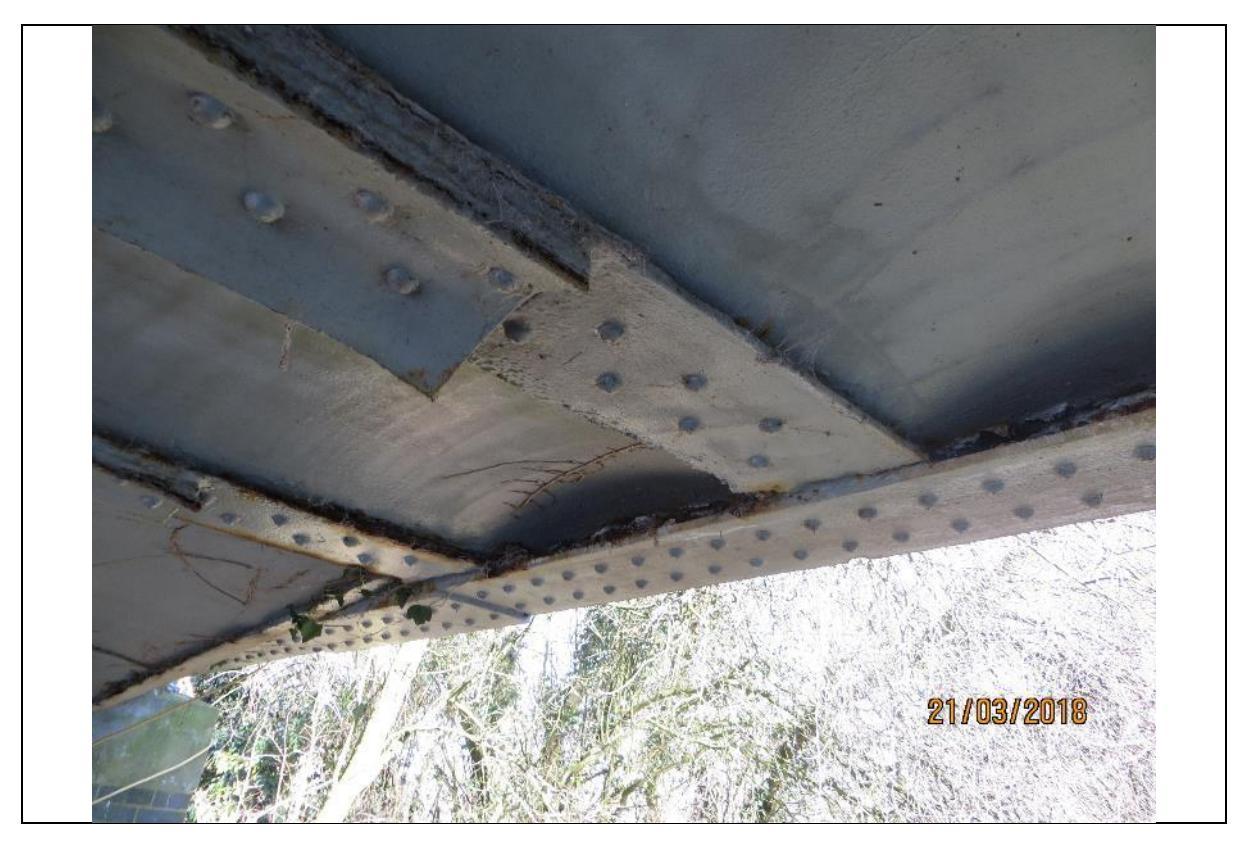
Photo. 10 Typical distortion of transverse beam bottom flange plates

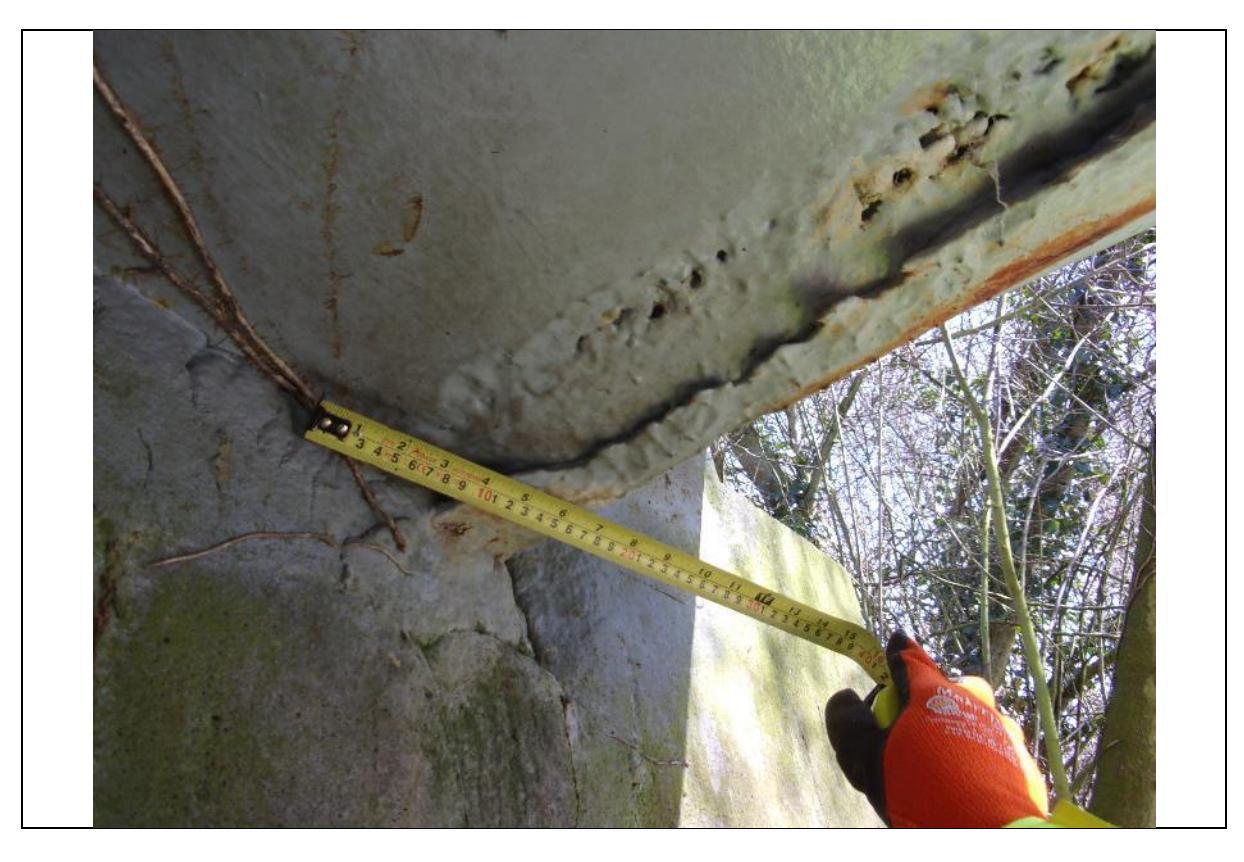
The corroded longitudinal tertiary rolled steel channels would be replaced with new members which would require local break out and replacement of the deck concrete fill and hogging plates.

Photo. 12 Longitudinal RSC bottom flange loss/hogging plate pitting (holes)

This could possibly be achieved by improving restraint of the existing edge girders and by replacing the heavily corroded longitudinal tertiary rolled steel channels.

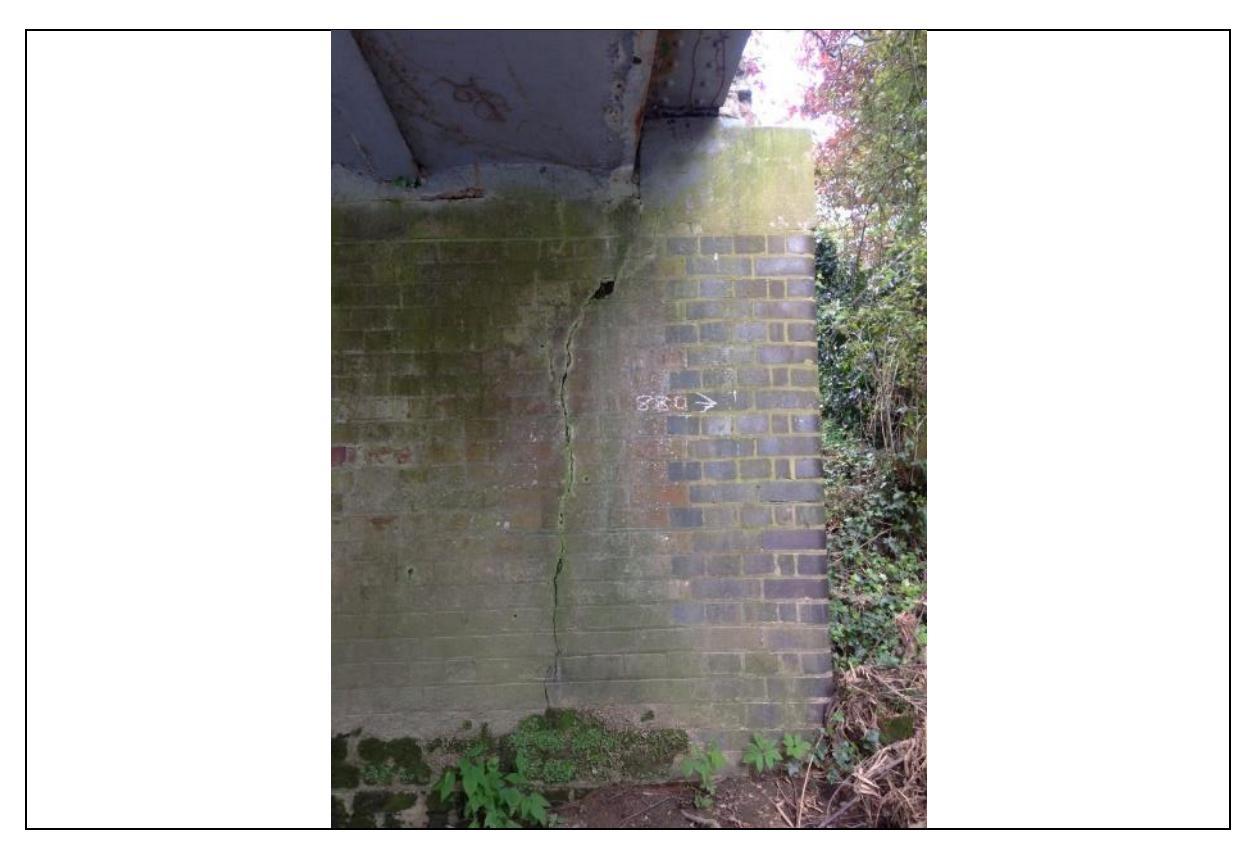
Maintenance of the structure has been deficient over a protracted period and elements of the bridge deck exhibit significant corrosion. There are cracks in the abutment walls which are likely to have resulted from vehicle collisions with the east edge girder.

Photo. 13 North abutment crack

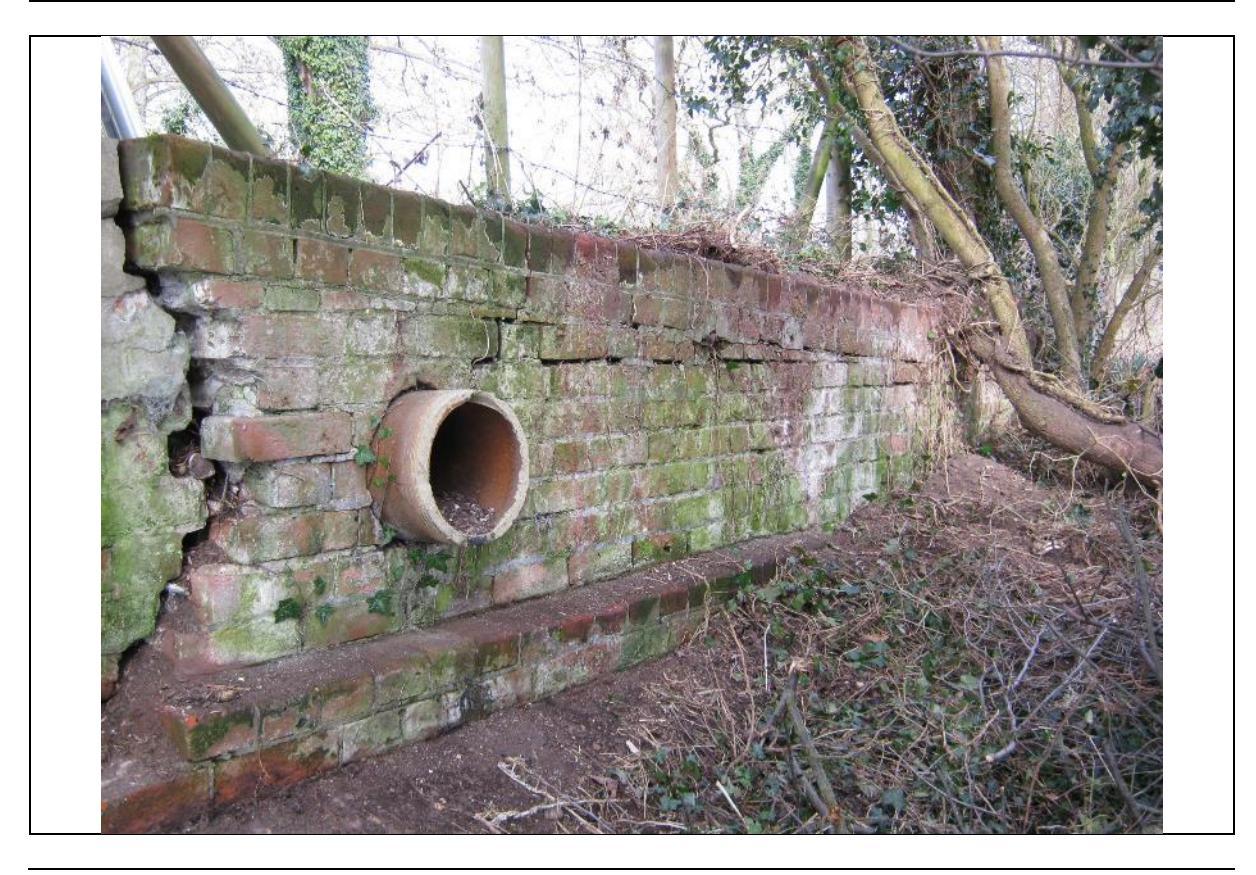
Brick retaining walls (with brick pilasters and stone copings) are located on the approaches to (and departures from) the bridge which support the highway above the level of the adjoining river banks. The retaining walls are generally in poor condition with extensive cracking and missing joint mortar.

Photo. 14 Bridge northeast approach retaining wall cracks

Option 5 works would include repair/partial reconstruction of the bridge approach retaining walls. A temporary full bridge/road closure would be required in order for these works to be undertaken with an estimated duration of 4 to 5 months.

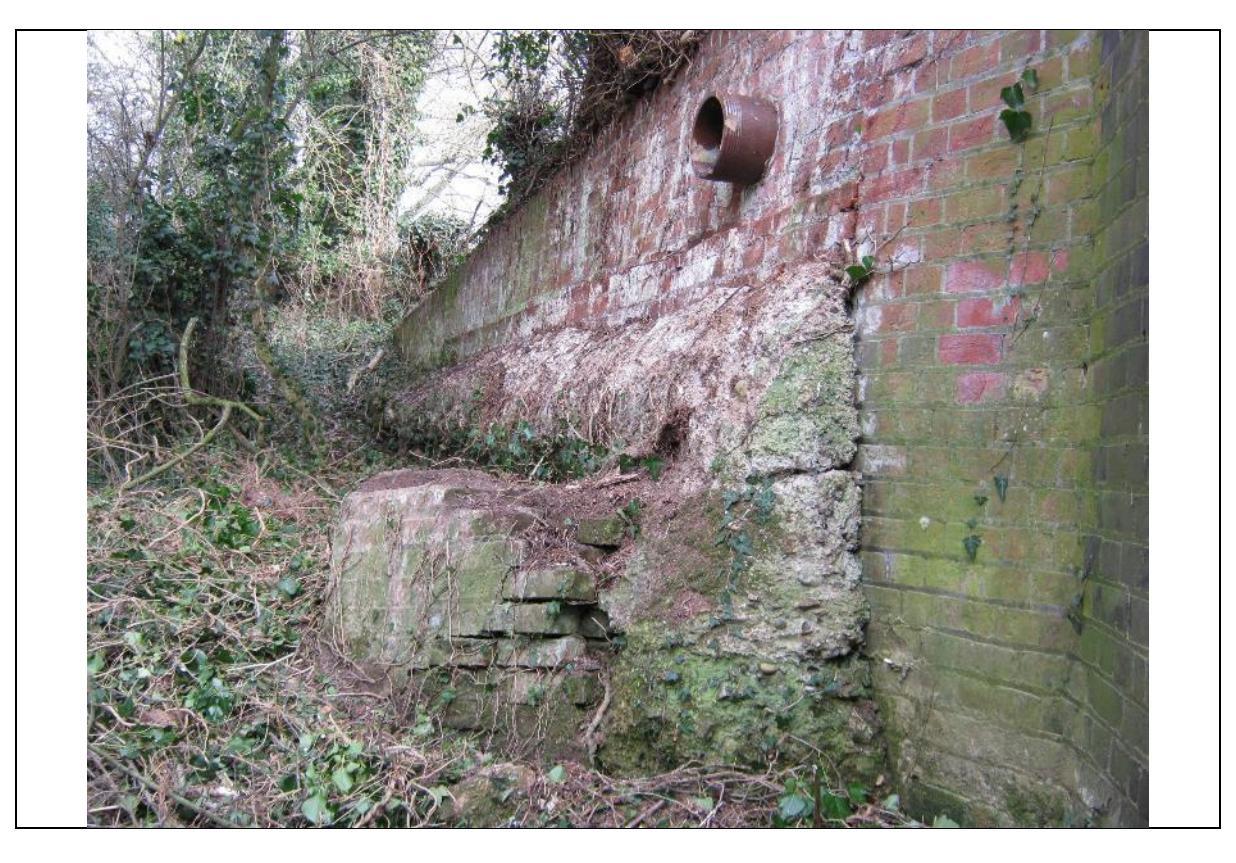
Photo. 15 Bridge northwest approach retaining wall

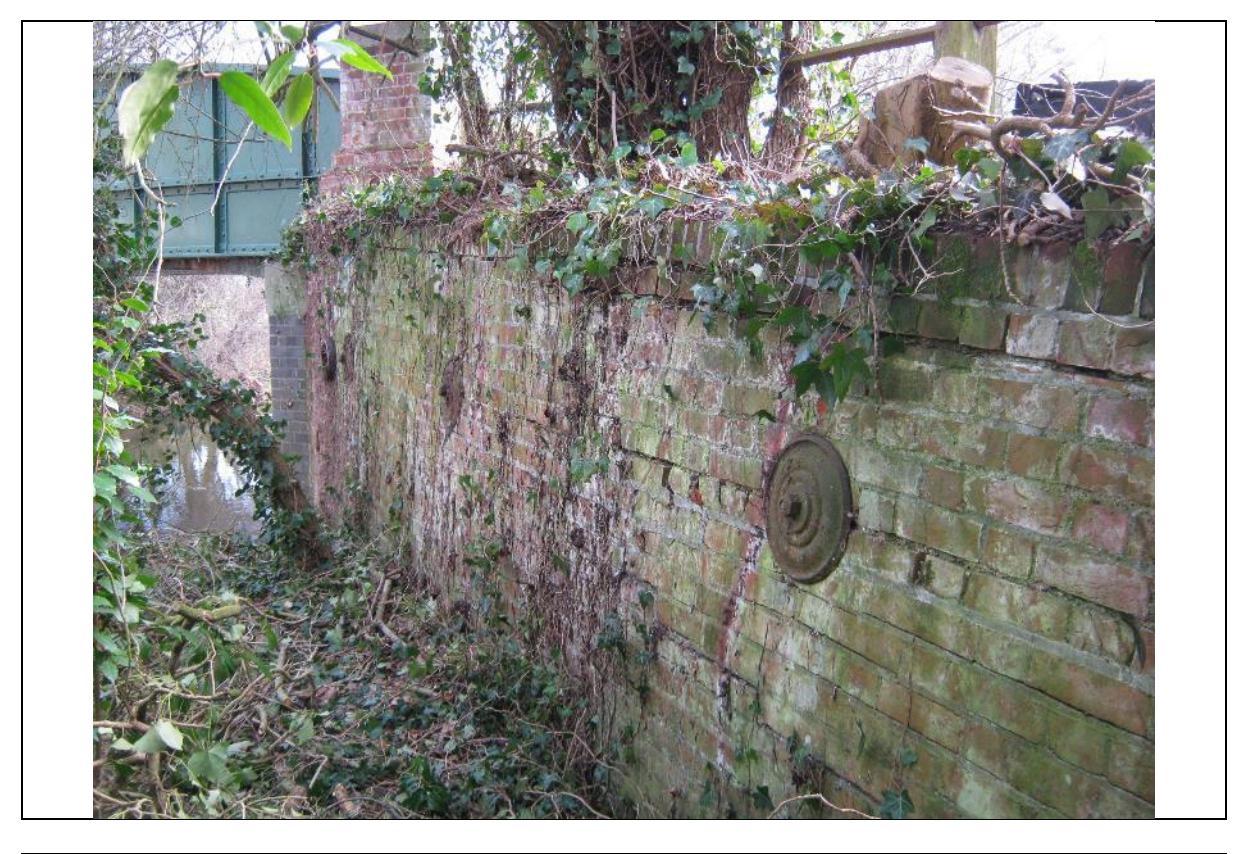
Photo. 16 Bridge southwest retaining wall

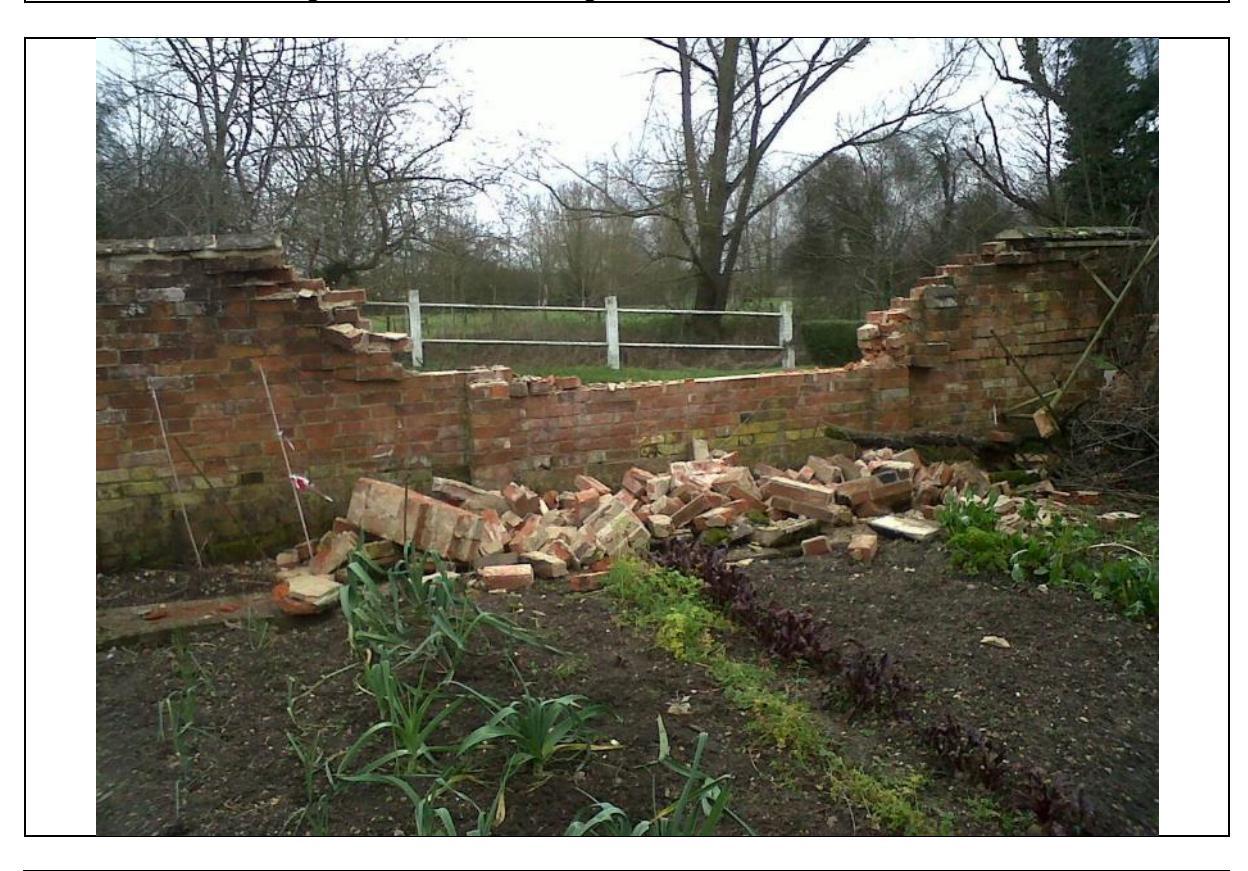
Photo. 17	Island Cottage boundary wall HGV impact damage (representative image 1)

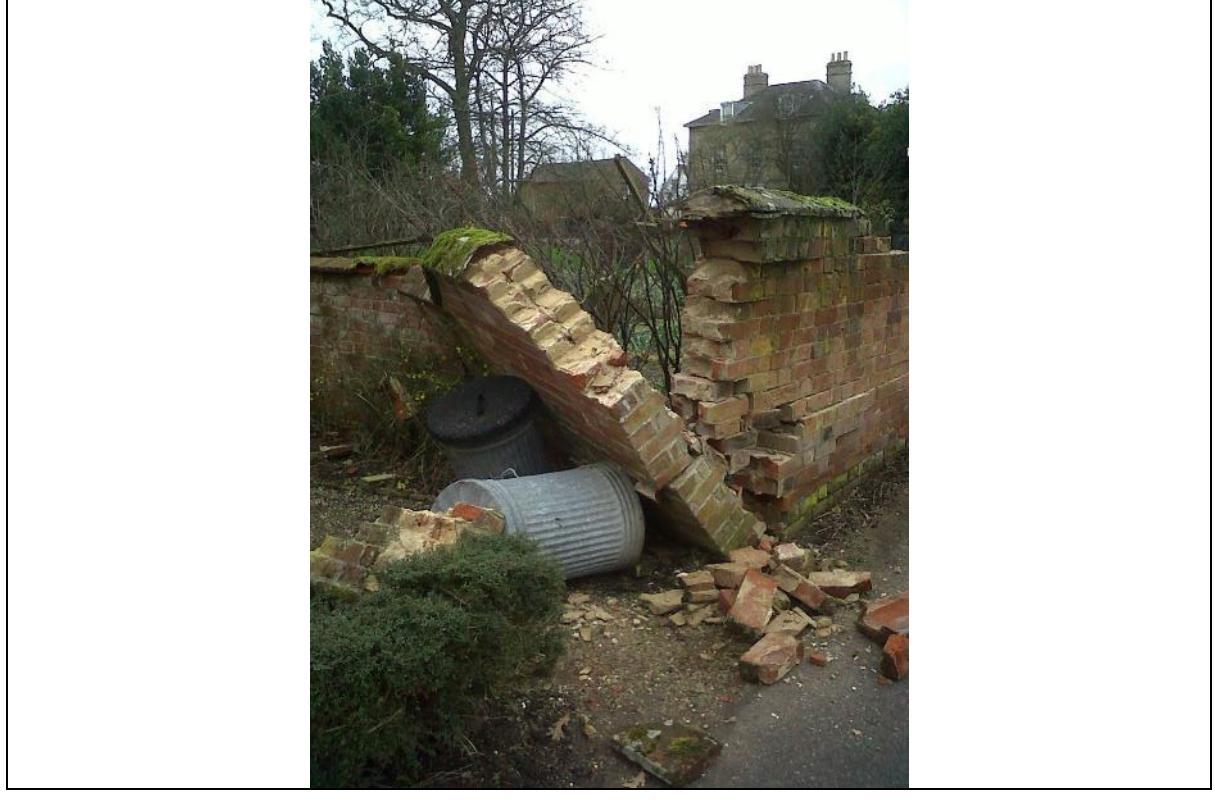
Photo. 18 Island Cottage boundary wall HGV impact damage (representative imag 2)
--
