Army and Navy Flyover ECC Bridge No. 1000

Future of the Army and Navy Flyover

Supplementary report to Interim Measures Version 01, 20/08/2019.

6th September, 2019

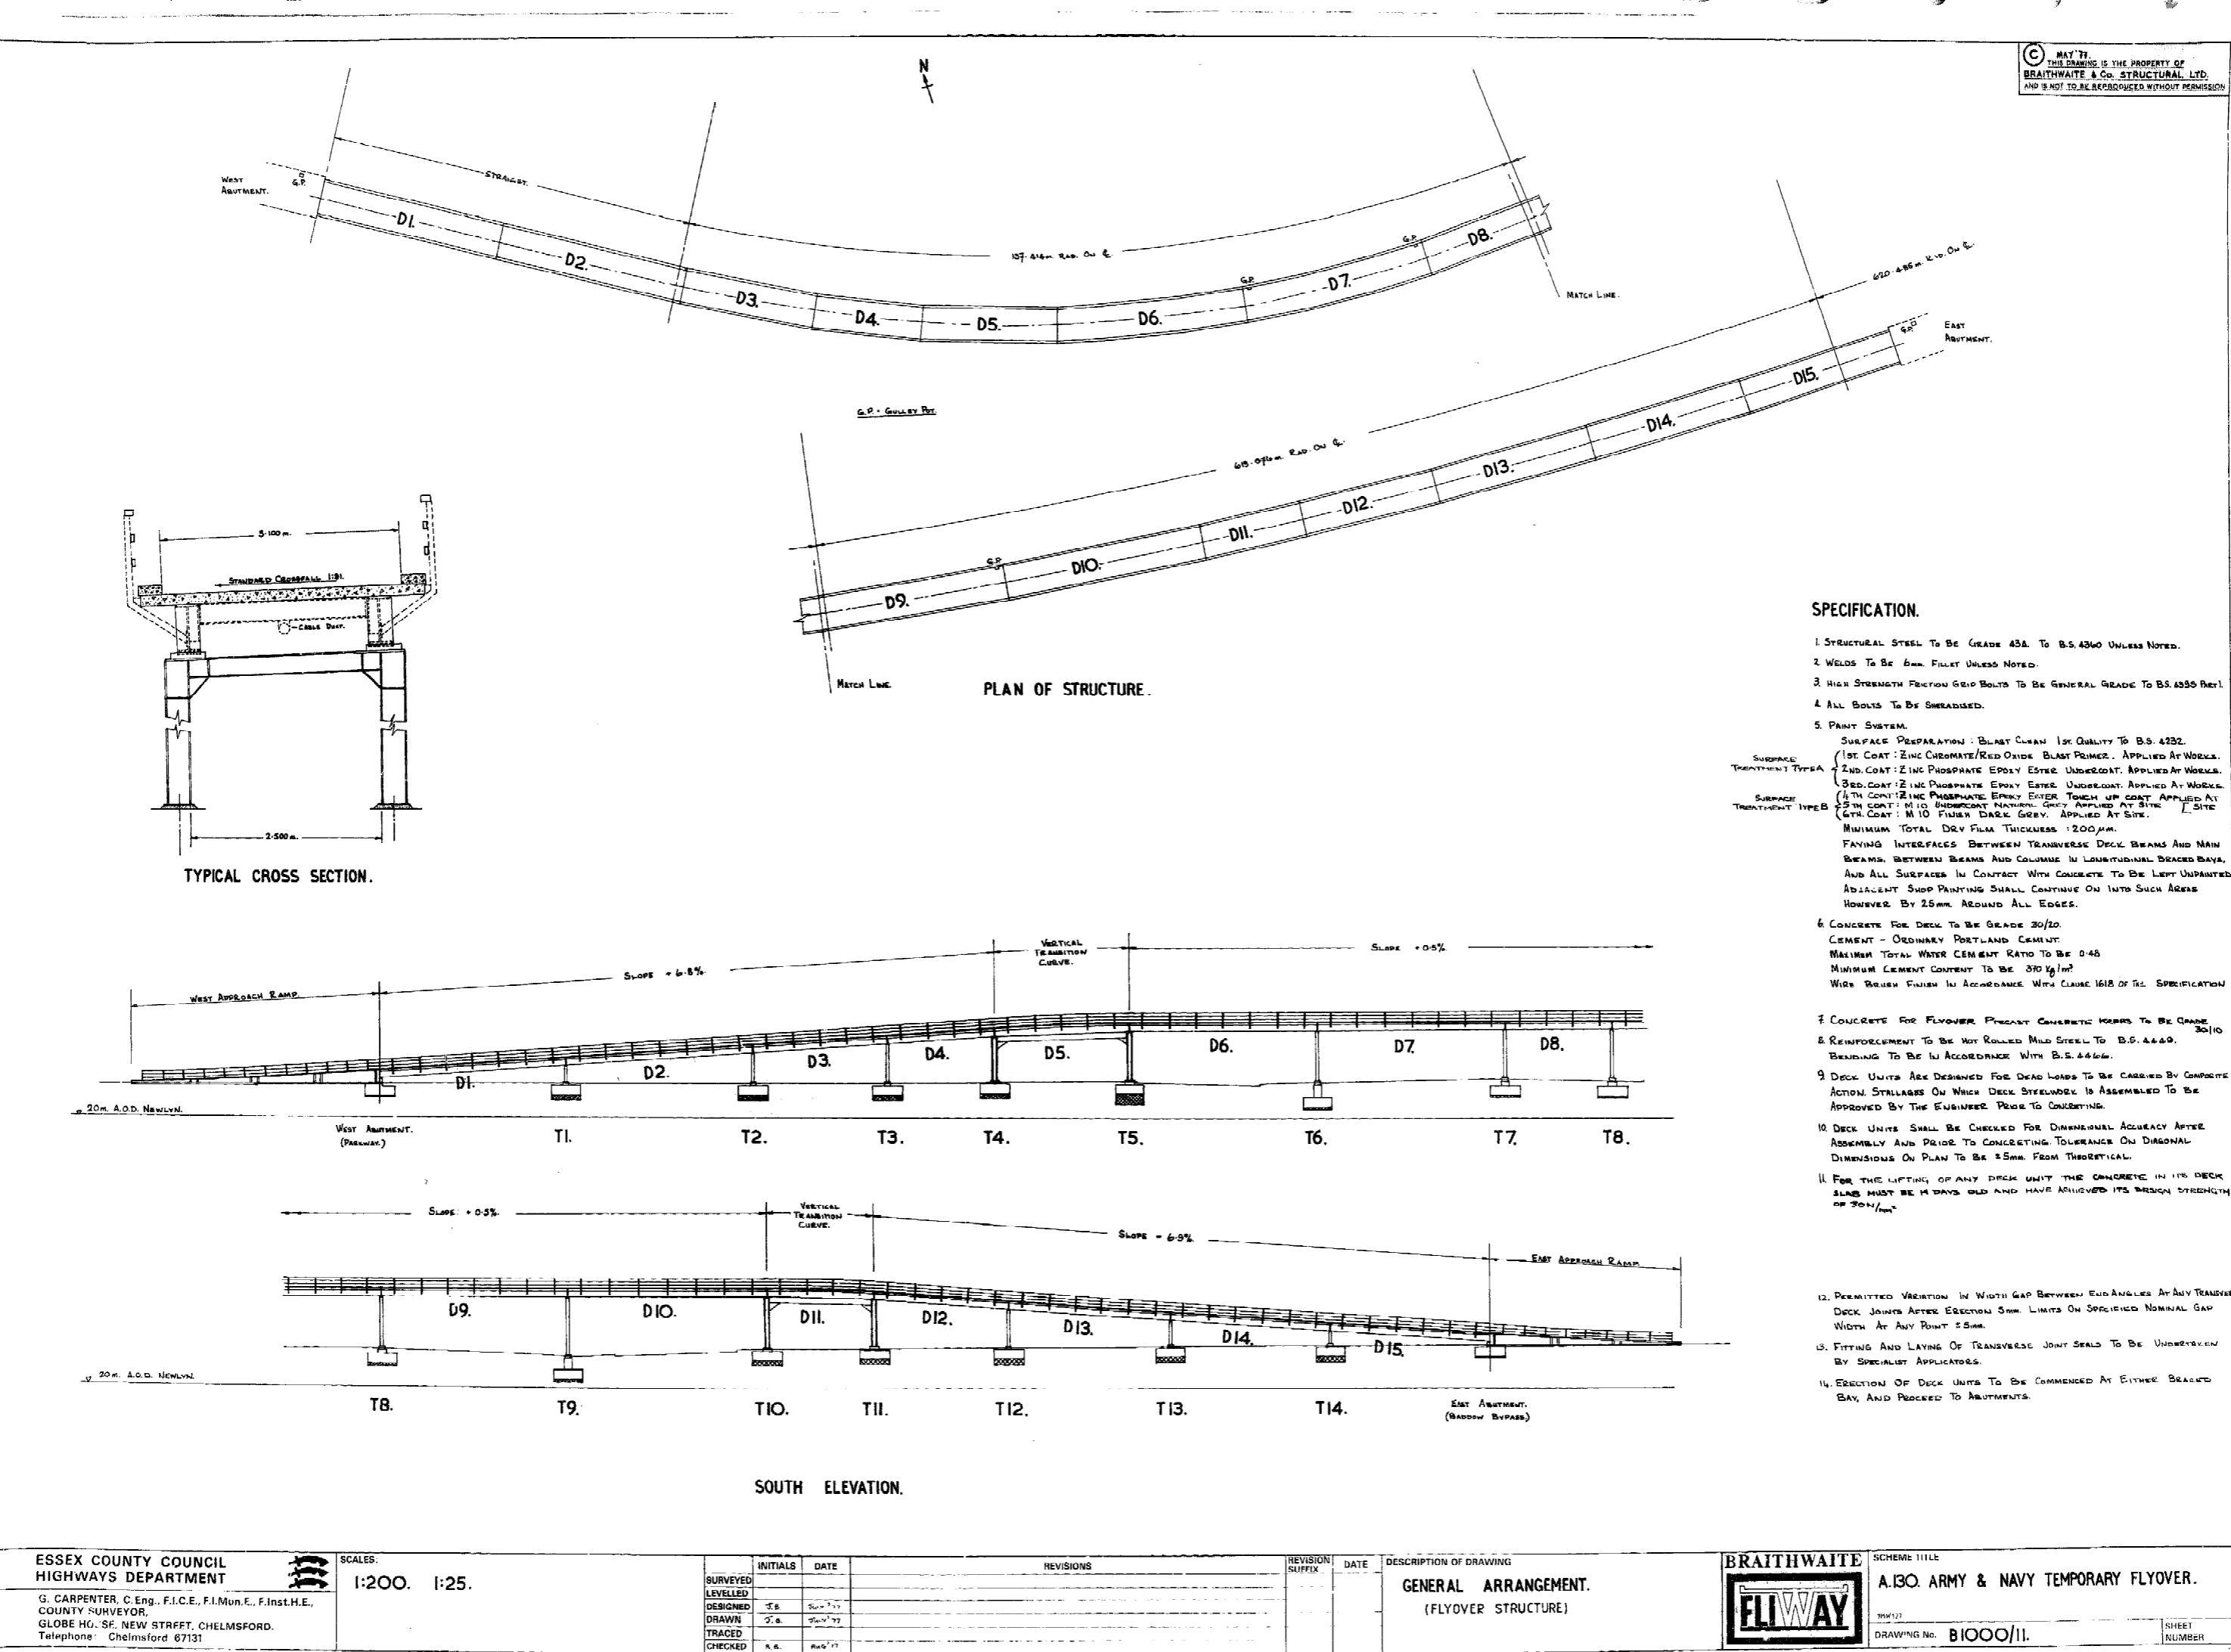
Appendix A – Record Drawing

The deck is supported by steel portal frame trestles consisting of a cross beam and two columns. Lateral stability of the structure is provided at each trestle by the cross beam with stiffened haunches that ensure portal frame action. Longitudinal stability of the structure is provided by additional framing that links four columns beneath spans D5 and D11 (see Appendix A).

For the purposes of this report, the bridge spans are numbered D1 to D15 from west to east as shown in Appendix A. Trestles are numbered T1 to T14, T1 being the first trestle in from the western abutment.
