Boxted Bridge - Questions and Answers

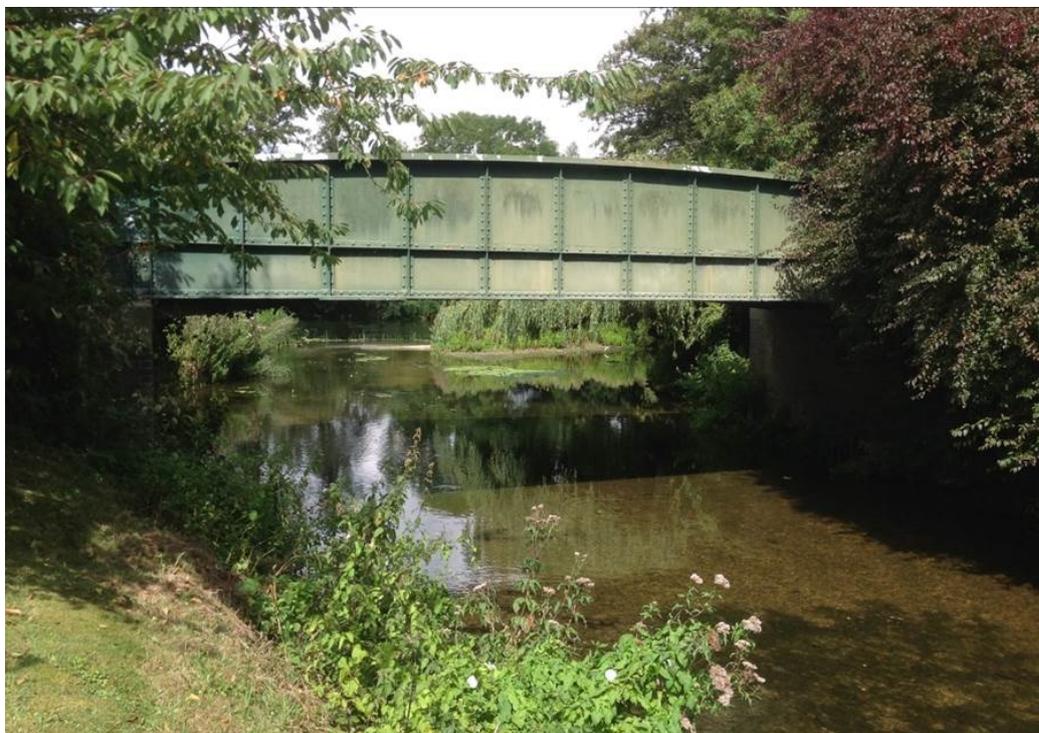
Below – Image 7 Existing structure

The bridge was constructed in 1897 and is nearing the end of its natural lifespan, as can be seen by the visual deterioration on the structure. Proposals are being considered for replacing the structure as a long-term solution, with inspections to monitor the condition of the structure increased from every two years to every six months in the meantime.
