TECHNICAL NOTE

Boxted Bridge ECC Br. No. 0059

Proving Load Test Commentary

December 2025

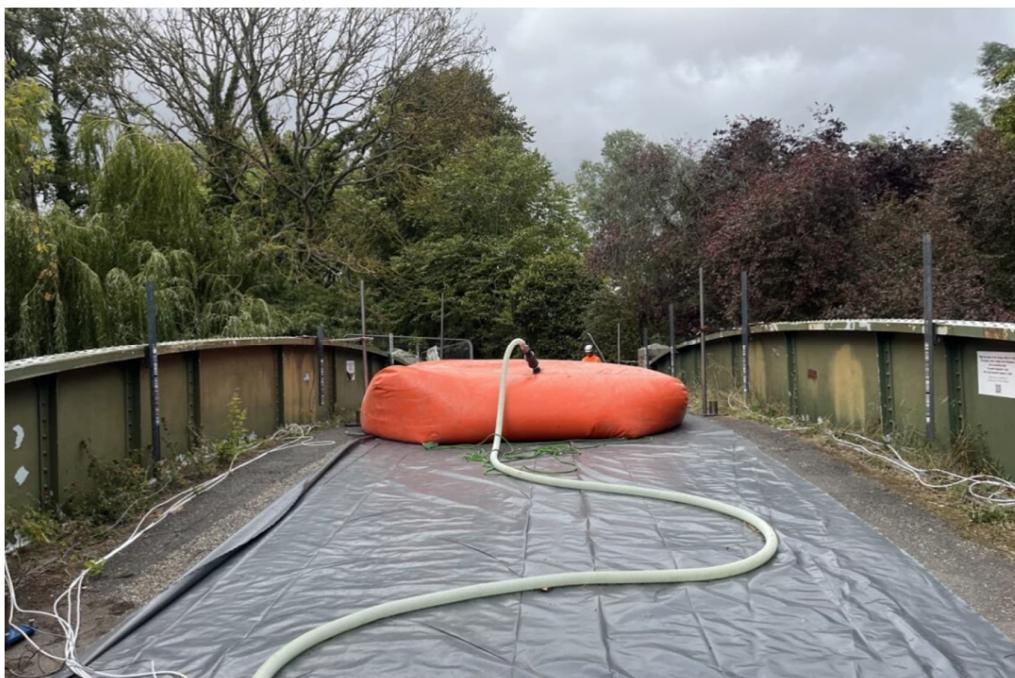
Figure 1. Boxted Bridge Load Test

The load test was carried out in accordance with CS 463. The pedestrian live load was simulated by a 3.4m x 3.4m water bag infilled with a prescribed volume of water, as shown in Figure 1 below. The volume was pre-determined to simulate the load effects of pedestrian traffic over a width of 2m through the centre of the bridge, i.e. 5kN/m² uniformly distributed load, multiplied by factors of safety of 1.1 x 1.5 = 1.65 in accordance with CS 454.

The load was applied in multiple stages including 1 tonne, 7.4 tonnes and 16 tonnes, each followed by full unloading to check for recovery of displacement. The 7.4 tonnes load was equivalent to the characteristic pedestrian load, while 12.2 tonnes is equivalent to the factored ultimate limit state pedestrian load (16 tonnes were applied for additional margin).

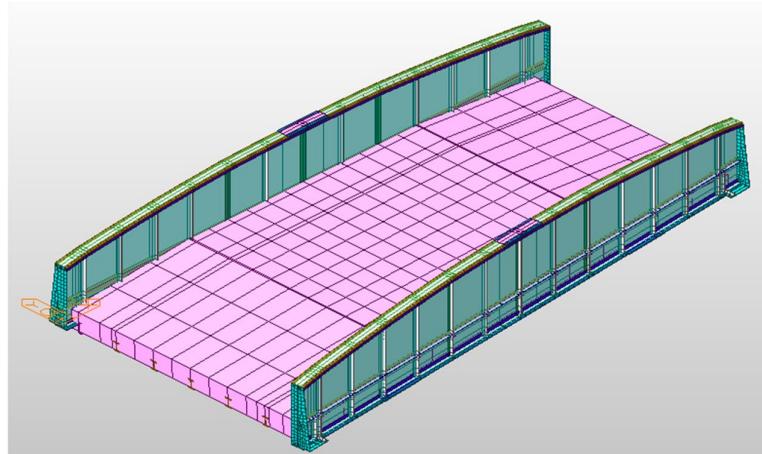
Figure 2. Boxted Bridge - Analysis Model

Structural analysis was undertaken by Ringway Jacobs/Essex Highways to determine the expected behaviour of the bridge, the maximum deflections expected in the load test as well as to aid the interpretation of the results from the test. The structure was modelled in a finite element software Midas Civil, where the edge girders and the concrete deck were modelled using plate elements, and the secondary beams using line elements. The test load was applied as a uniformly distributed load representing the weight of the 3.4m x 3.4m water bag. The temperature variations measured during the test were also applied in the model. Only the superstructure was modelled, with pinned support conditions. Various forms of analysis were undertaken, including:

- Linear elastic analysis,
- Geometric non-linear analysis – with the test load and temperature changes applied in increments,
- Variations of the above analyses with and without assumed initial imperfections in the edge girders,
- Variations of the above analyses with and without 'U-frame' action, i.e. with either full or no rotational stiffness at the connection between the cross-beams and the edge girders.

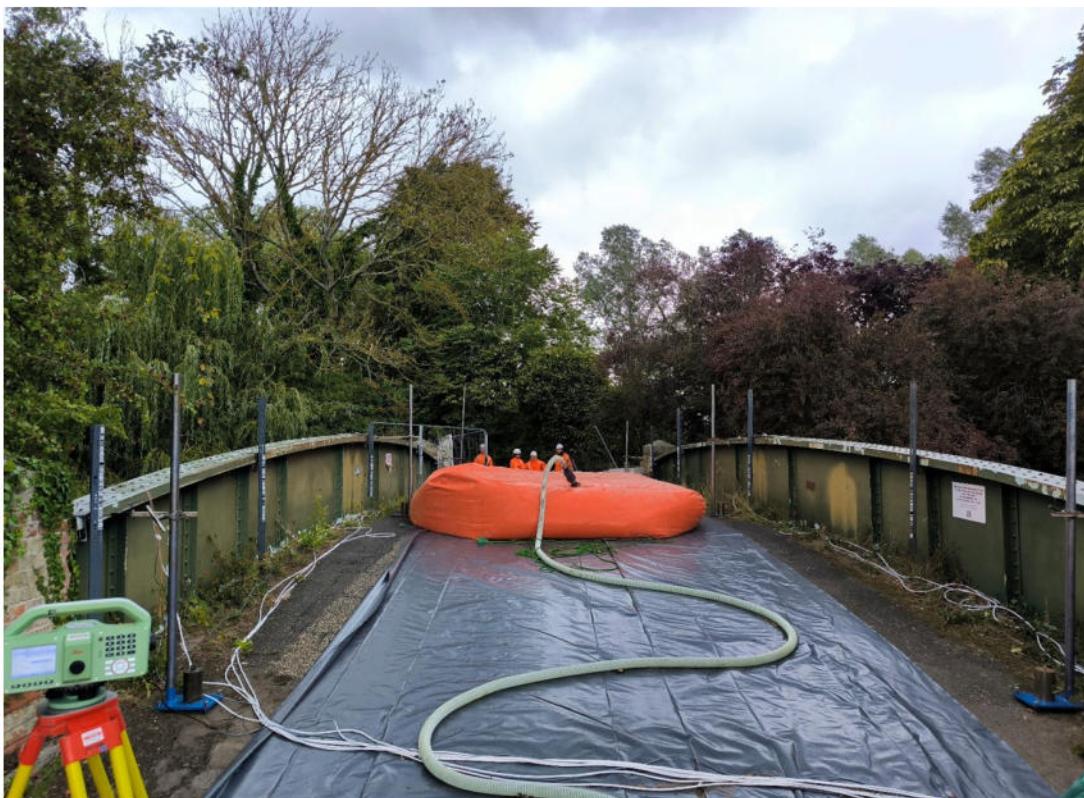
Figure 1 - Load testing of Boxted Bridge (load shown is approaching 12.2 tonnes)

This report presents factual data of the test. Results show behaviour within the stop criteria in all except the recovery of vertical displacement/deformation. An approximated recovery of 52% is measured compared to the desired criteria of 90%.

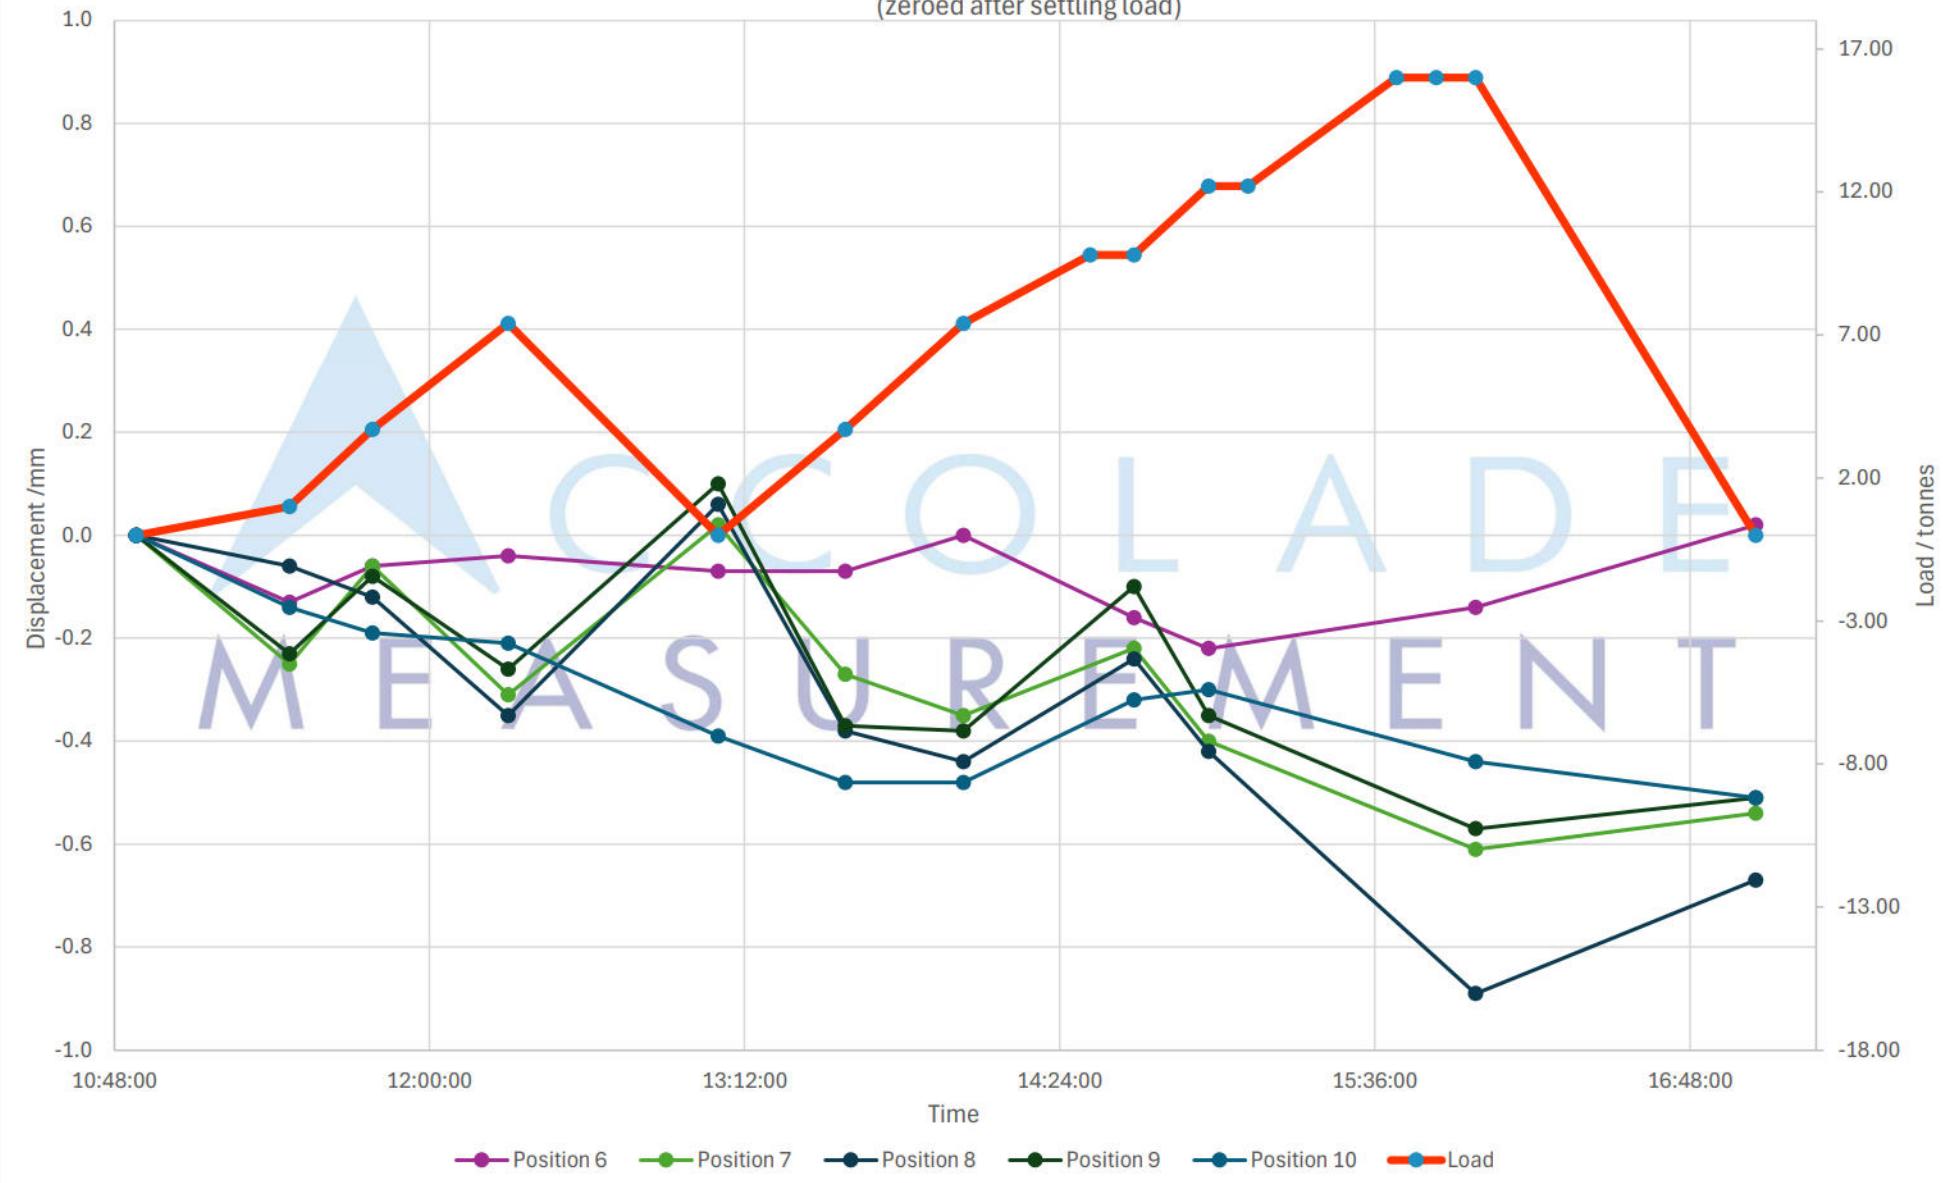
Boxted Load Test - Mid-span Vertical Displacement vs. Load
(zeroed after settling load)

During the load test, some vertical settlement without recovery has been noted at the north abutment's reference points after the final load was removed (see Appendix A):

It is possible that this settlement occurred due to the foundations 're-seating' considering the structure has not been subject to similar loads in a long time, since the bridge closure enforced in 2023. This settlement is not attributed to issues with the superstructure and is considered small considering the magnitude of the applied load.

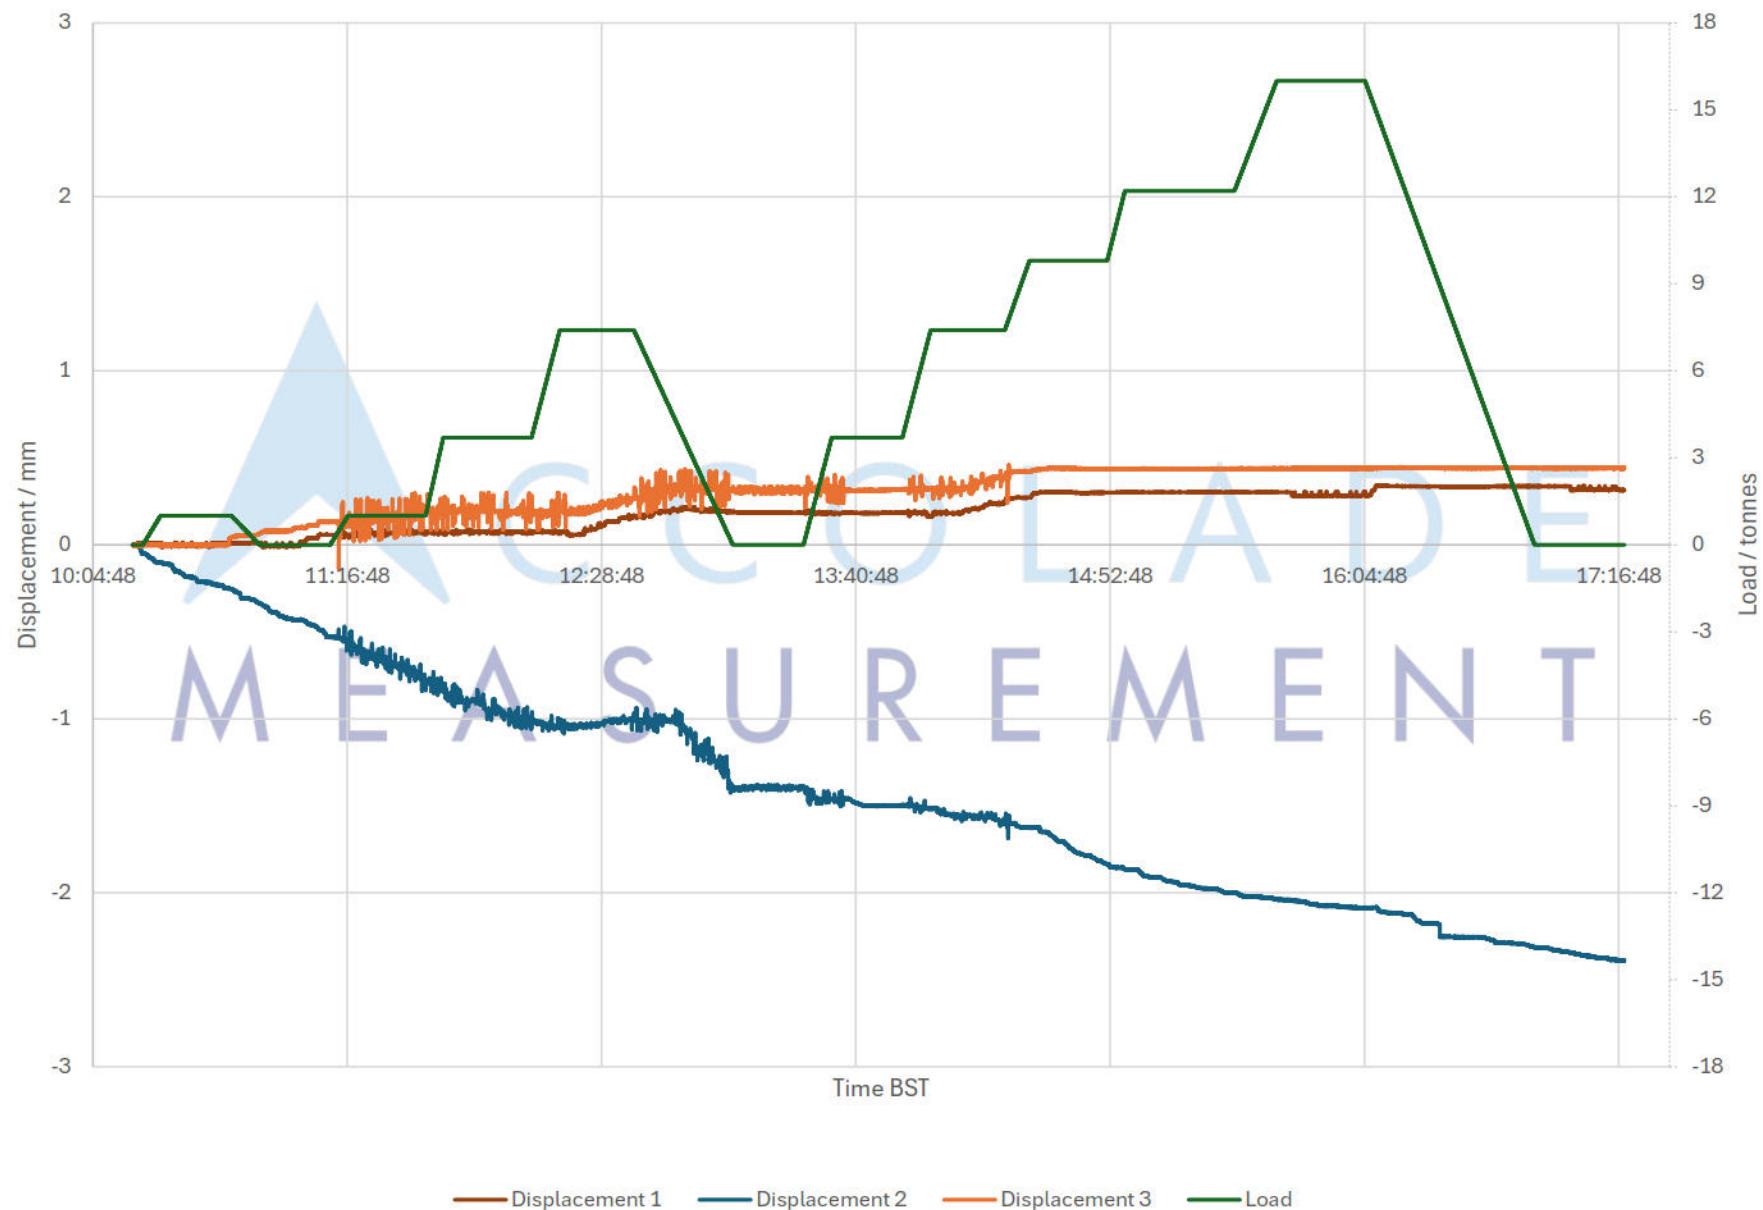
Boxted Load Test - Lateral Displacement (West) vs. Time

The readings from the displacement gauges generally are not as expected, as they indicate outward movements of the top flanges. In order to verify this, the data from the tilt sensors and inclinometers was also processed and the angles of rotation converted to horizontal movement, assuming the whole girder cross-section rotates by the measured angle – the results are included in Figure 4 and Figure 5 as well.

The results from the converted inclinometer and tilt sensor data generally show the expected and desired behaviour of the girders, where the top flange moves towards the bridge as the test load is applied, and recovery can be observed when the load is removed. These results also match the output from the analysis model within a reasonable range, especially at the east girder. Similar to the case with the vertical measurements, the differences can be explained by the limited accuracy of temperature modelling, as well as unknown horizontal support stiffness, unknown details of initial imperfections of the girders, and no account of corrosion section loss in the analysis.

No movement or instability was observed at the sensor mountings. However, the support for horizontal displacement sensor #5 at mid-span of the west girder was moved by contact with the water bag during the final load increment (16 tonnes). Data from that sensor at the affected increment has been noted, but excluded from the graphical representations.
