Spring Lane and Bakers Lane Route study Highway Improvements

September 2015

Report Title	Spring + Bakers Lane Route Study
Project Number	DC3330
Status	Final
Revision	-
Control Date	September 2015

Maldon Road Tiptree Proposed Footway Highway Improvements Team

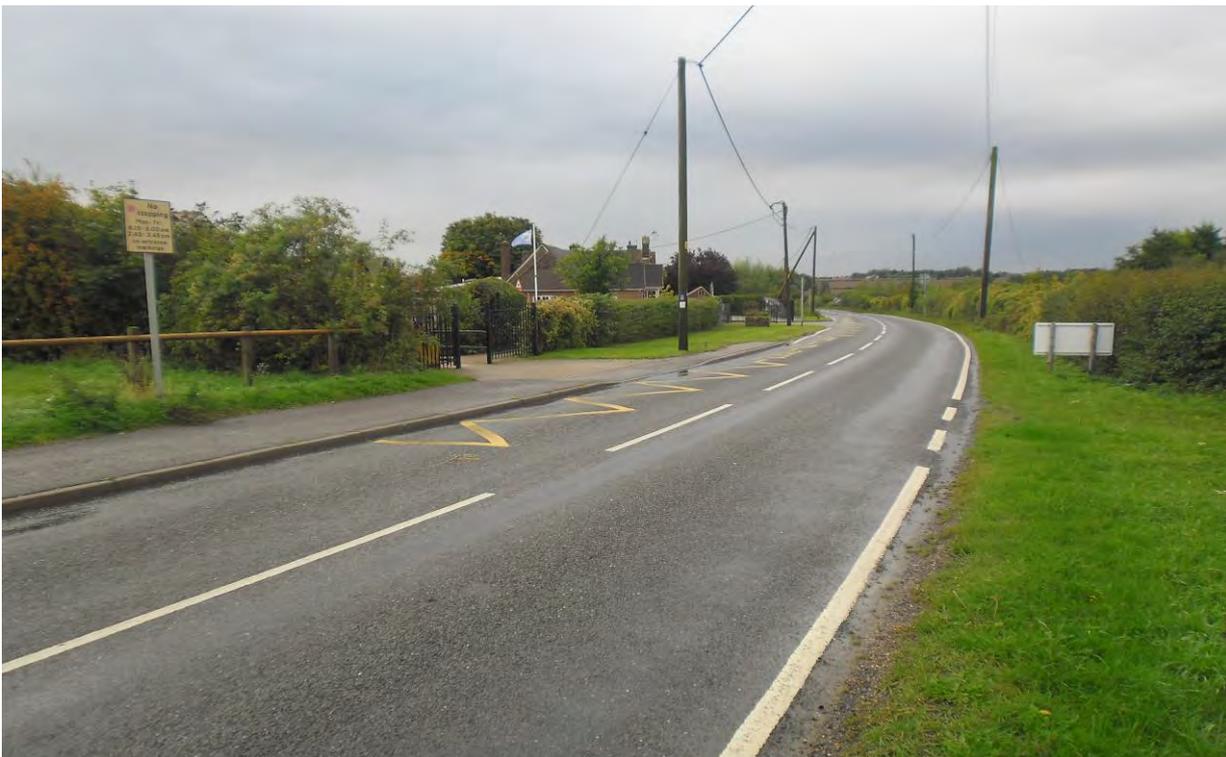
Figure 1: Mill Road section in front of School

The school is located on the eastern side of Mill Road close to where it meets Church Road. Mill Road is bounded by verges on both sides and hedges. There are overhead power lines and poles positioned at the rear of verges. The measured width of the Mill Road adjacent to the school entrance is 5.9m

3. There was a School Crossing Patrol Unit for southbound vehicles but this was some distance from the patrol site, currently located at the Church Road Junction with Fiddlers Hill.
4. The lack of guard railing outside the pedestrian entrance to the school.
5. A school warning sign on the southbound approach to the school
6. 2 sets of School Zig Zags have currently been installed on the road to cover both entrances to prohibit vehicles parking at such entrances as seen in Figure 1.
7. Vegetation obscuring School warning signs.
8. Overhead BT and UKPN cables.
